NGE-TFT Project # 5731-20

Southcentral Foundation  
4501 Diplomacy Drive  
Anchorage, AK 99508

**RE: SUMMARY OF FILL PAD CONSTRUCTION MONITORING ACTIVITIES FOR  
THE PLANNED TAKOTNA HEALTH CLINIC – TAKOTNA, ALASKA**

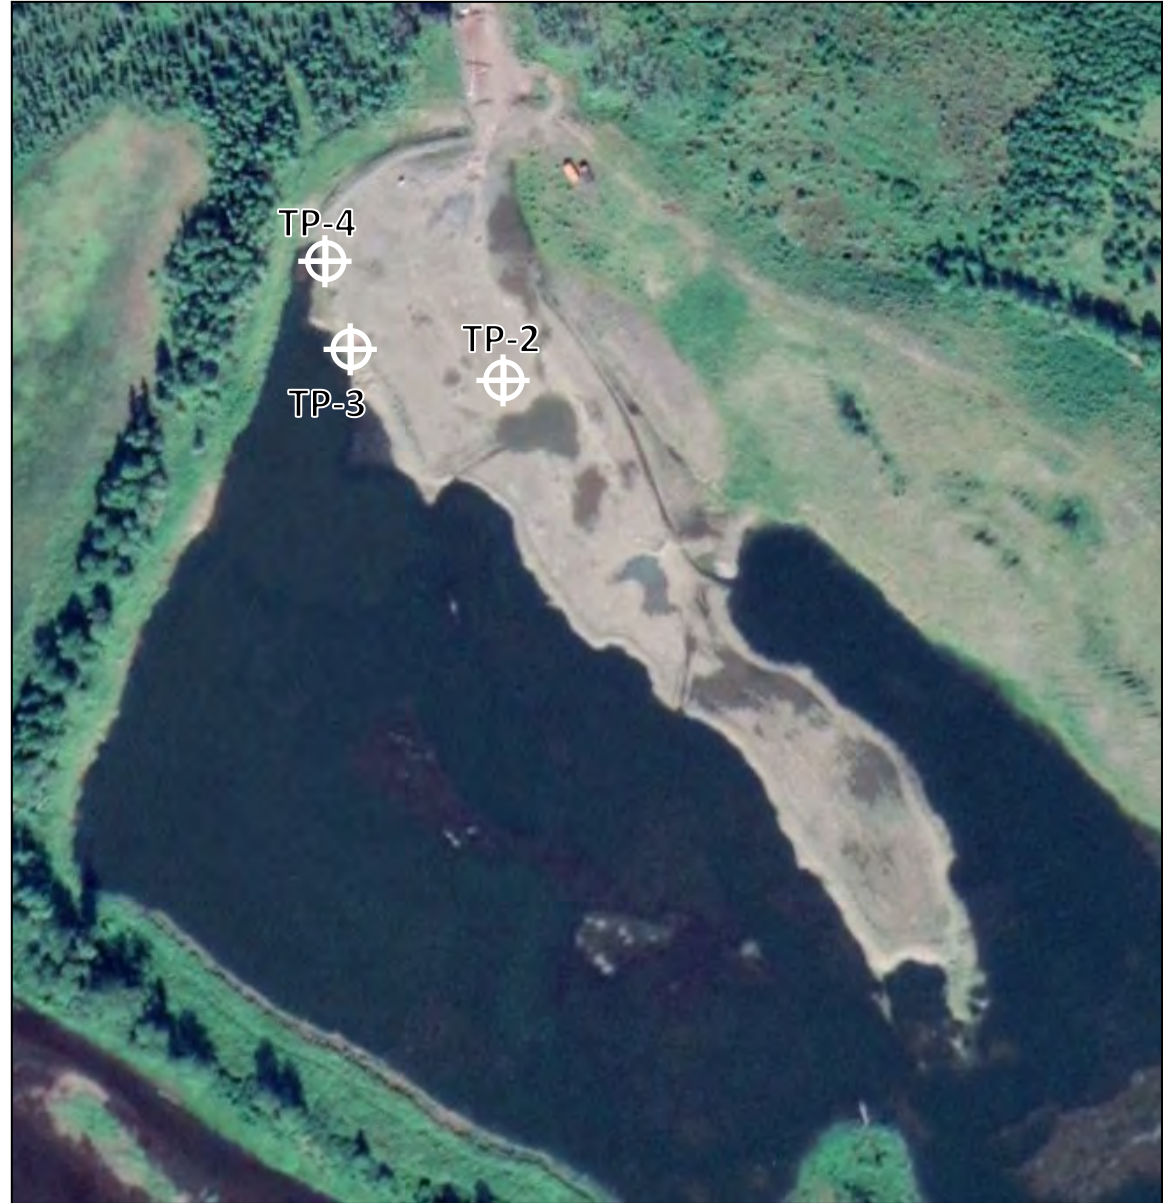
FIGURE TITLE:  
 BORROW PIT SITE AND SAMPLING LOCATIONS

To aid in the sourcing of suitable filter material for construction of the on-site septic system, we collected soil samples from the existing borrow pit site located at the northeast end of the Takotna airport. We have detailed the borrow pit site and sampling locations in Figure 1 of this letter. We collected three representative samples from prospective areas in the borrow pit (Attachment A, Photos 9 through 11). The sampling locations included a windrow of reworked borrow material which appears to have the most favorable gradation for filter sand production. We submitted our borrow source samples to our Anchorage laboratory for gradational analysis. We have included the results of our laboratory analysis in Appendix C of this letter.

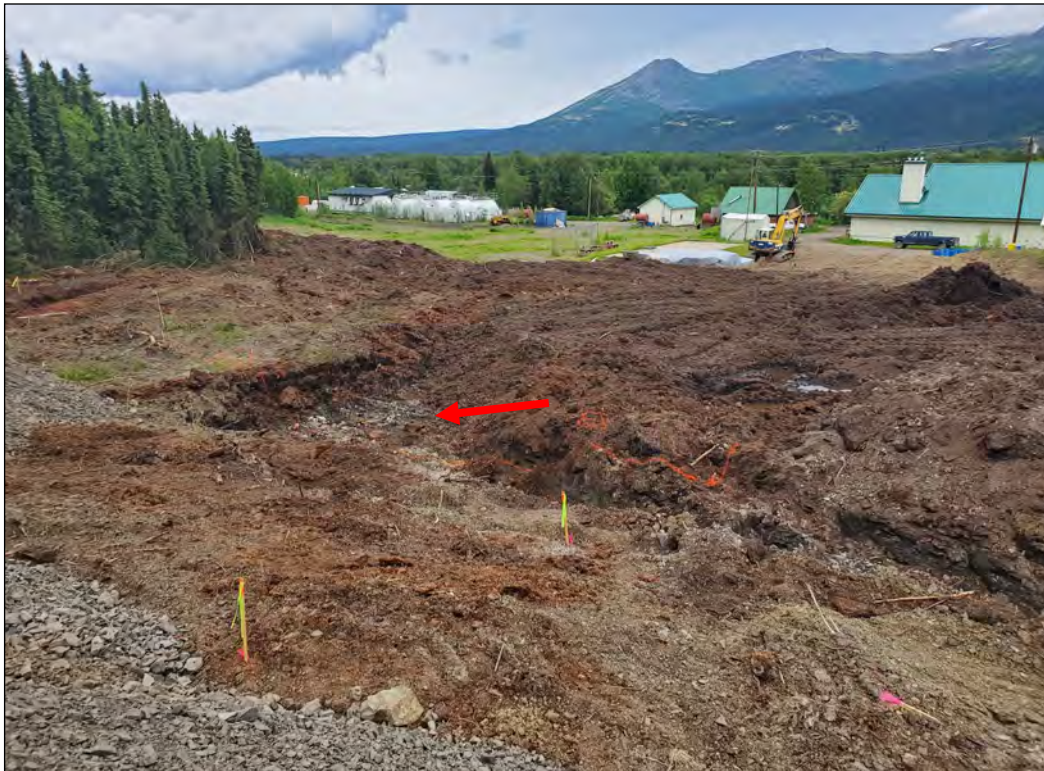
A recent excavation was found to be partially within the footprint of the northern side of the pad (Appendix A, Photo 1). As per our recommendation, the organic soils were completely removed from all areas within 10 feet of the footprint of the clinic structure (Appendix A, Photo 2). Following the removal of the organic materials. We inspected the bottom of the excavation to ensure that all organic soils were completely removed to both their lateral and vertical extents, and confirm that the subgrade mineral soils are as we anticipated. Following our inspection, the bottom of the excavation was graded level with a minimal amount of imported structural fill and a layer of Geogrid material was installed across the bottom of the excavation and the first lift of structural fill was placed (Appendix A, Photos 3 and 4) above it and track-rolled using the available excavation equipment. Fill compaction efforts for the first lift were hampered by excessive moisture in the excavation which tended to accumulate at the lower areas of the excavation. As such, to avoid damage to underlying geogrid due to the displacement of fill under equipment, the compaction efforts for the first lift were halted before uniform compaction could be achieved (Appendix A, Photo 5). Following compaction, the surface of the fill was inspected and two areas

**Photograph 1: Proposed pad footprint (orange paint) looking south, northwest corner in foreground with existing excavation partially within footprint (red arrow).**

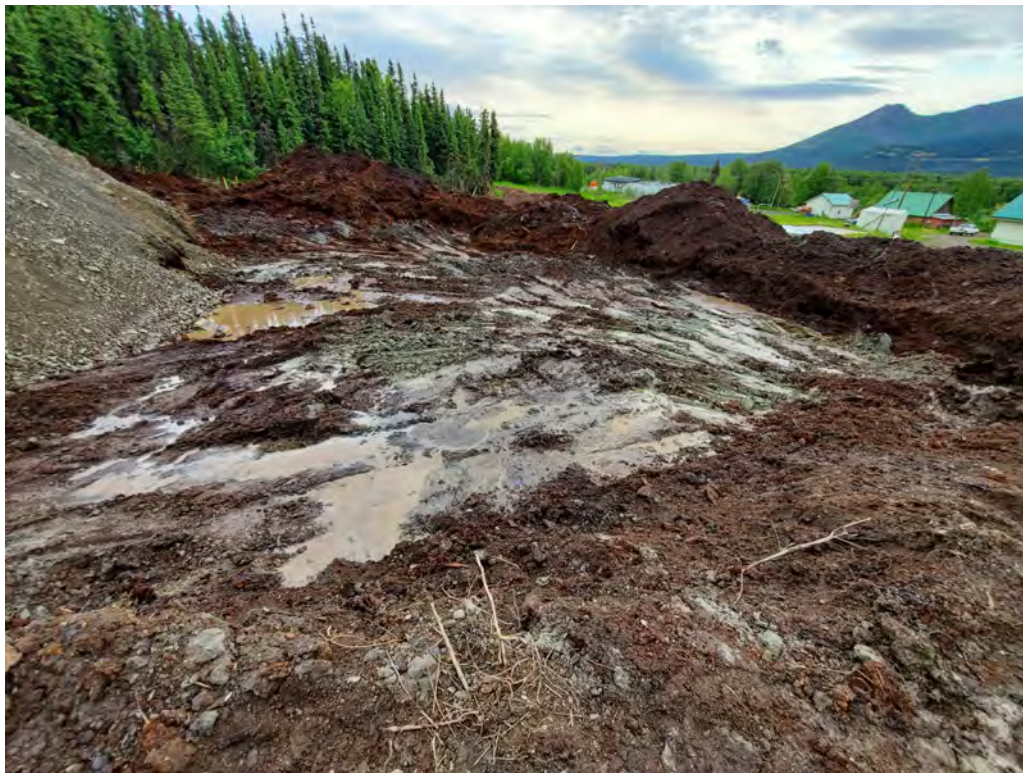
**Photograph 2: Completed excavation. Looking east from west side of pad footprint.**

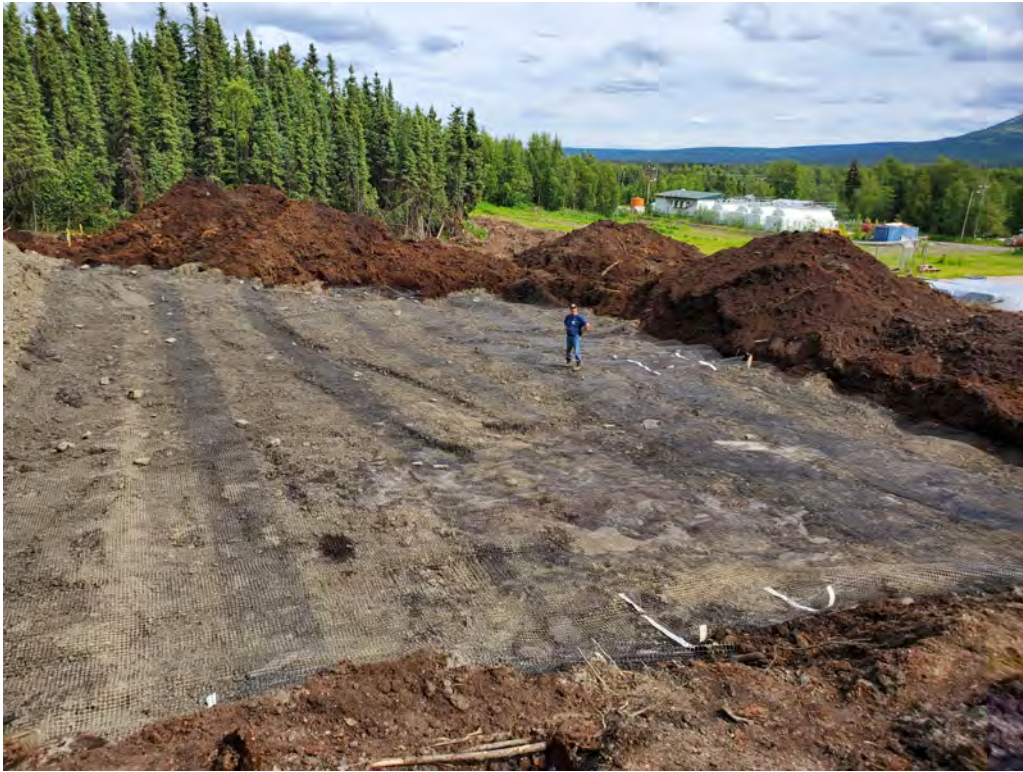
**Photograph 3: Photograph of Geogrid laid over leveling course.**

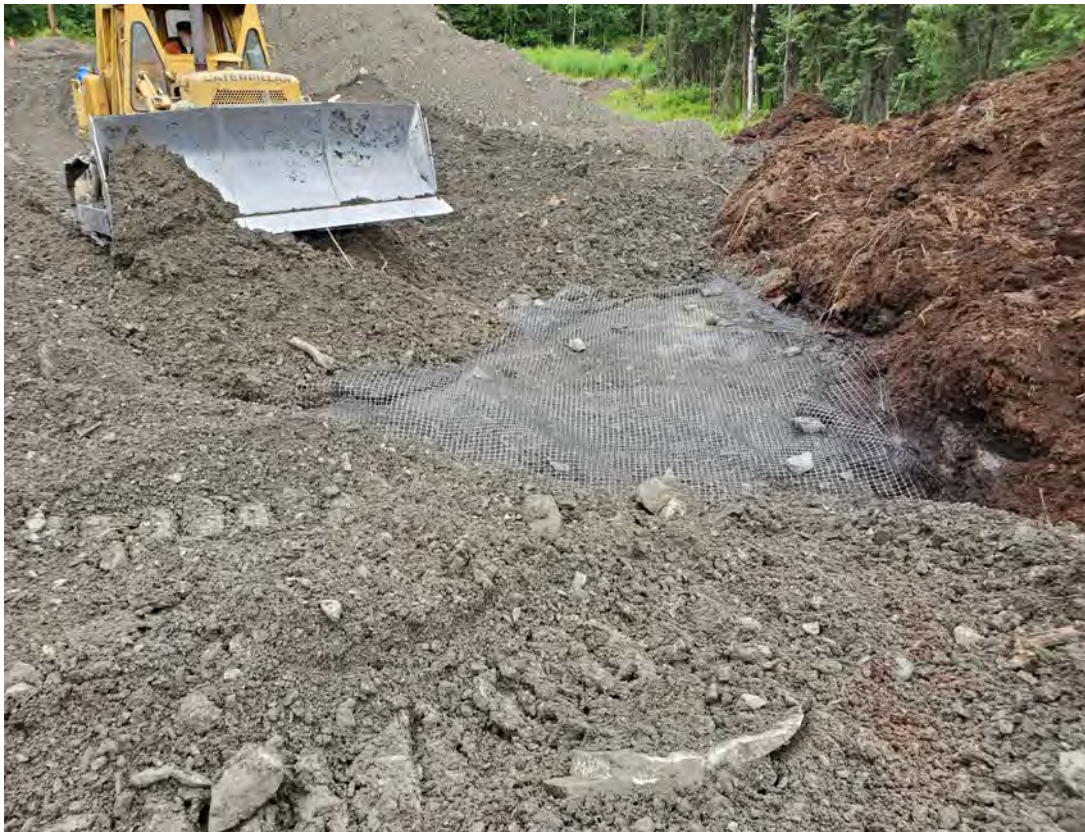
**Photograph 4: Photograph of fill placement over Geogrid (first lift).**

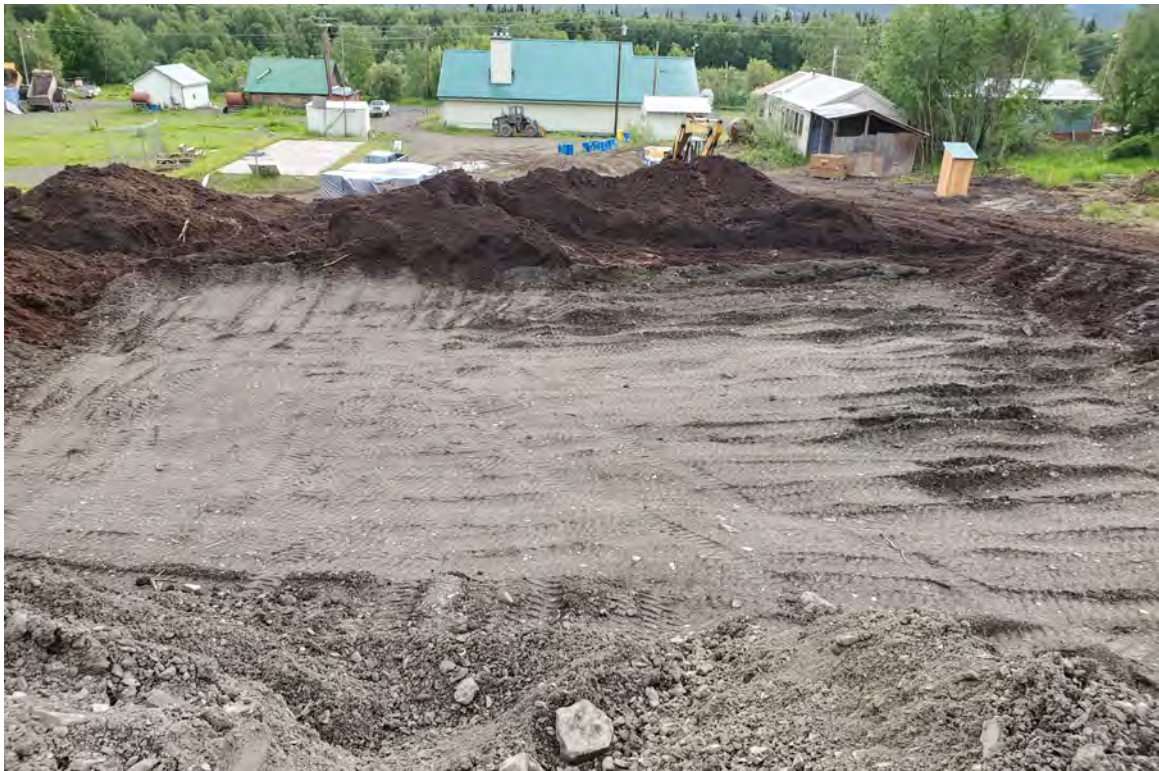
**Photograph 5: Fill pad after compaction of first lift.**

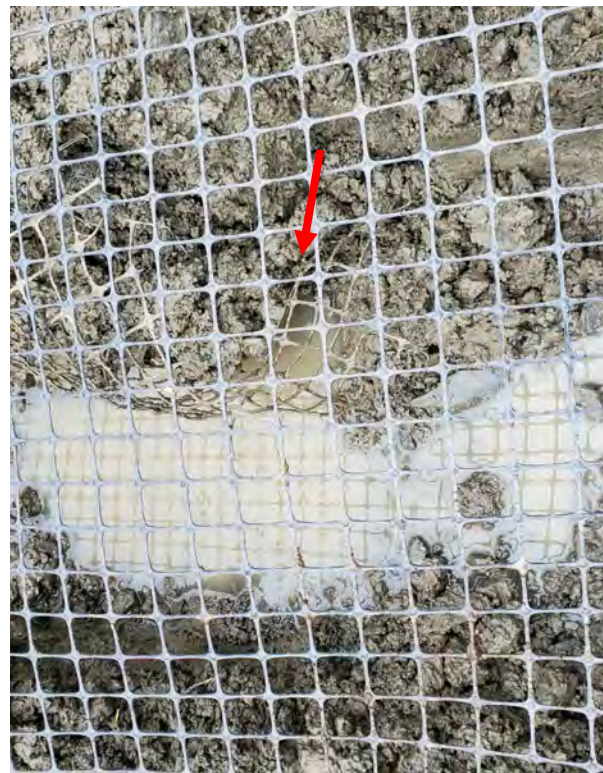
were found to have exposed geogrid which appeared to have migrated to the surface of the fill and potentially sustained minor damages, likely from contact with equipment. To repair these potentially damaged areas of the geogrid we instructed the contractor to apply a supplemental layer of geogrid across the damaged geogrid sections (Appendix A, Photos 6 and 7). These repairs (i.e., patches) consisted of full width strips of geogrid cut to 30 foot long to provide ample overlap given the uncertainty with respect to inferred potential extent of damage to the original layer of geogrid. Next, a two to three foot thick lift of fill was placed across the entire excavation foot print. We monitored the placement of additional fill to ensure adequate thickness of fill protect the Geogrid and avoid damage during compaction efforts (Appendix A, Photo 8). At this point we concluded our construction monitoring efforts. Our daily field reports are provided in Appendix B of this letter.

**Photograph 6: Photograph of exposed, potentially damaged Geogrid (arrow), with repair patch overlaid.**

Two locations had geogrid exposed which migrated to surface and had been sliced though it did not appear that the geogrid strip had been completely cut through. Likely just a wrinkle from edge of strip at overlap.

install placed (2) "patches" of geogrid to span areas which had possibly been damaged.

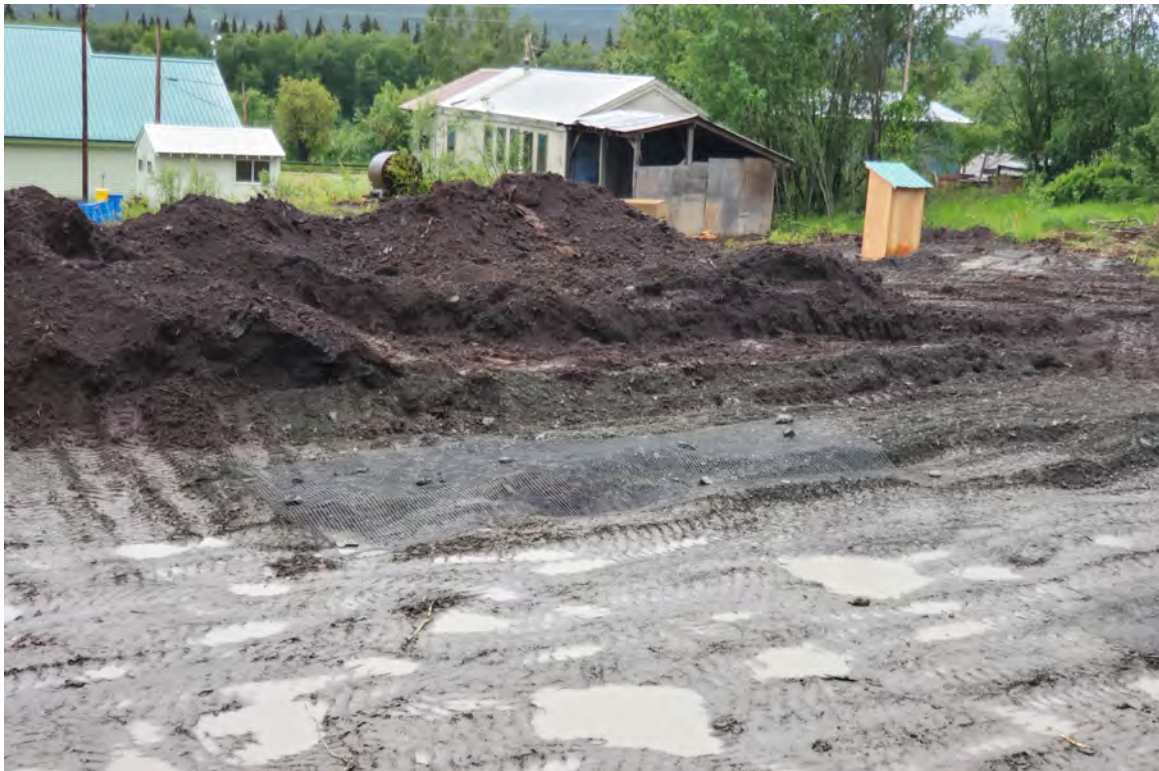
**Photograph 7:** Photograph of a repair strip of Geogrid placed over first lift at south side of pad.

The "patches" were 30' long strips of geogrid

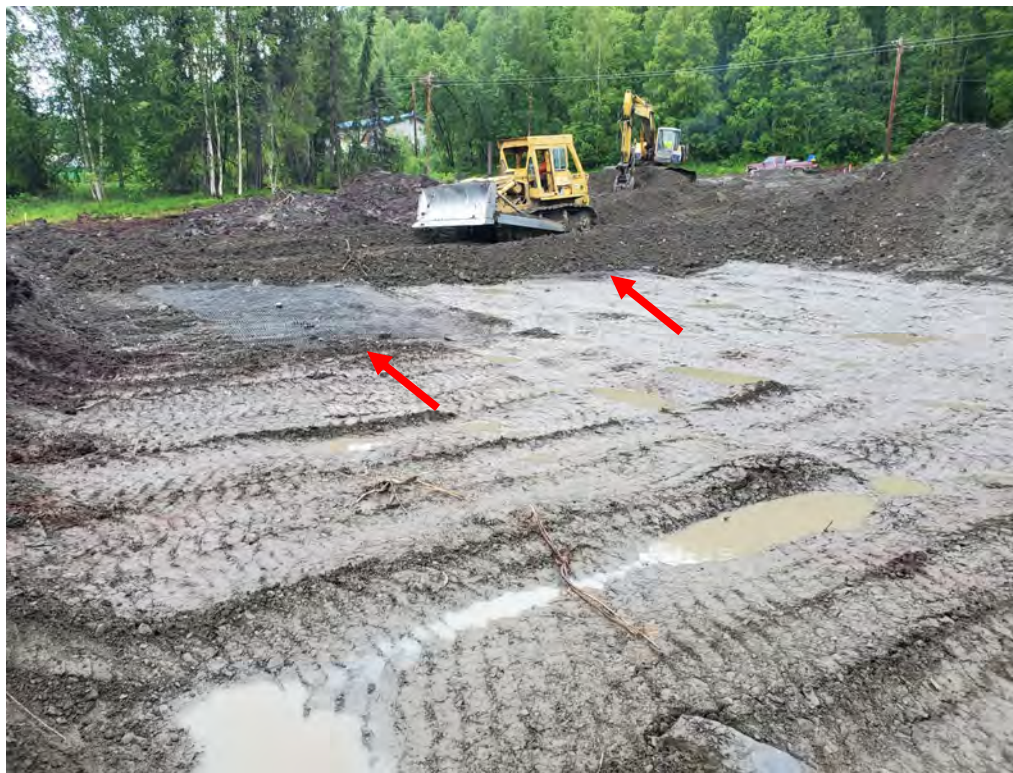
**Photograph 8:** Photograph of fill placement over Geogrid repair patches. View is looking west, location of repairs indicated with red arrows.

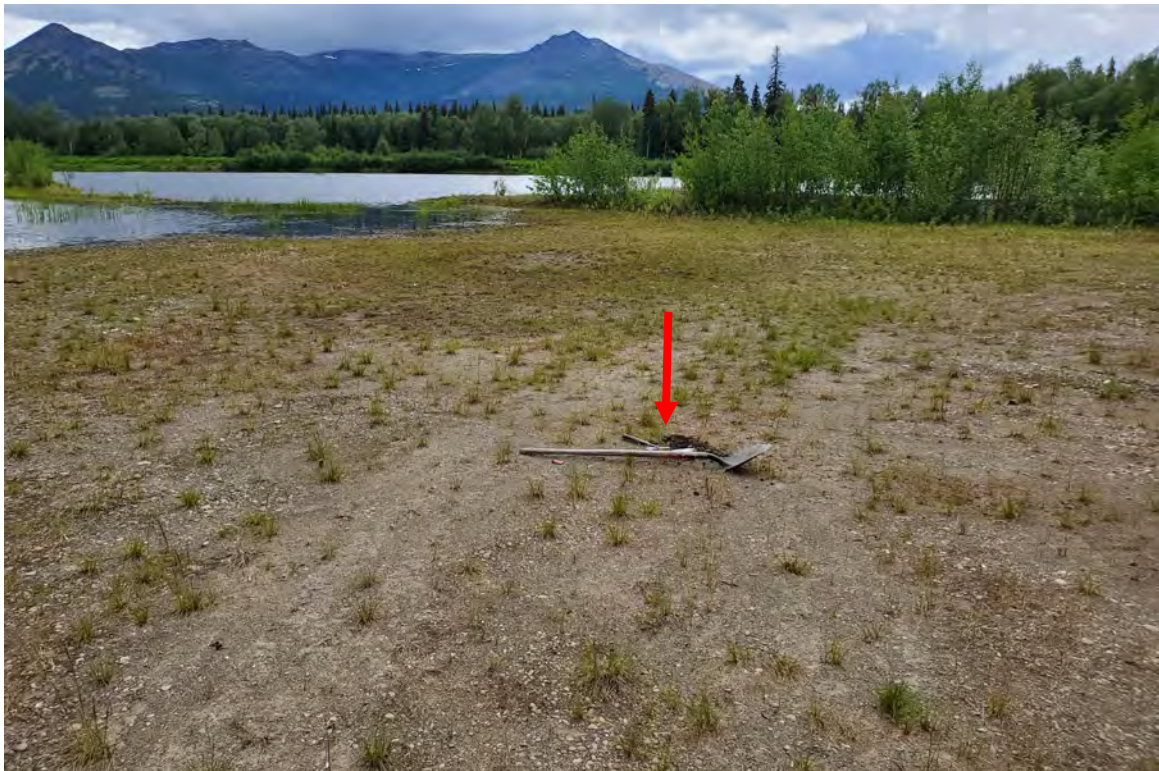
**Photograph 9:** Photograph of Test Pit #2 sampling location at Borrow pit site.

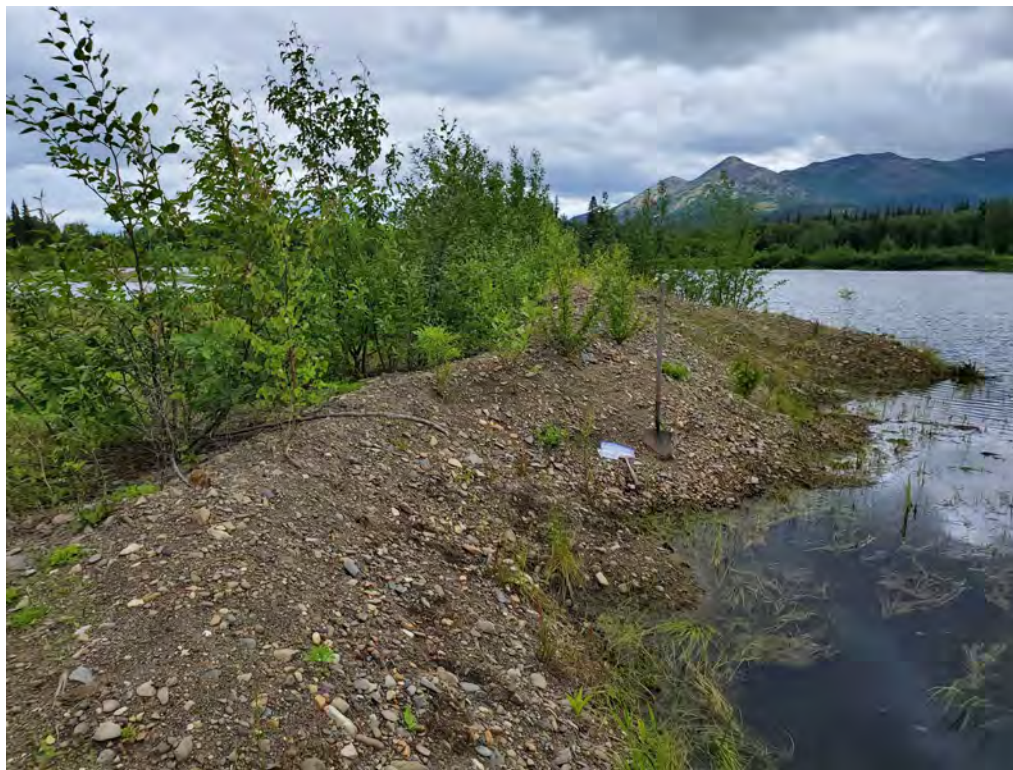
**Photograph 10:** Photograph of Test Pit #3 sampling location, windrow of reworked material.

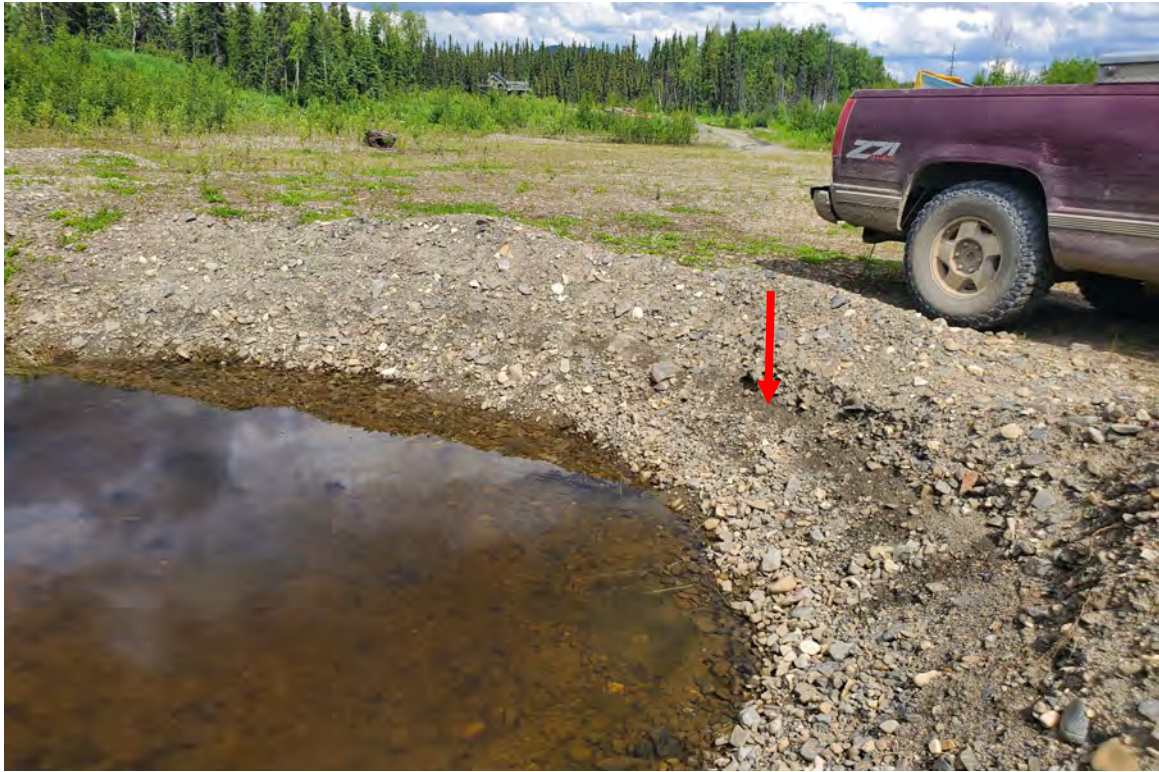
**Photograph 11: Photograph of Test Pit #4 sampling location at Borrow pit site.**
