4450 Flattop Garage Brick Removal Report

10/29/2020 - We finished removing most of the loose thin brick from the North and South shear walls on the Flattop Garage.

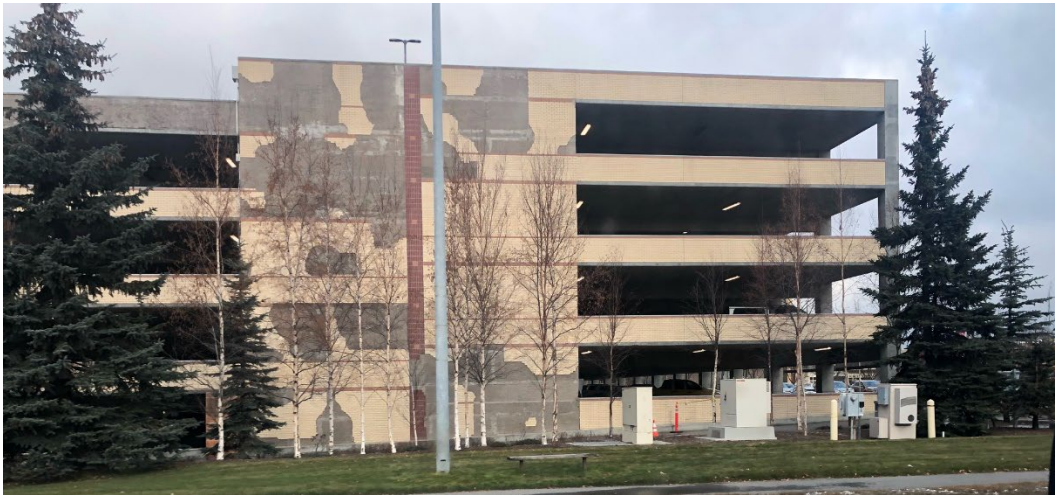
South Side

The South side of the garage had sporadic delamination of the brick comprising of about 60% - 70% of the total surface area. To safely remove the brick the Southcentral Foundation Sign had to be removed from the garage. We removed roughly 99% of the loose brick, a few loose bricks were left in the middle of solid fields of brick.

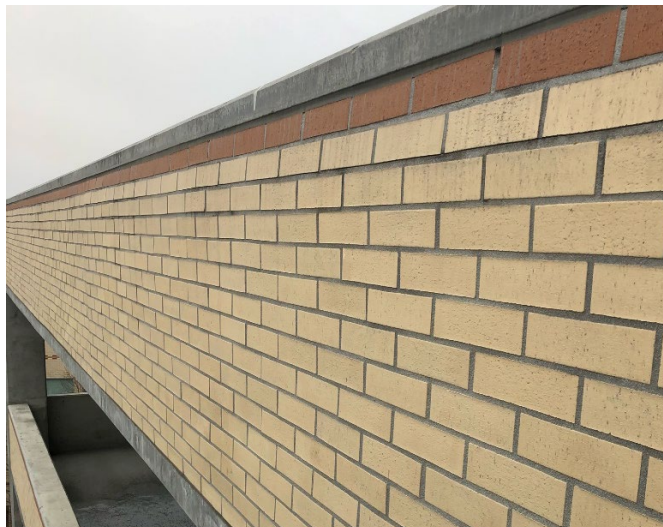
The area of brick on the top left of the South side was in such poor condition creating a safety hazard, we removed it immediately upon discovery.

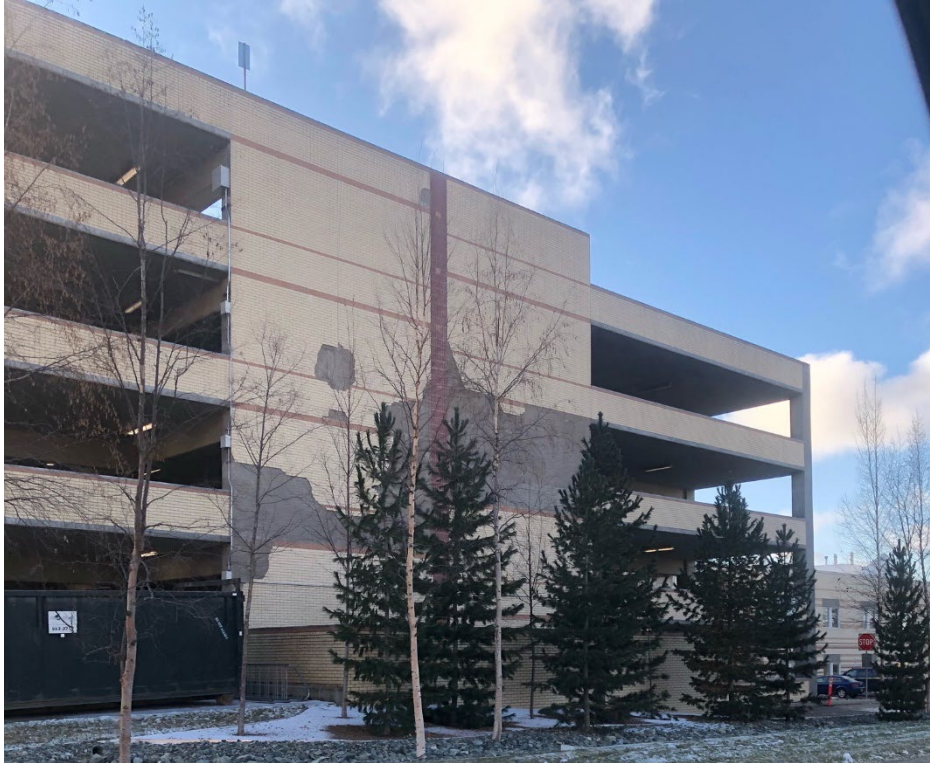
The North Side of the garage had much larger sheets that had failed and were ready to come down with the slightest manipulation. The total amount of failed brick on the shear wall was in the 20-30% range. We removed approximately 99% of the loose bricks, leaving only a 1-2 bricks in the middle of solid fields in a couple of places.

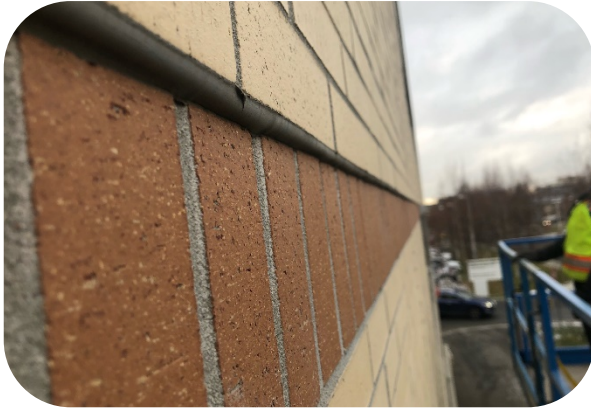
Caulking holding the
brick in place.

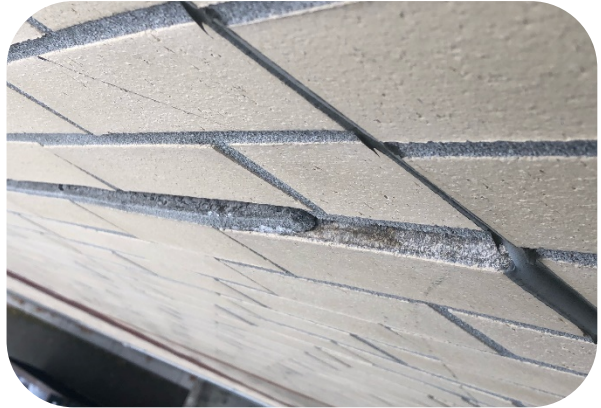
Grout lines cracking and
brick sheets peeling
away from wall.

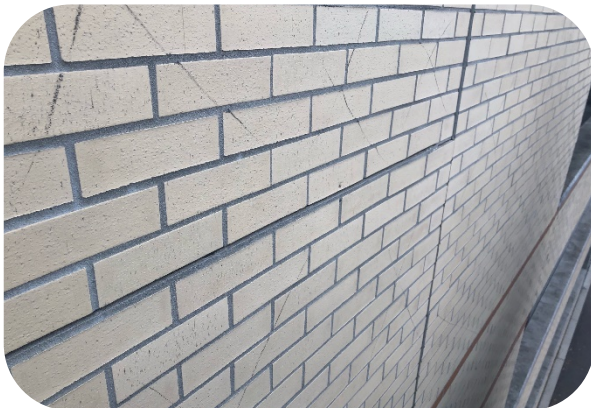
Failed Sheet.

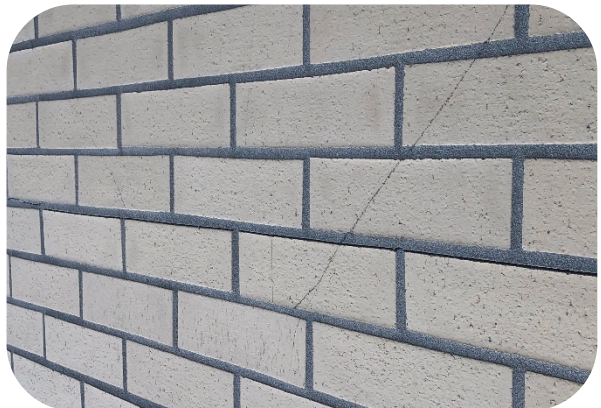
Cracking sheet.
