3606 RHONE CIRCLE
ANCHORAGE, ALASKA

LIMITED HAZARDOUS BUILDING MATERIALS INVENTORY

SEPTEMBER 2023

Submitted to: **Bill Paulsberg**
Director of Facilities
Southcentral Foundation
4501 Diplomacy Drive
Anchorage, Alaska 99508

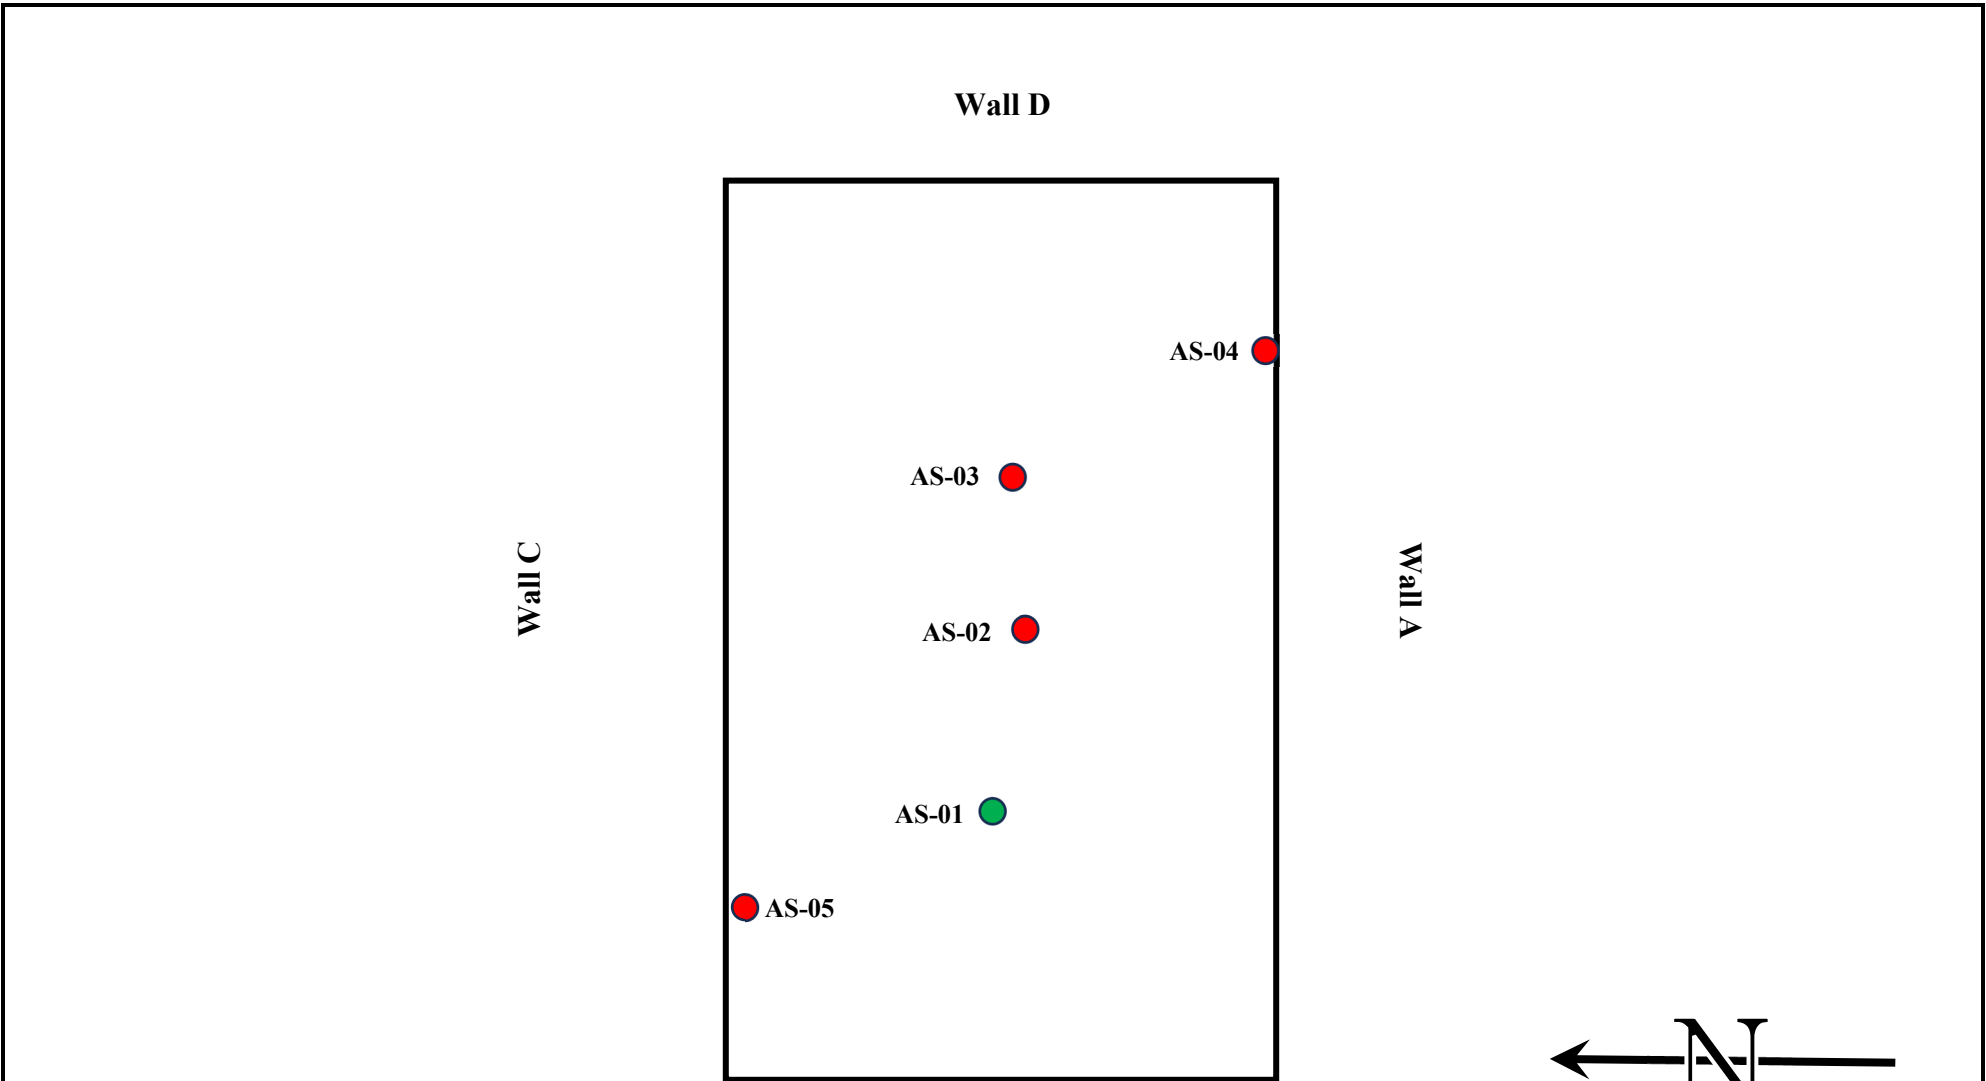
September 2023	Figure 1
---	----------------	----------

A total of 6 bulk samples (5 samples with 1 additional layer) were collected from PACBM identified in the inspected areas on the roof of the building at the subject property (Figure 1). The samples were sent to an accredited laboratory and were analyzed using Polarized Light Microscopy (PLM), in accordance with EPA Method 600/R-93/116. According to the National Emissions Standard for Hazardous Air Pollutants (NESHAP), Asbestos-Containing Materials (ACMs) are defined as containing at least 1 percent asbestos; including but not limited to chrysotile, amosite, tremolite, actinolite, and crocidolite asbestos. Samples were collected from roofing materials. Four of the samples were found to contain 2 percent chrysotile asbestos and are therefore considered to be “asbestos-containing” according to the NESHAP definition.

ACM ID #	Testing Location	Building Component	Result	Approximate Area (estimated total for unit/common area)
AS-02	Central Roof	Roofing Material	2% Chrysotile	4,243 Square Feet
AS-03	Central Roof	Roofing Material	2% Chrysotile	
AS-04	Southeast Roof	Roofing Material	2% Chrysotile	
AS-05	Northwest Roof	Roofing Material	2% Chrysotile

Positive ACM Sample Locations

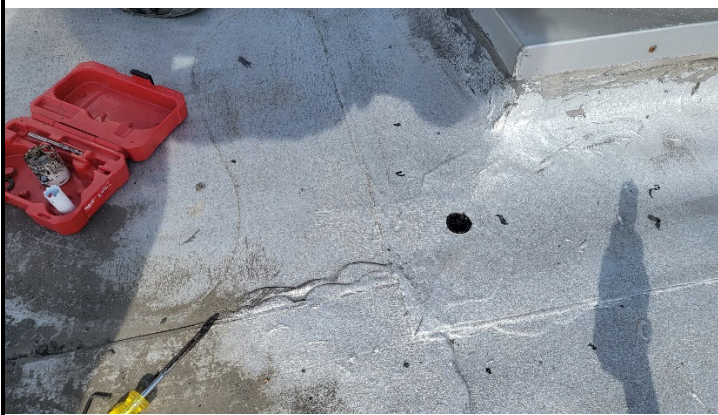
Photo 1. Sample AS-02 – Central Roof; Roofing Materials.

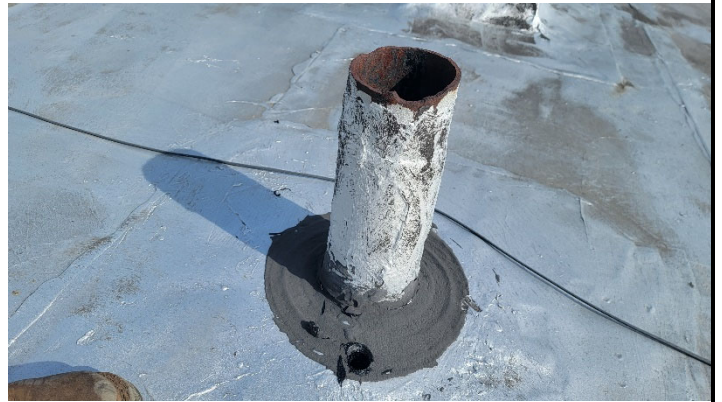
Photo 2. Sample AS-03 – Central Roof; Roofing Materials.

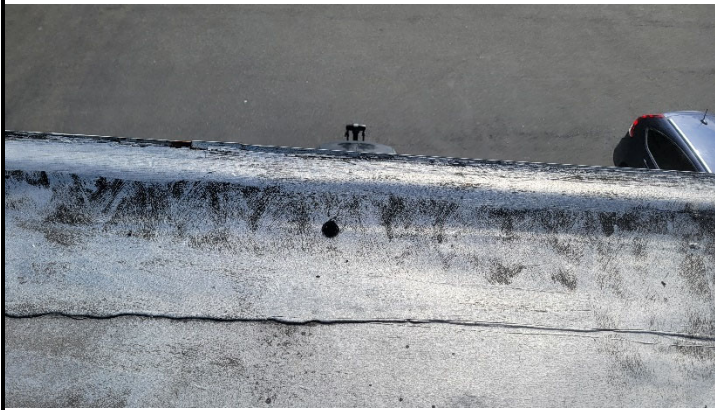
Photo 3. Sample AS-04 – Southeast Roof; Roofing Materials.

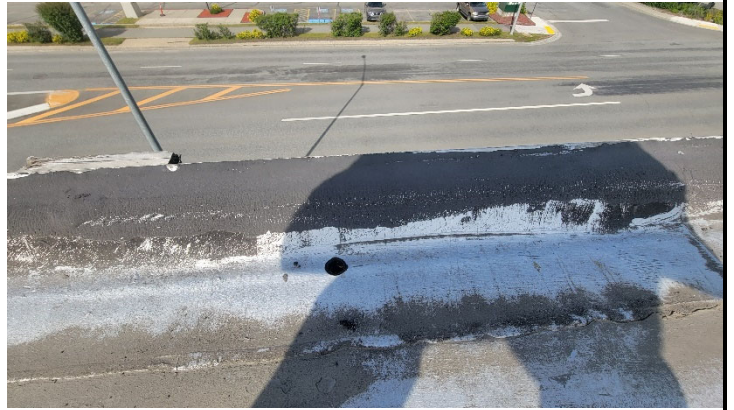
Photo 4. Sample AS-05 – Northwest Roof; Roofing Materials.
