# AK Native Primary Care Center Bldgs. I, II, III Roof IR Report

Thermographic Imaging of the ANPCC Roof for  
Moisture Detection & Heat Loss.

Project: SCF ANPCC, Anchorage ALASKA

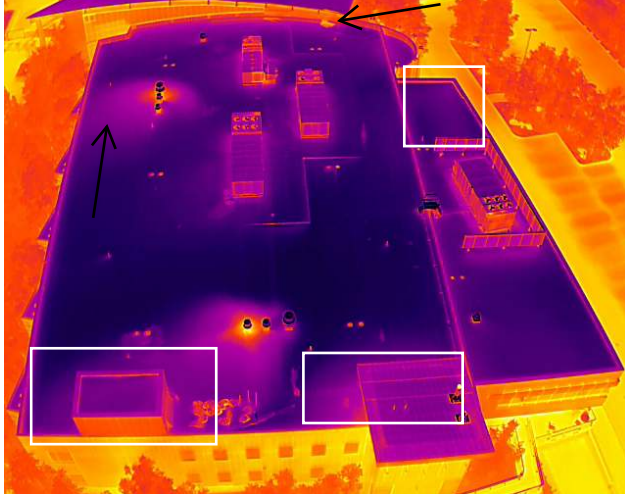
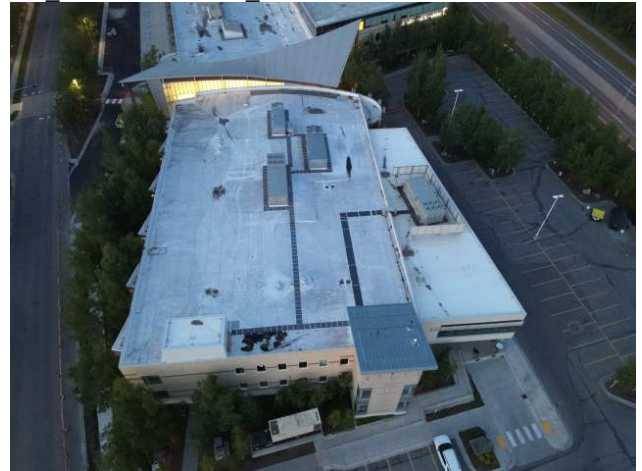
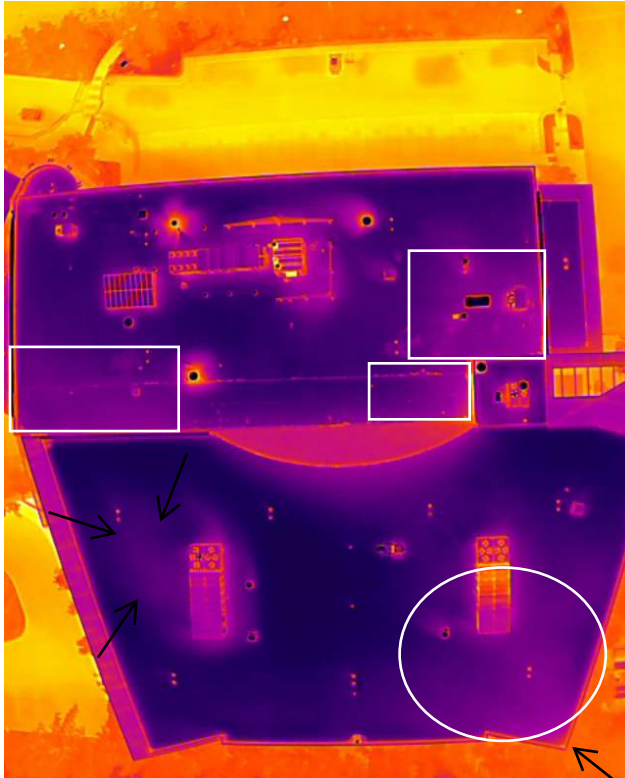
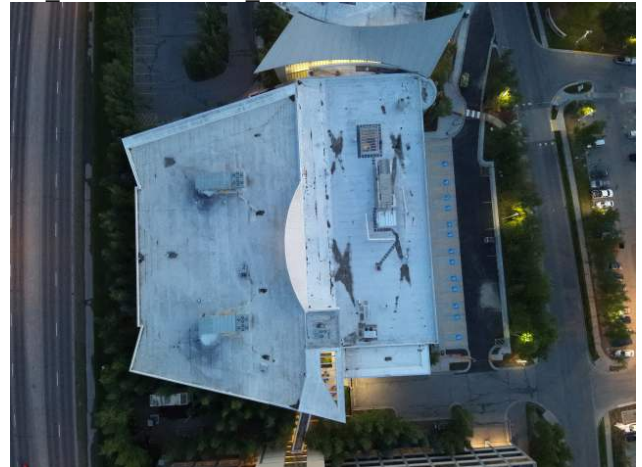
PCC 2 above, and PCC 1 & 3 below, have very similar signatures and reflect their age and level of degradation over time caused by excessive air leakage and building pressurization. White squares and circles reflect areas of moisture loading. Black arrows are call outs related to moisture signatures, puddles or air leakage pathways in the IR pictures.

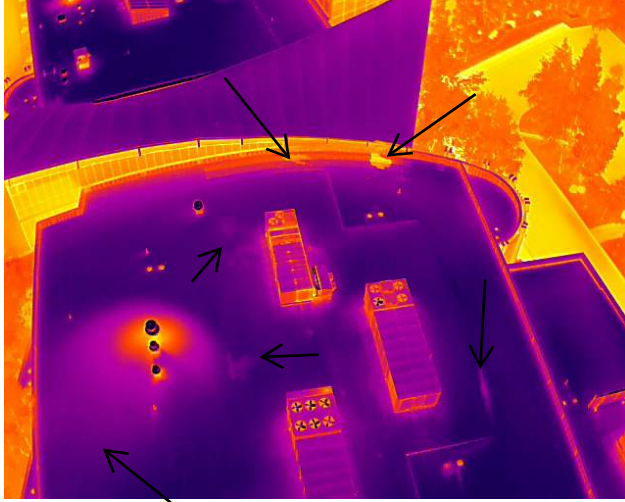
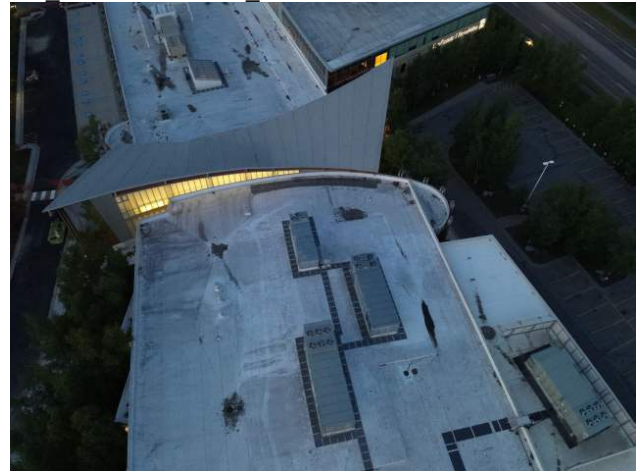
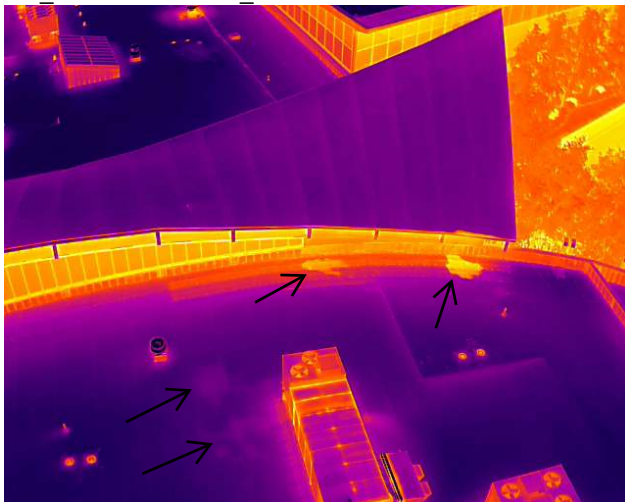
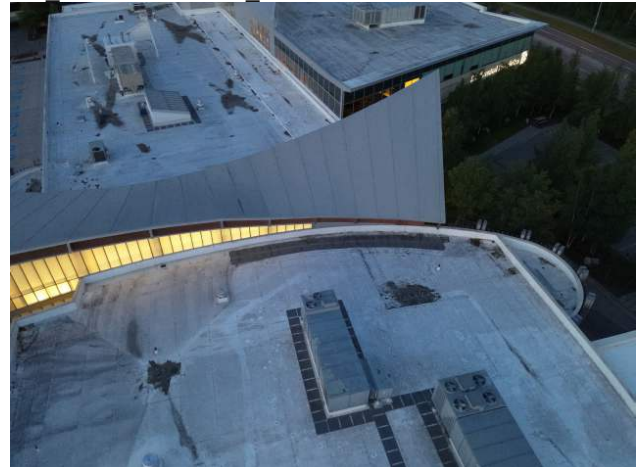
Two puddles were located in the insulation layers up against the twisted roof West wall Several other anomalous signatures were visible near the center of the roof near HVAC equipment.

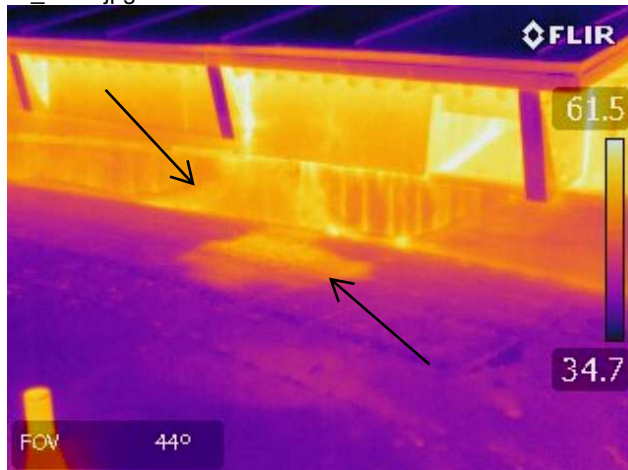
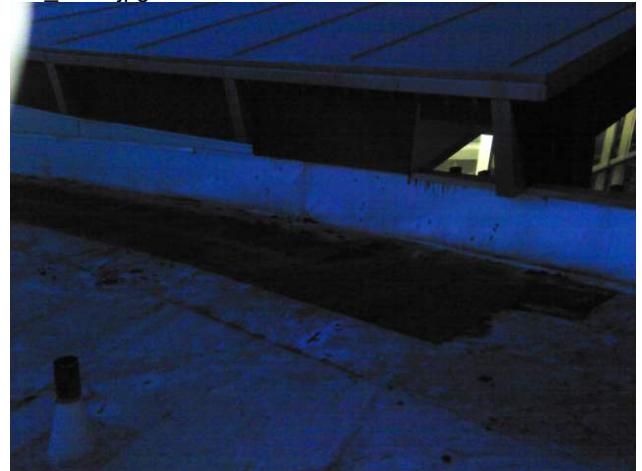
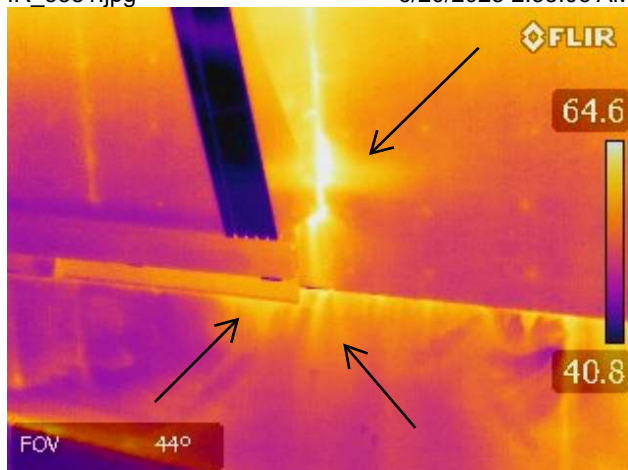
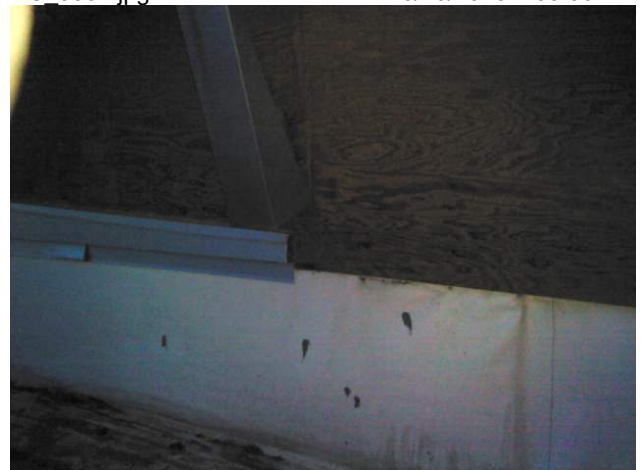
In these images air leakage signatures at the West Twisted Roof Wall is directly tied to or above a puddle signature in the roofing below it.

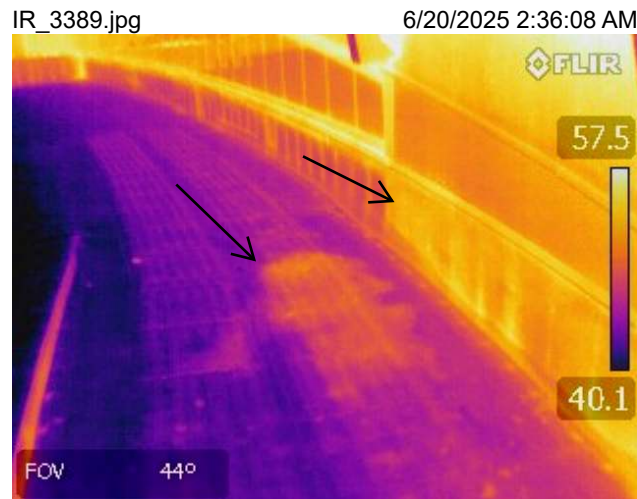
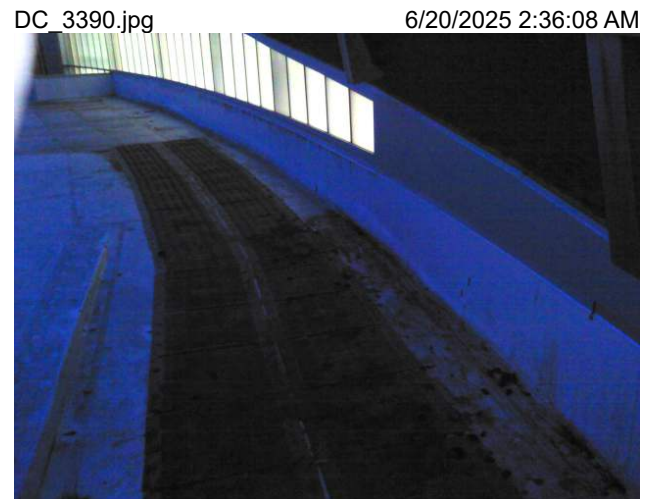
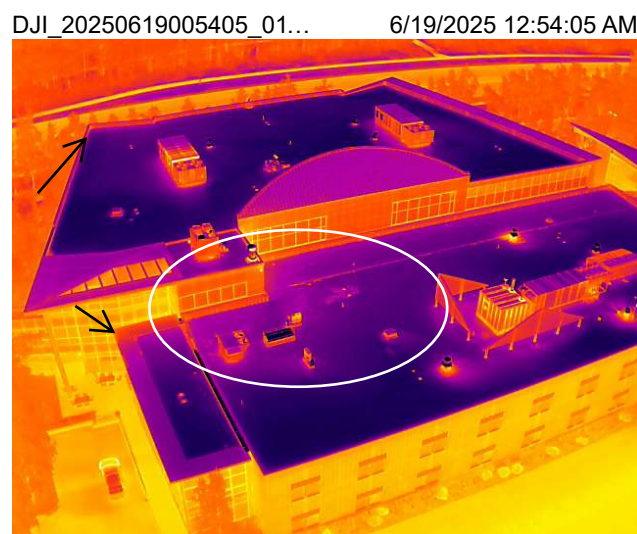
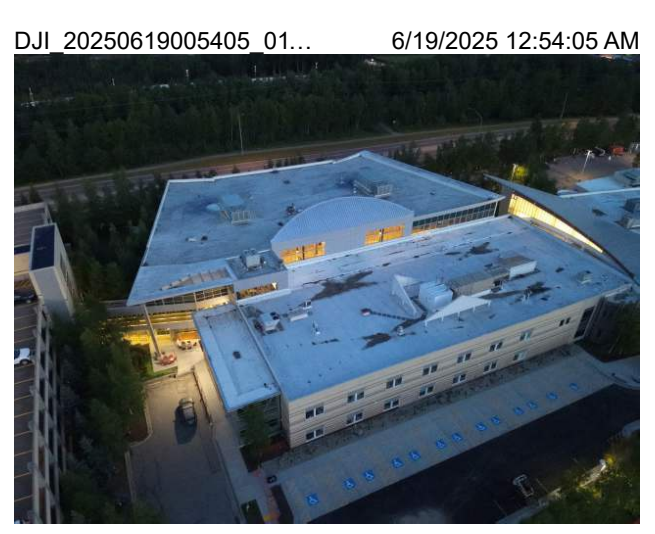
PCC 2 Roof near the Twisted roof West wall.
