AK Native Primary Care Center Bldgs I,II, III  
Roof IR Report 6-18-2025 & 6-20-2025  
Thermographic Imaging of the ANPCC Roof for Moisture  
Detection & Heat Loss.

## PCC #3 Roof

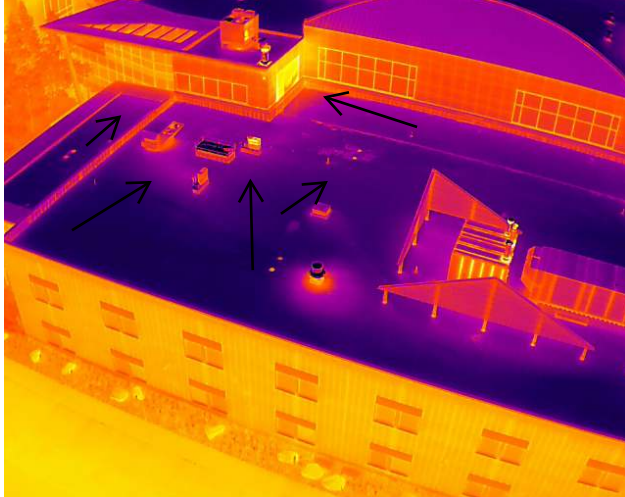
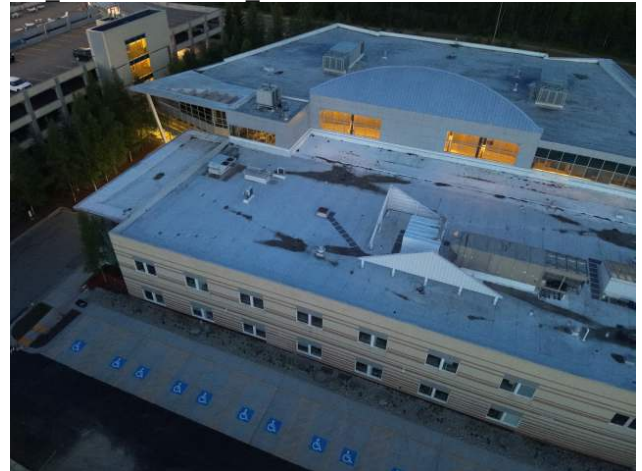
**Comment:** The walls sections at column S0 and N5 between PCC 1 and PCC 3 have significant air leakage at the roof to wall joint that over time has driven vapor into the roofing and degraded the dens deck and caused the PVC roof delaminate from the substrate. The impact of relying on the roofing membrane as the primary air barrier is the shortened life and eventual failure of the roofing system due to the moisture loading of the roof in a cold climate over time.

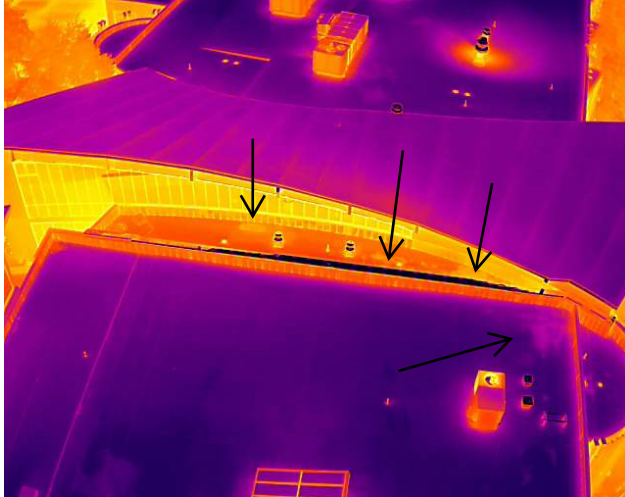
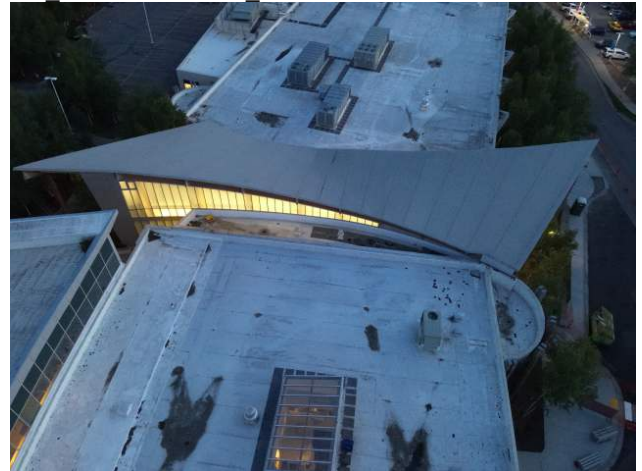
Comment: The pool areas located between PCC1 and the Main Lobby has puddling in the insulation at the north side and center. The roof to wall joints and wall section below the clerestory windows has increased air leakage.

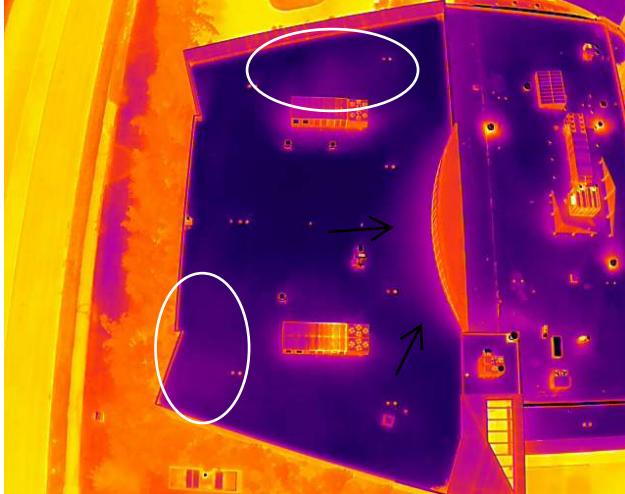
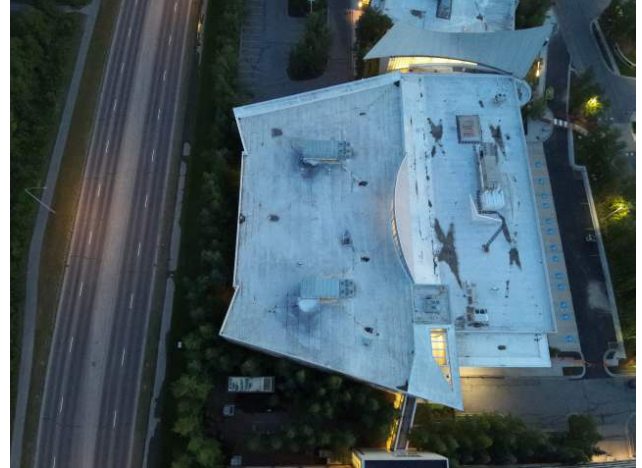
Comment: PCC 3 Roof shows heavy moisture loading at Grid line SH & S5.1 due to air leakage at both corners. The curved signature in front of the curtain wall along Column S1 has an anomalous signature with the center of the signature east of the curtain wall. The moisture loading at the curtain wall does match other moisture logged roofing layers and appears to be similar damp conditions caused by air leakage associated with the roof to wall joint.

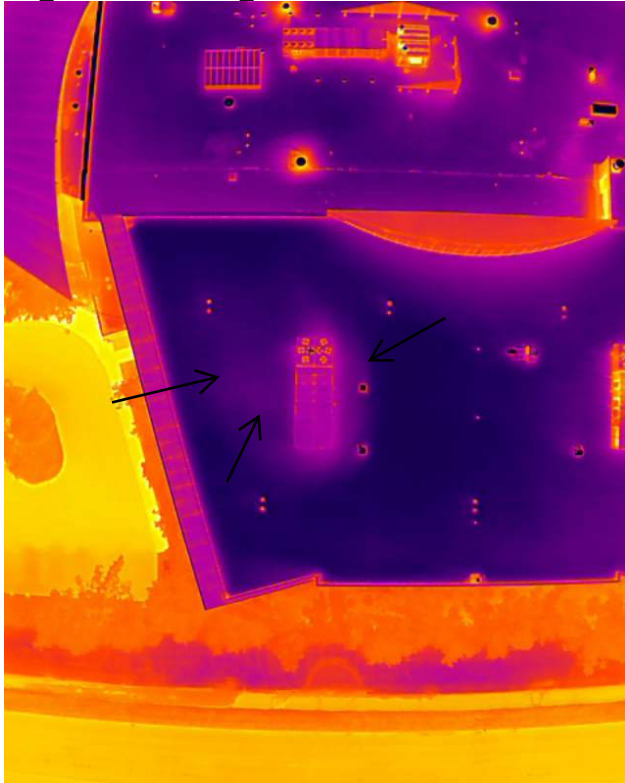
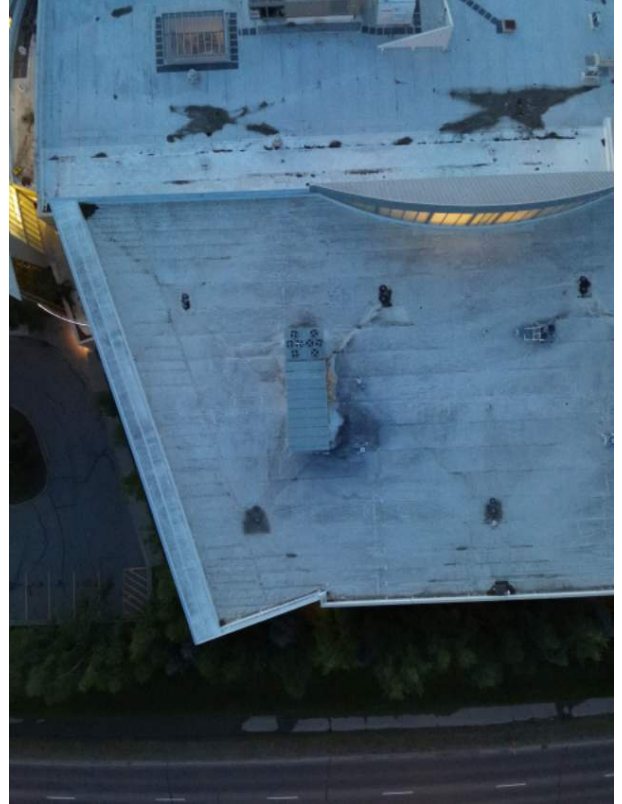
Comment: The PCC 3 West side of the roof has a damp signature wrapping around the west HVAC RTU. Below the parapet walls of PCC3 had significant air leakage signatures at building corners. Where significant air leakage signatures were found the PVC roofing and parapet walls could typically be observed ballooning.
