AK Native Primary Care Center Bldgs I,II, III  
Roof IR Report 6-18-2025 & 6-20-2025  
Thermographic Imaging of the ANPCC Roof for Moisture  
Detection & Heat Loss.

**PCC 2 Southwest Building Corner at Mechanical Penthouse**

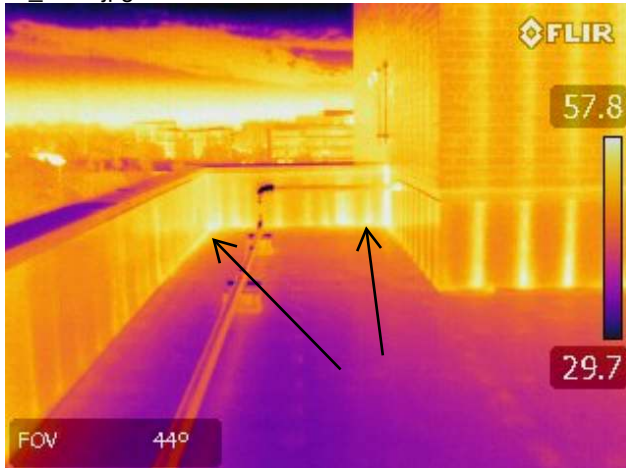
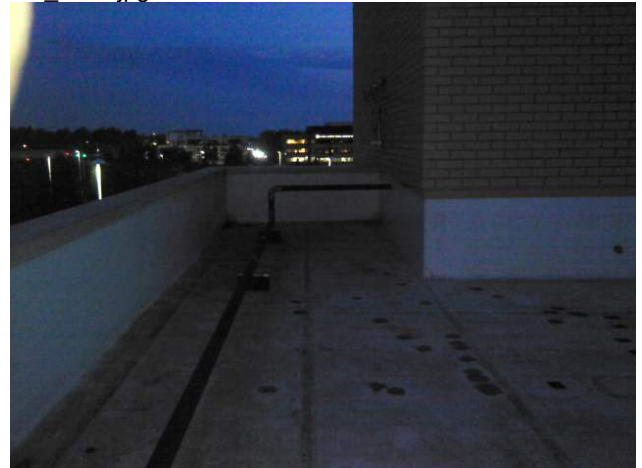
IR\_3359.jpg

Comment: The parapet walls and roof to wall joints show increased air leakage

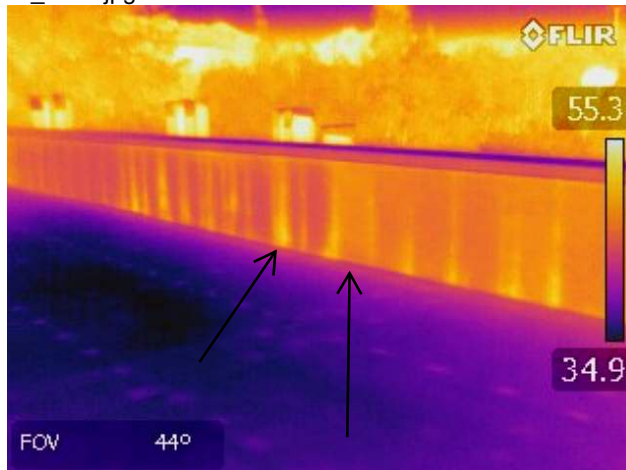
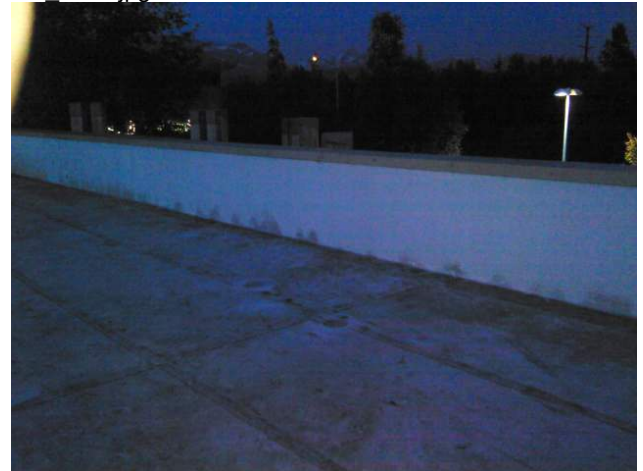
IR\_3373.jpg

Building corners and parapet walls had increased air leakage signatures with the building pressurized. Air leakage pathways are mapped out in detail on page four.

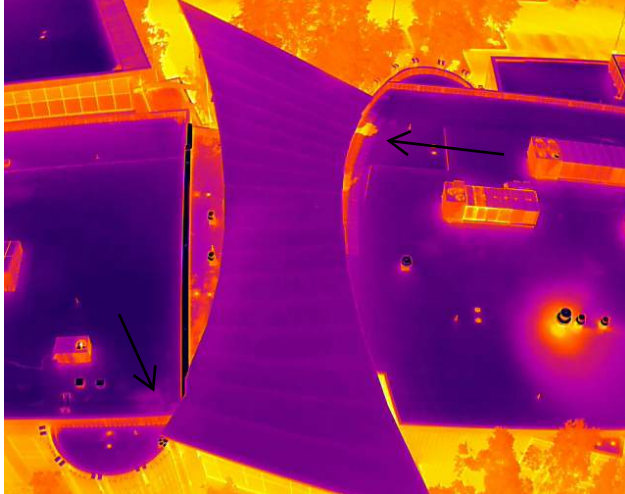
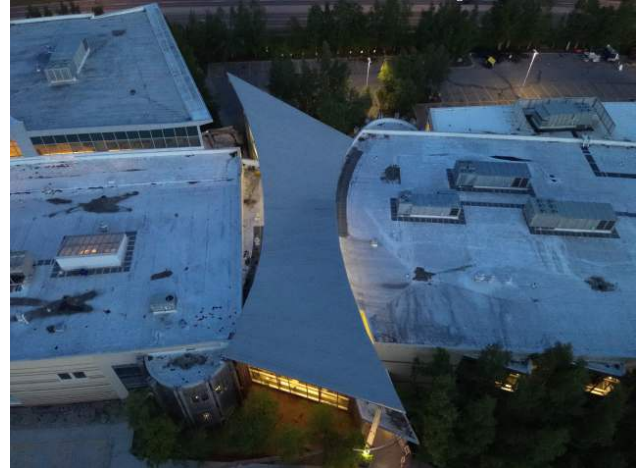
DJI\_20250619005031\_01... 6/19/2025 12:50:31 AM

Comment: The twisted roof at the main lobby by has a largely uniform signature. A faint change in color happens at the perimeter of the roof line. See images below for potential cause of the change in signature.

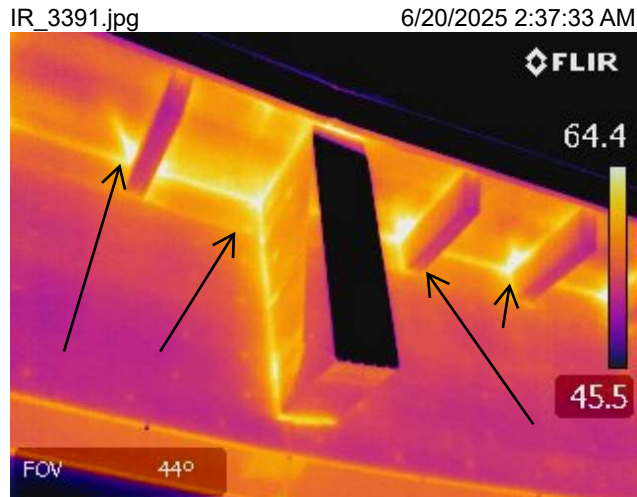
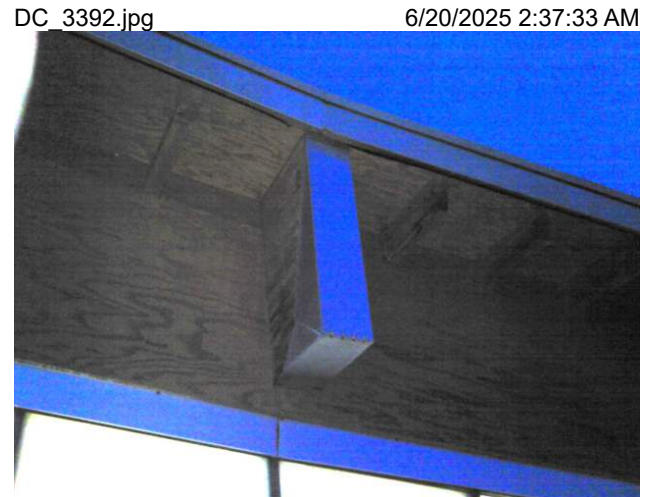
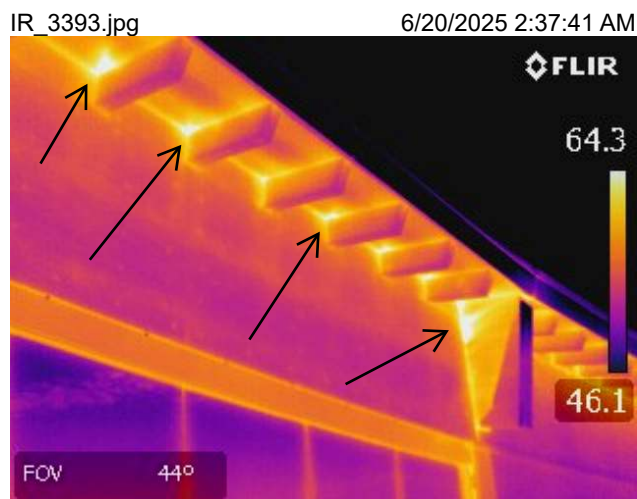
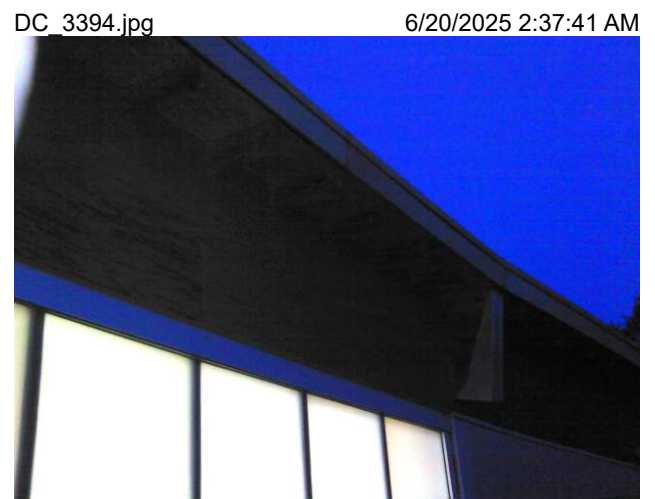
Comment: The roof to wall joint and beam penetrations around the entire perimeter of the main lobby has air leakage signatures under normal building pressures.
