AK Native Primary Care Center Bldgs I,II, III  
Roof IR Report 6-18-2025 & 6-20-2025  
Thermographic Imaging of the ANPCC Roof for Moisture  
Detection & Heat Loss.

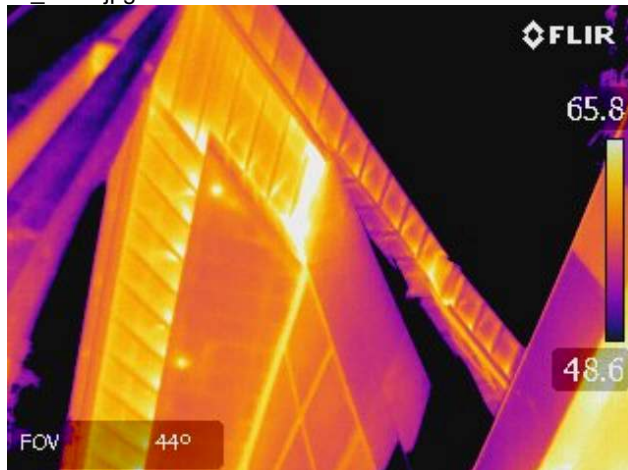
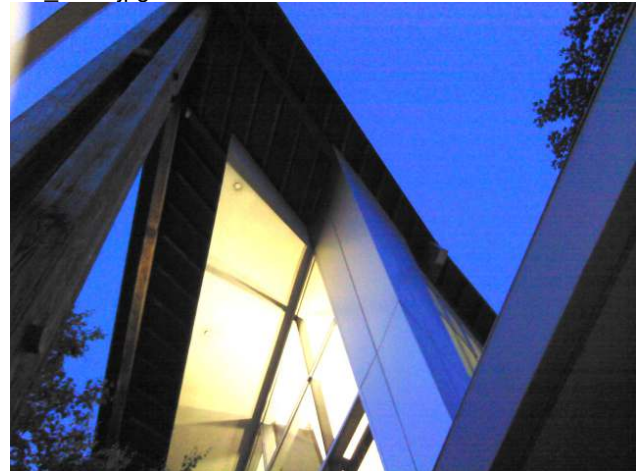
IR\_3501.jpg

Comment: Significant air leakage is apparent at all four sides of the main Lobby Twisted Roof. While this air leakage is significantly it is indirectly causing the snow to melt off and slide off onto lower roof sections.

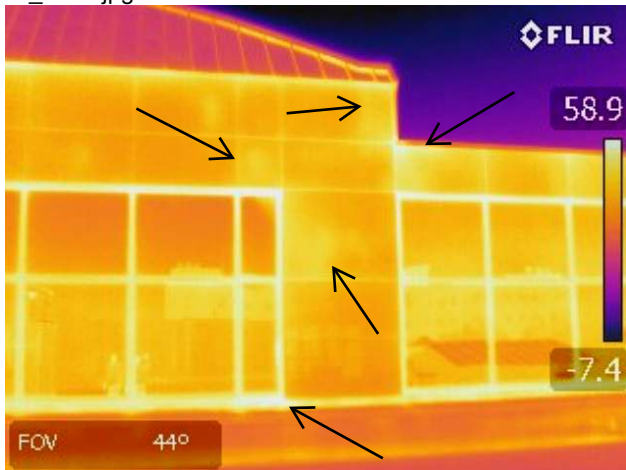
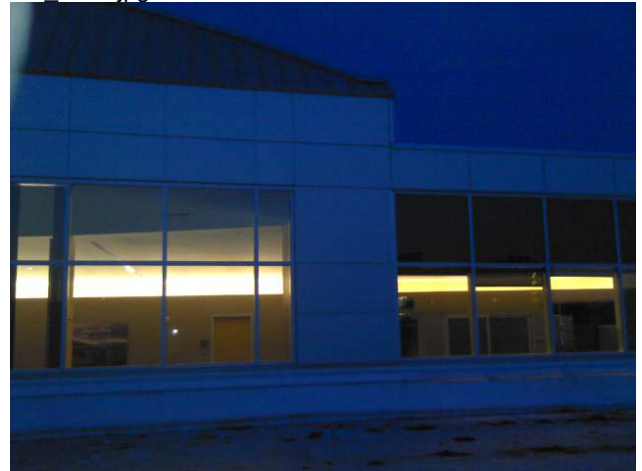
IR\_3349.jpg 6/20/2025 2:24:05 AM

Comment: Several wall sections showed air leakage signatures during the walk through the of the building. These air leakage pathways are typical of building corners, fenestrations and entryways.

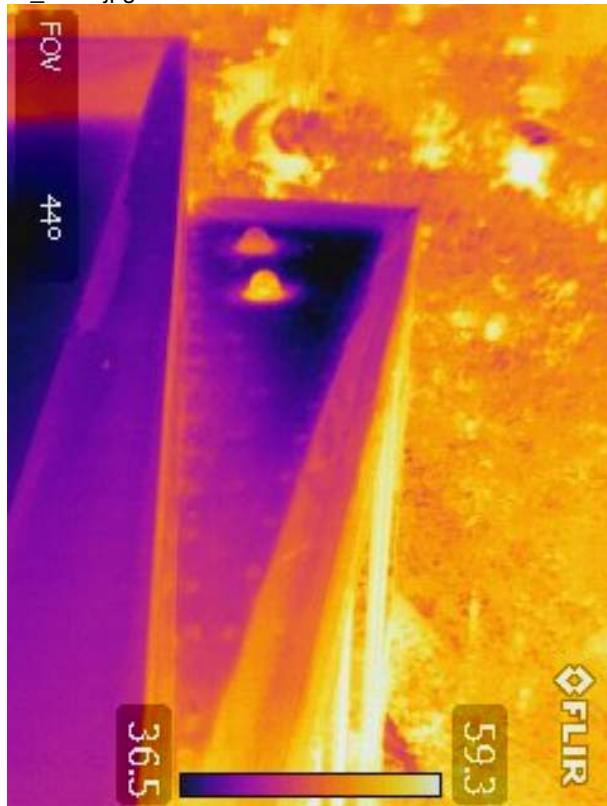
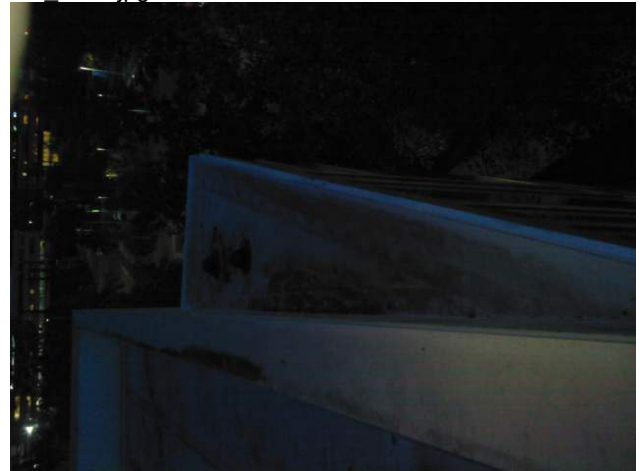
IR\_3427.jpg

Comment: The lower roof sections along the north side of PCC2 were found to have normal uniform signatures with leakage present at the narrow roof connection to the main building and parapet corners of the of the lower roofs near column WF.
