# SOUTHCENTRAL FOUNDATION

## Anchorage Native Primary Care Center Facility Conditions Assessment

ROOFS AND MECHANICAL EQUIPMENT

August 28, 2025

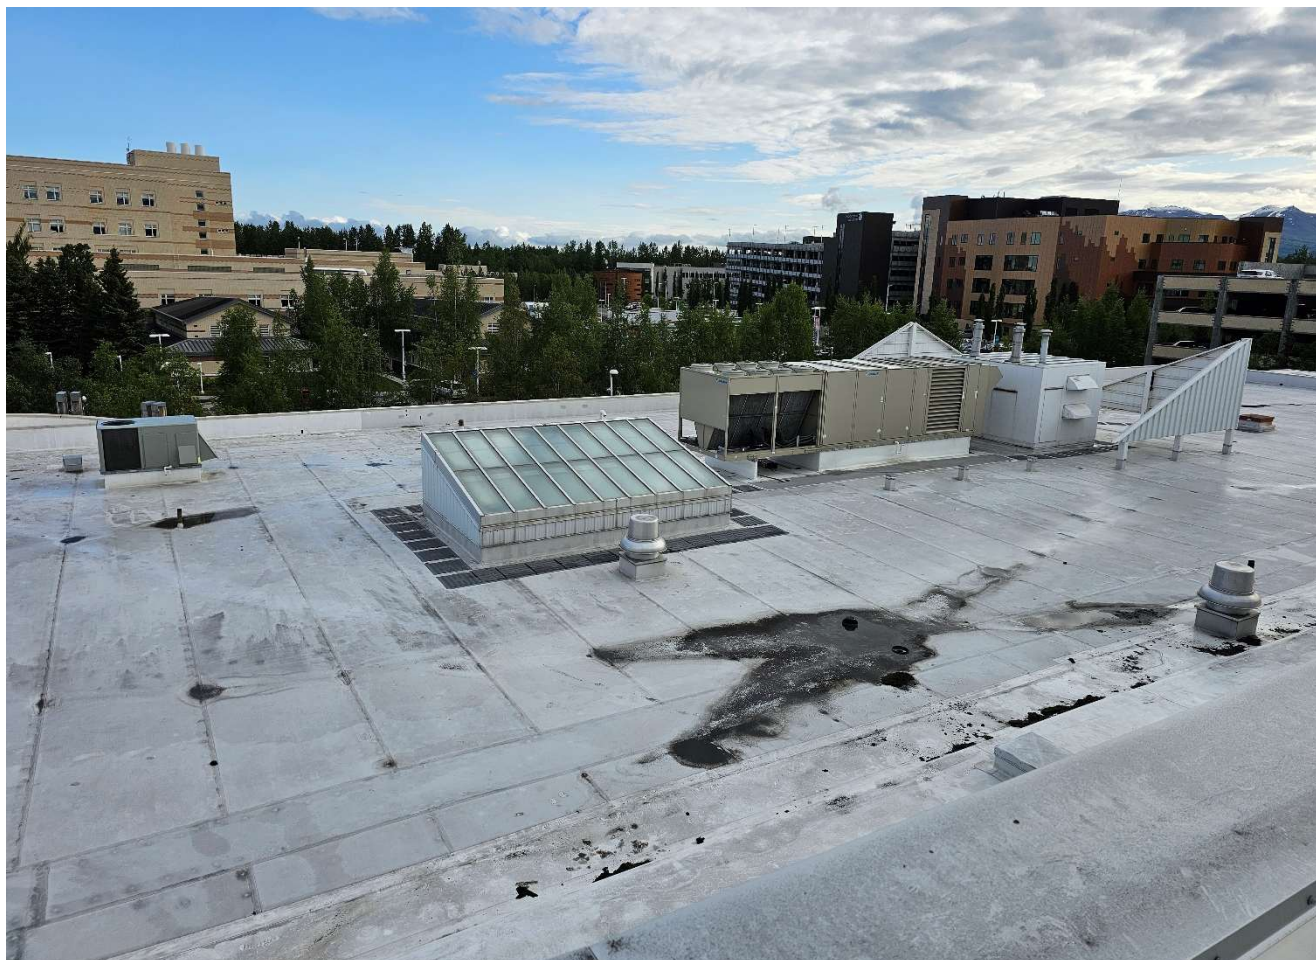
*PCC 1 Roof – facing northeast*

- Roof membrane shows a history of patches and repairs and is approaching the end of its useful life. Thermal imaging study indicates damp insulation and puddling moisture trapped within the roof assembly at several locations near the west side of the roof, adjacent to the Atrium.
- There are numerous abandoned equipment curbs, openings, and equipment screen structural posts that have been capped with sheet metal.
- Roof slopes are not adequately directing rainwater to the internal roof drains. Slopes are insufficient to prevent ponding water (observed during the walk-through).

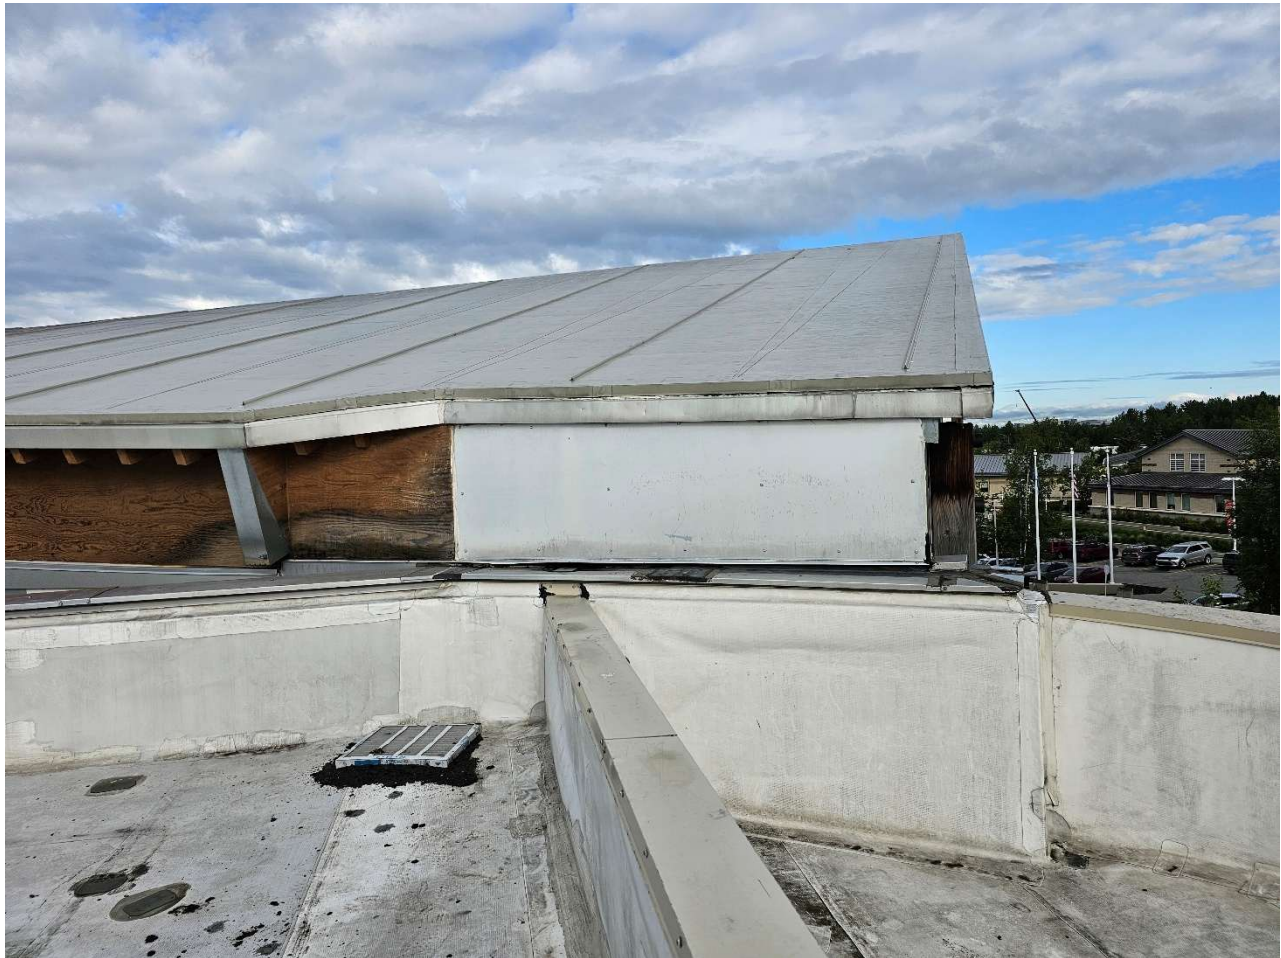
- During average to high snowfall years, the Atrium roof sheds significant quantities of snow onto the northwest corner of PCC 1. The same situation occurs along the south edge of the PCC 1 roof underneath the PCC 3 “lens” (see 2.09 for lens description). The weight of accumulated snow can exceed the load bearing capacity of the roof in these areas, requiring maintenance personnel to manually remove the snow using shovels and other tools, which causes damage to the roof membrane. Snow accumulation is causing damage to the exposed plywood finish and joint sealants at the Atrium sidewalls.

*PCC 1 Roof – northwest corner – Atrium roof snow shed zone*

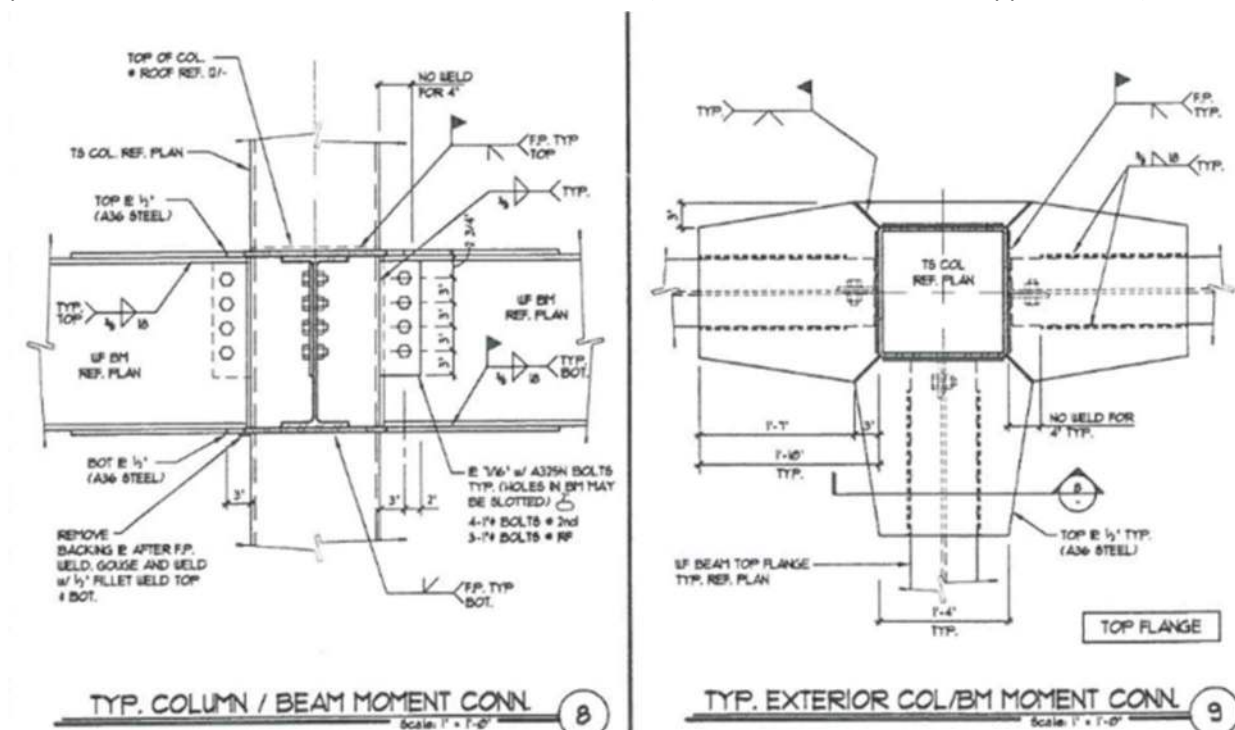
Fig. 2 - Existing PCC1 Moment Frame Connections and Protected Zone

The building is two stories tall. The gravity and lateral framing system consists of wide-flange steel beams and tube-steel columns. All of the primary girders, in both directions, at both floors, are moment-connected to all of the tube steel columns using a cover plate design that extends out 1'-10" from the face of the column. The area from the face of the column to 2'-9" away from the face of the column is a protected zone and cannot be welded to or modified (which can limit renovation opportunities).

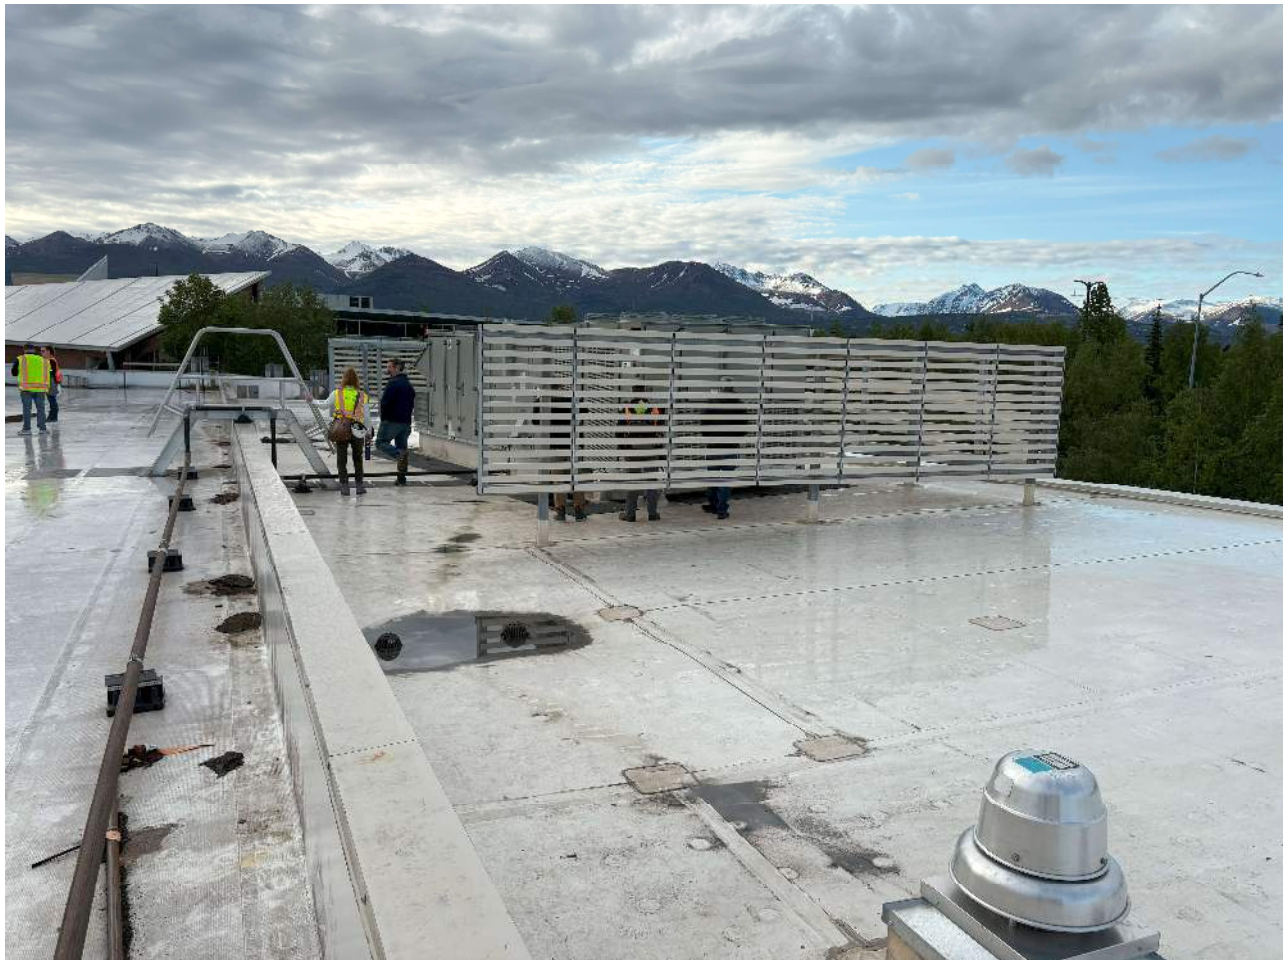
*PCC 2 Roof – 2022 addition and RTU-2.4 surrounded by equipment screen*

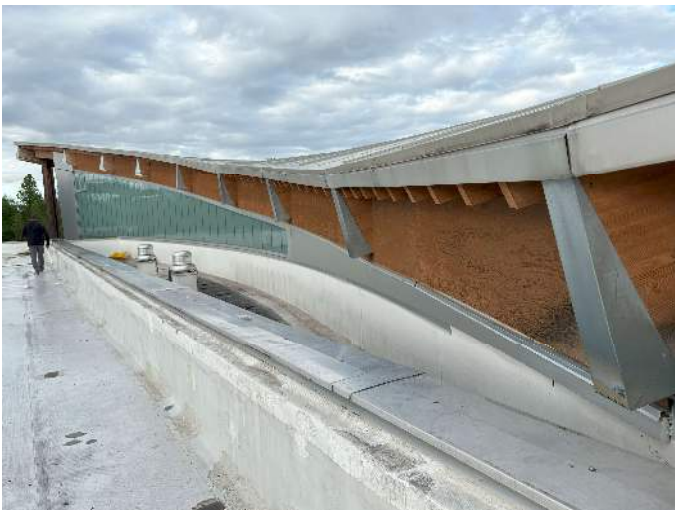
- While the roof itself is in good condition and appears to have some amount of useful life remaining, the key problems of the Atrium roof are the form and the composition of the assembly.
  - The high degree of slope at the north and south ends of the roof causes snow to shed onto the lower roofs of PCC 1 and PCC 2. The accumulated snow can occasionally exceed the structural capacity of the lower roofs and must be removed manually, which causes damage to those lower roofs.
  - Snow accumulation below the Atrium eaves is causing damage to the exposed rough-sawn plywood finish and joint sealants at the Atrium sidewalls, particularly at PCC 1.
- There is no permanent access point (ladder or otherwise) and no fall protection system on the Atrium or adjacent roofs that enable safe access onto the Atrium roof. Note: There is no major mechanical equipment on the Atrium roof to be serviced.

*Atrium – from PCC1, looking southwest*

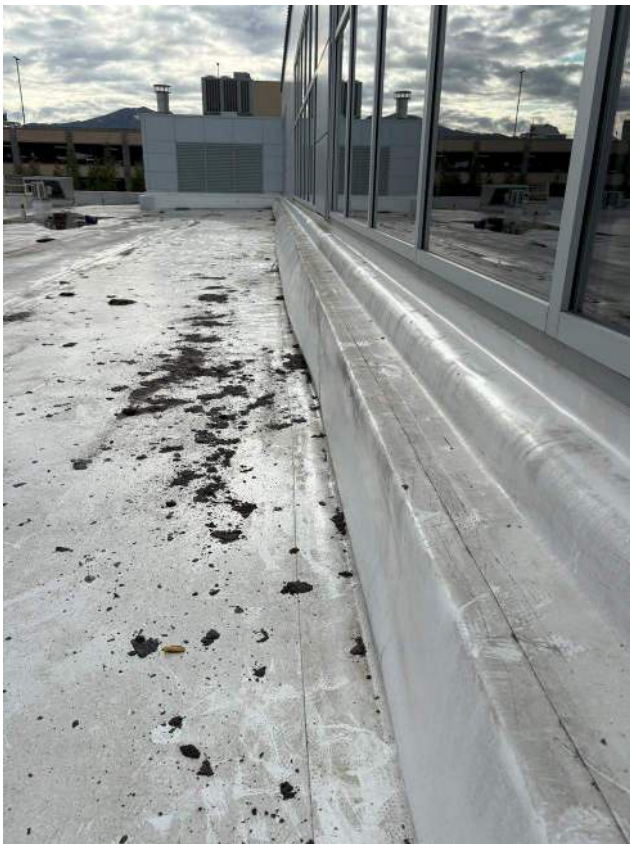
*PCC 1 Roof – billowing at south sidewall*

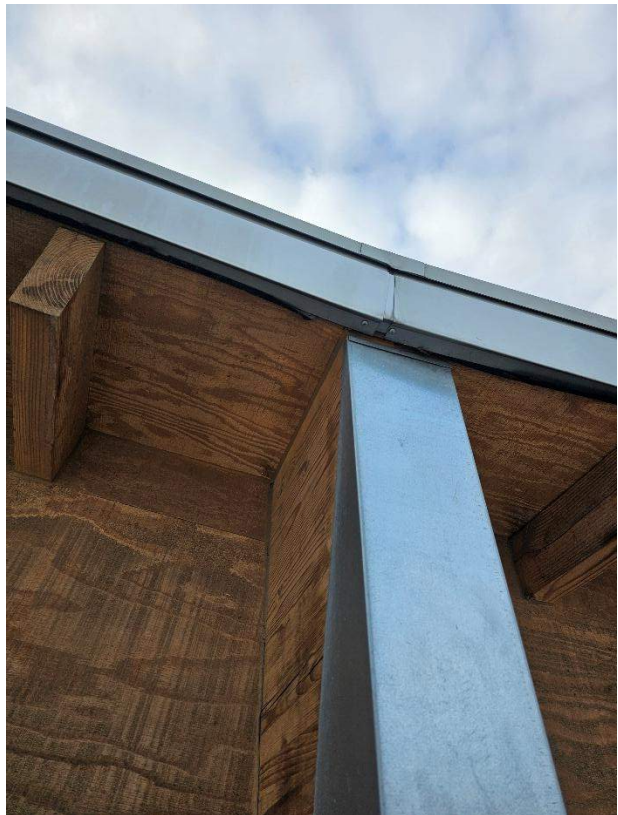
*Atrium – eave flashing splice joint*

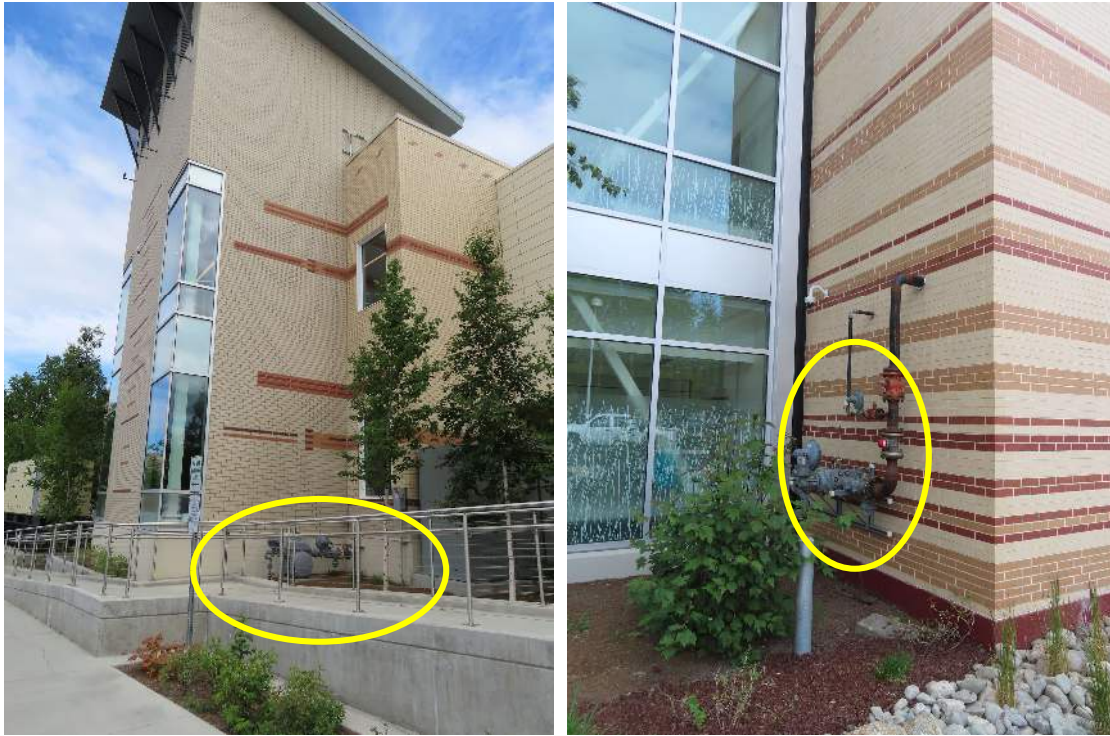
Gas meter #738 on west wall (left photo) and presumably, meter 192112 on NE corner of PCC1 (right photo), although the meter number for the NE meter do not match up with accounting invoices
