**TO:** Neil Bhargava, Sr. Project Manager/Executive  
 Neeser Construction, Inc.

**FROM:** Henry Ashburn, Senior Consultant  
 McKay Conant Hoover Inc

**SUBJECT:** SCF PCC1, PCC2, PCC3 HVAC – Acoustic Site Observation  
 MCH Project #26002

**DATE:** 10 February 2026

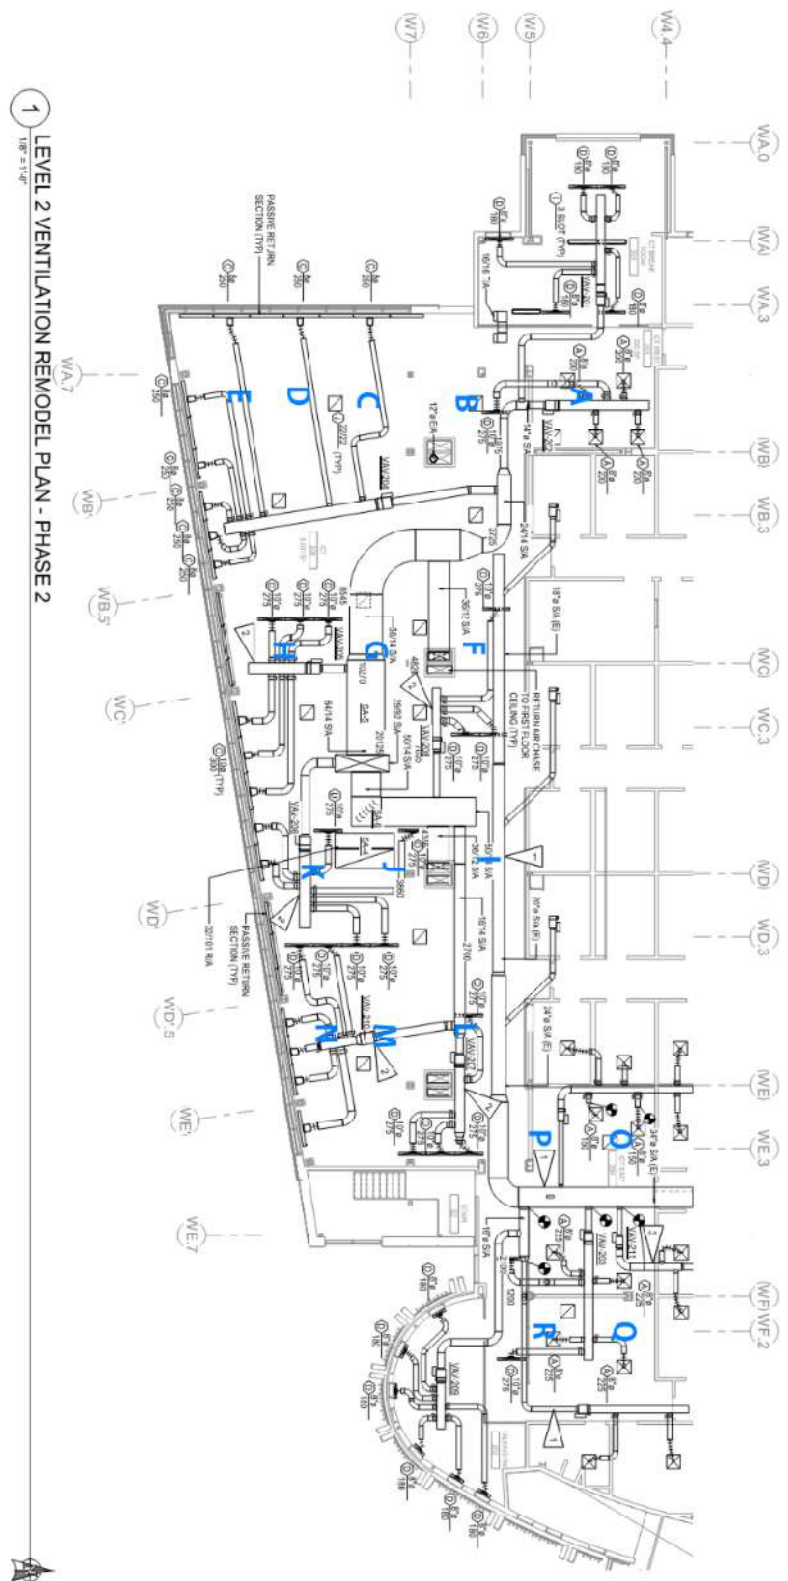
Figure 1: Open Office Measurement Locations

Areas under RTU-2.4 (open office) exhibited noise issues of various origins. See Figure 8 at the end of this section for visual and spatial markup of the observed conditions. Observations noted below are listed in decreasing order of perceived loudness.

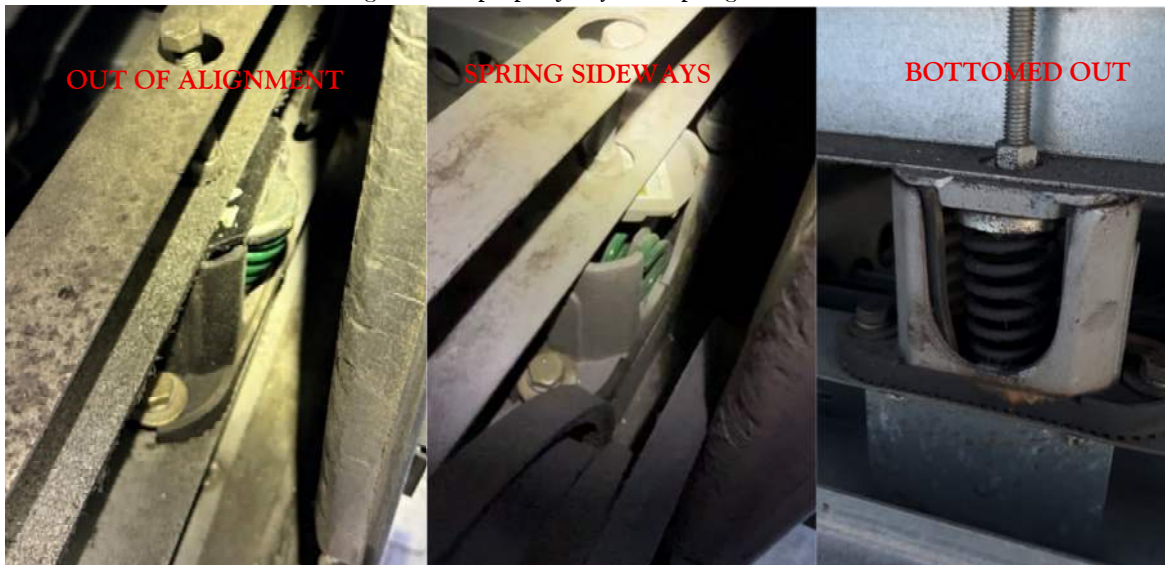
A few vibration-isolation issues were observed under the supply fans within RTU-2.2, RTU-3.1, and RTU-3.2. Several spring isolators appeared to be improperly adjusted and/or installed. See Figure 2.

Figure 2: Improperly adjusted spring isolators

- f. Ensure the fans, motors, and other equipment within the RTU are properly maintained, balanced, and adjusted for proper operation.
- g. Ensure vibration-isolation systems (new or existing) are properly selected for the operating weight of the equipment and are properly installed. Ensure spring isolators are correctly adjusted. If spring isolators were improperly selected for the fan/equipment weight, consider replacing them with new units providing the proper minimum static deflection under load.
- h. Reduce RTU airflow delivery as much as possible while still providing the required amount of air to occupied spaces, and then rebalance the system.
- i. Reconfigure ductwork to be much smoother and/or less restrictive. This may involve modifying duct dimensions, locations, lengths, or turning-vane configurations, or slightly

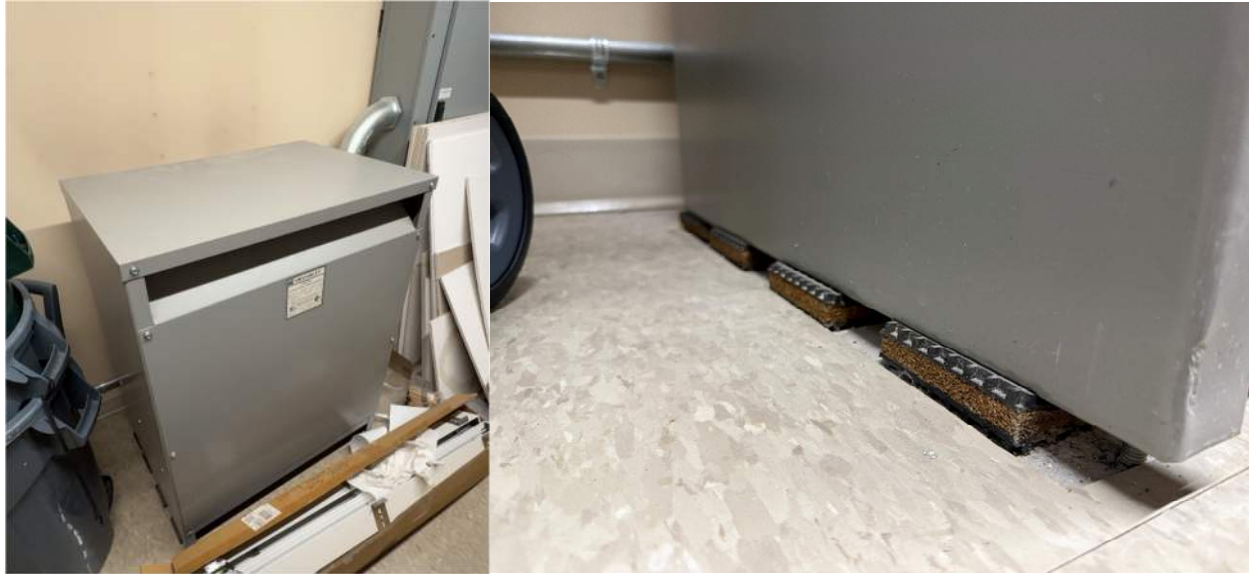
1. Transformer Noise (electrical)
  - a. The floor-mounted transformer in Electrical 2309 was improperly vibration-isolated (see Figure 3), and the surrounding constructions (walls and door assembly) were inadequate for blocking airborne sound radiated from the transformer housing.
  - b. Readily perceptible vibrations from the transformer were present in the floor slab within Electrical 2309 and adjacent patient rooms.
  - c. The front metal panel of the transformer resonated at a strong tonal frequency; however, this tone could be significantly reduced with the application of slight manual pressure.

Figure 3: Electrical 2309 transformer and existing support pads

- a. Adjust the front panel of the floor-mounted transformer in Electrical 2309 so the high-frequency panel resonance is minimized. This may involve tightening or loosening the screws securing the front plate or permanently applying pressure or damping material to alter the panel's natural resonance. Reattaching the front panel with elastomeric washers or similar might also work. Consult the transformer manufacturer before adjusting this panel.

- b. Install the transformer in Electrical 2309 on captured neoprene mounts providing a minimum of 0.15in minimum static deflection under load. Mason Industries RBA or similar products can typically provide the required deflection while also offering tension, compression, and shear ratings for seismic performance. Consult Mason Industries and/or structural engineer for final selections and seismic concerns. Mason Industries will need to know unit weight and distribution to properly spec isolators.

- c. Where possible, use flexible conduit on the transformer in Electrical 2309 to reduce vibration transfer into the structure. At minimum, support conduit connections with elastomeric or neoprene material/mounts to minimize structure-borne transmission.

- d. If the door can accept a bottom gasket, consider gasketing the entire door to Electrical 2309 to minimize airborne transformer noise entering the corridor and adjacent rooms. Consider one or two rows of adhesive-backed triple flange or teardrop gasketing (e.g., Pemko or Zero) and an adjustable stop gasket with a neoprene seal. Install an operable bottom gasket and ensure full contact with the threshold/floor. All perimeter gasketing (header, jams, threshold) should be adjusted to achieve an airtight seal—no visible light leakage, and a business card should not be able to slide between the door and the gasket system.

- e. If transformer noise persists after implementing the modifications above, consider more substantial architectural improvements. Substantial improvements would typically involve removing a layer of gypsum board from surrounding walls and reinstalling the layer on resilient isolation clips (e.g., PAC International RSIC-1) with required backer brackets for mounting as applicable. Ensure stud cavities contain full-depth batt insulation before reinstalling gypsum board. If RSIC-1 clips are not feasible due to excessive surface-mounted elements, consider constructing a separate furred wall with resilient bracing (e.g., Mason Industries DNSB or WIC). The goal is to decouple the gypsum board from the studs to reduce sound transmission from the transformer side of the wall to the adjacent exam rooms. The sway brace element (if required) would only be there for seismic considerations.

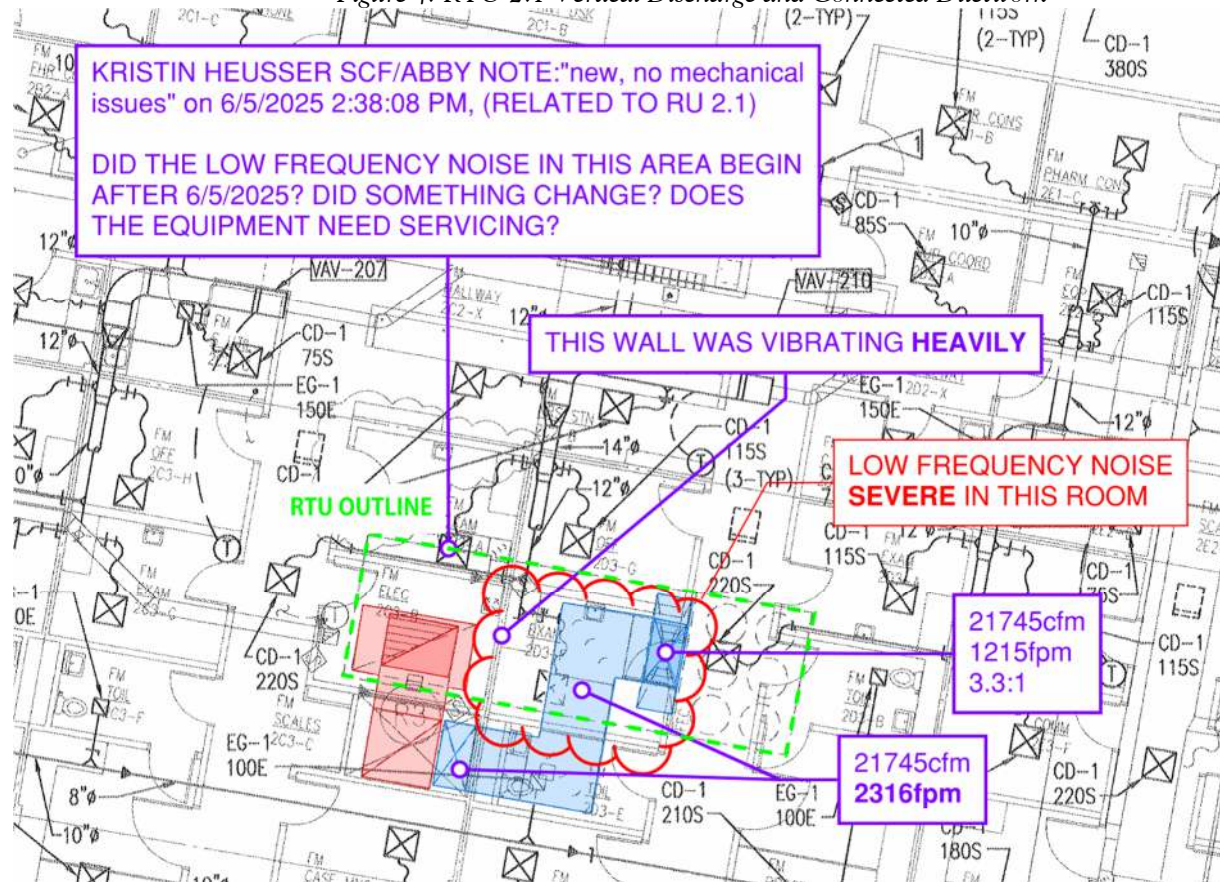
- b. Due to low frequency characteristics, it was omni-present and difficult to pinpoint to a single source.
  - a. The most pronounced effects of RTU-2.1 were observed in Room 2210. Adjacent rooms were similarly affected, though to a slightly lesser degree.

- b. The west wall of Room 2210 was visibly shaking due to low-frequency energy; the gypsum board wall surface rattled, as did the attached cabinetry.

- c. The resultant noise appeared to be a combination of direct sound transmission from above and re-radiated sound from the vibrating western gypsum board wall.

- d. The western gypsum board wall is shared with Electrical 2309 and extended fully to structure, with robust steel connections to the underside of the roof deck supporting RTU-2.1. This was one of the few full-height walls in the ceiling plenum in this vicinity. We suspect this wall is load bearing and cannot be easily adjusted to reduce re-radiation.

- e. The low-frequency noise fluctuated randomly, suggesting the primary noise source may be turbulent airflow. Drawings indicate very high airflow velocities and multiple abrupt airflow direction changes (see Figure 4).

Figure 4: RTU 2.1 Vertical Discharge and Connected Ductwork

shifting the RTU during reinstallation and reconfiguring the unit for horizontal discharge instead of vertical discharge. For reference, other RTUs do not force full-RTU-quantity airflow at the unit discharge through four consecutive elbows in quick succession at 2,300 fpm+. Consider mimicking other, quieter RTU discharge ductwork schemes. Consider 45° diagonal duct runs to minimize the number of 90° turns. Turning vanes sometimes add to airflow turbulence issues when located at the unit discharge. Consider removal of vanes, if possible from a mechanical standpoint.

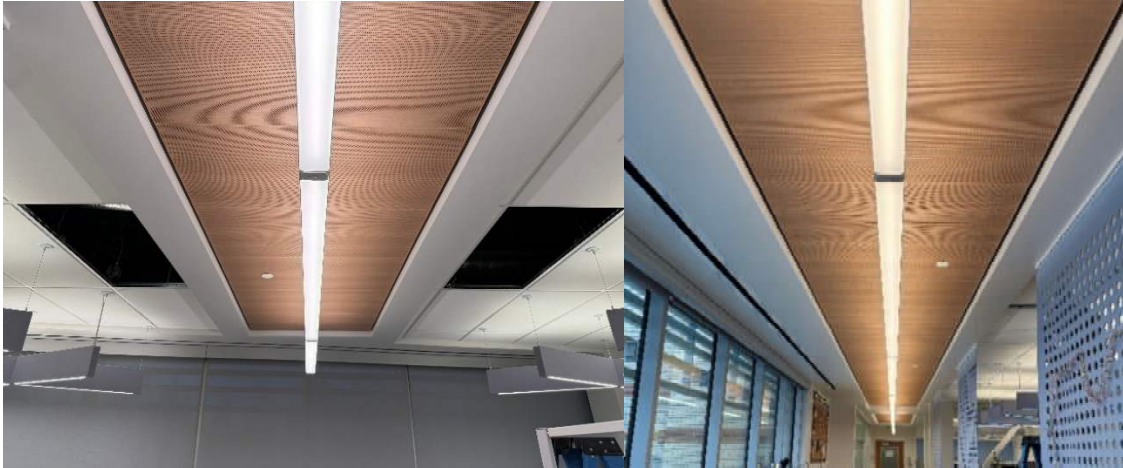
2. Radiated noise through perforated acoustic ceiling panels, Location 2.1, 2.2

Noises of various sorts (RTU-2.4 vertical discharge noise, piping flow noise, excessive airflow velocities) were audible through the wood-look perforated acoustic ceiling panels at Location 2.1,

2.2. It was not clear if these panel sections were being used for return air to the ceiling plenum, as there were various other return air grilles. The wood-look panels featured acoustic “fleece” backing for sound absorption benefit. This fleece is not used for blocking sound transmission. See Figure 5 below for visual depiction of the described wood-look ceiling panels.

*Figure 5: Open Office areas with wood-look perforated ceiling panels*

- b. If the wood-look perforated ceiling panels around Locations 2.1 & 2.2 are visual/acoustic only (i.e., not used for return air flow to the ceiling plenum), consider backing the ceiling panels with gypsum board or plywood to improve noise-blocking performance and reduce transmitted sound from vertical discharge and piping flow.

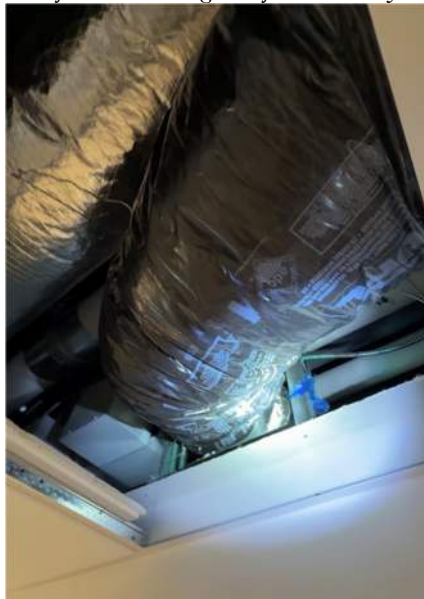
Mid-frequency noise was present near VAV-202 near Location 3. This appeared to be partly caused by the abrupt, acute angles formed by the flex duct and subsequent transition to rigid duct, which likely contributed to poor and turbulent airflow. Airflow velocities are also calculated to be around 1847fpm which is excessive. Noise was audible through the open return air grille in very close proximity to noise source. These grilles are designed to allow passage of air, and therefore allow for passage of nearby noise as well. See Figure 6

*Figure 6: Section of duct with high airflow velocity and abrupt transition*

- c. Consider relocating the return air grille panel to a location further away from the noise source around Location 3. If noise issues persist, consider reducing airflow or increasing effective final runout duct diameter for slower airflow velocities and straightening sections of duct around Location 3 to promote smoother airflow.

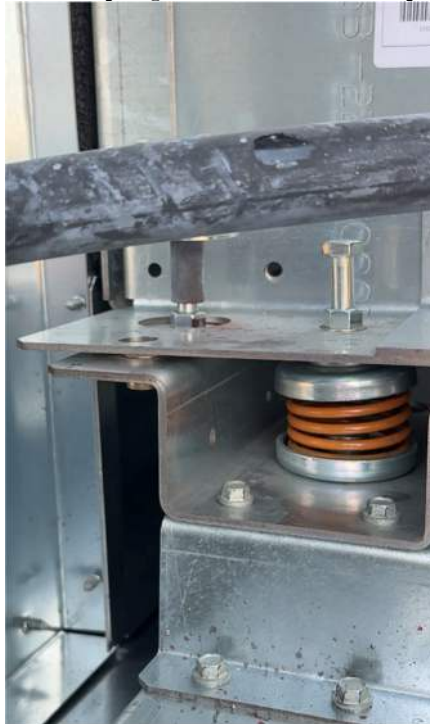
4. Duct leakage, Location 4  
High frequency air leakage was observed at Location 4. This was due to poor duct connections, poor/lack of sealant, misalignment, or improper duct sizing.
5. Vibration Isolation, internal to RTU-2.4  
Internal vibration isolation supporting the supply fan closest to the unit access door on RTU-2.4 was improperly selected and/or adjusted. The fan mounting bracket was contacting the RTU housing, short circuiting the spring isolator, and reducing its effectiveness. See Figure 7.

*Figure 7: Bottomed out spring isolator in RTU-2.4 (potentially overloaded)*

- d. Seal duct connections around Location 4 with appropriate duct-seal material to minimize air leakage.
- e. Ensure all internal RTU vibration isolation is properly installed and adjusted. Vibration isolated equipment should be free to move (albeit very small displacements) on their isolation systems.
