NGE-TFT Project # 5731-20

Southcentral Foundation  
4501 Diplomacy Drive  
Anchorage, AK 99508

**RE: SUMMARY OF FILL PAD CONSTRUCTION MONITORING ACTIVITIES FOR  
THE PLANNED TAKOTNA HEALTH CLINIC – TAKOTNA, ALASKA**

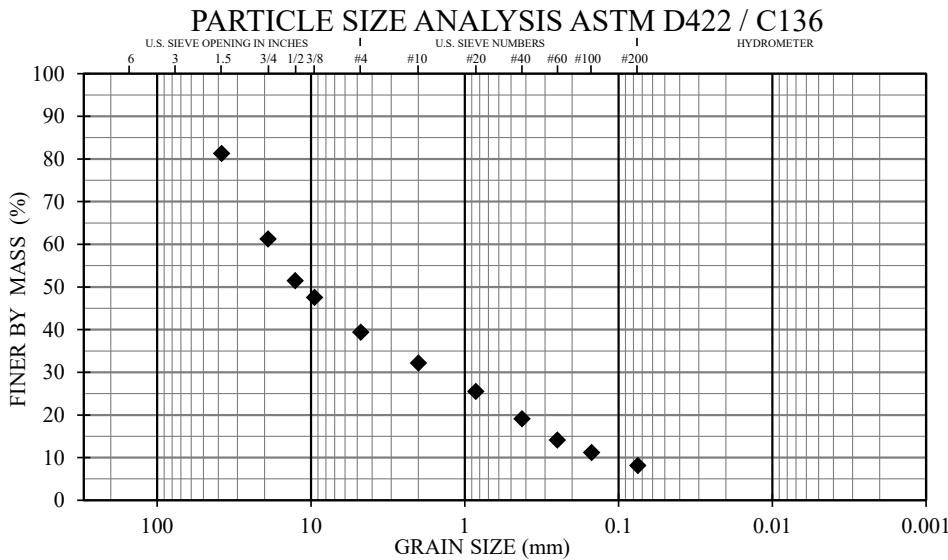
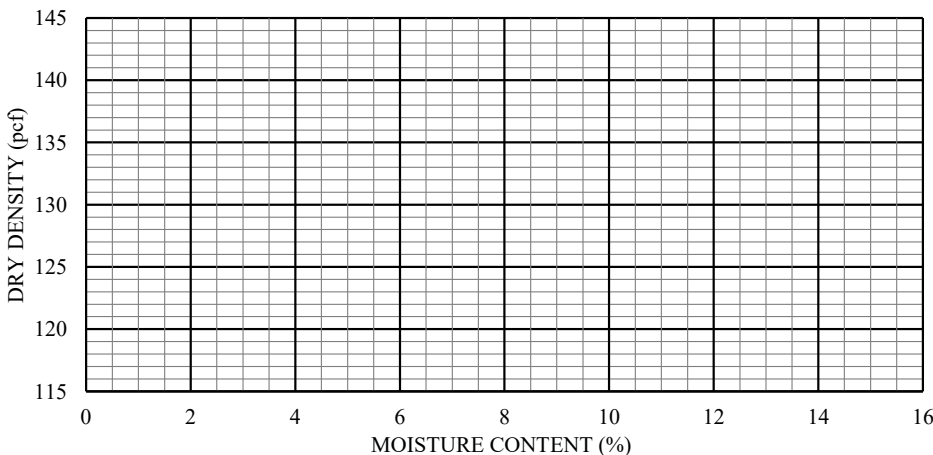
PROJECT CLIENT:	SCF
PROJECT NAME:	Takotna Clinic
PROJECT NO.:	5731-20
SAMPLE LOC.:	TP4
NUMBER/ DEPTH:	S1 / 1 - 2'
DESCRIPTION:	Well-graded gravel w/ silt and sand
DATE RECEIVED:	7/2/2020
TESTED BY:	
REVIEWED BY:	Erik Anderson

% GRAVEL	60.6	USCS	GW-GM
% SAND	31.2	USACOE FC	N/A
% SILT/CLAY	8.2	% PASS. 0.02 mm	N/A
% MOIST. CONTENT	5.2	% PASS. 0.002 mm	N/A
UNIFORMITY COEFFICIENT ( $C_u$ )		150.5	
COEFFICIENT OF GRADATION ( $C_g$ )		1.2	
ASTM D1557 (uncorrected)		N/A	
ASTM D4718 (corrected)		N/A	
OPTIMUM MOIST. CONTENT. (corrected)		N/A

SIEVE SIZE (mm)	SIEVE SIZE (U.S.)	TOTAL % PASSING	SPECIFICATION (% PASSING)
152.40	6"		
76.20	3"		
38.10	1.5"	81	
19.00	3/4"	61	
12.70	1/2"	51	
9.50	3/8"	48	
4.75	#4	39	
2.00	#10	32	
0.85	#20	26	
0.43	#40	19	
0.25	#60	14	
0.15	#100	11	
0.075	#200	8.2

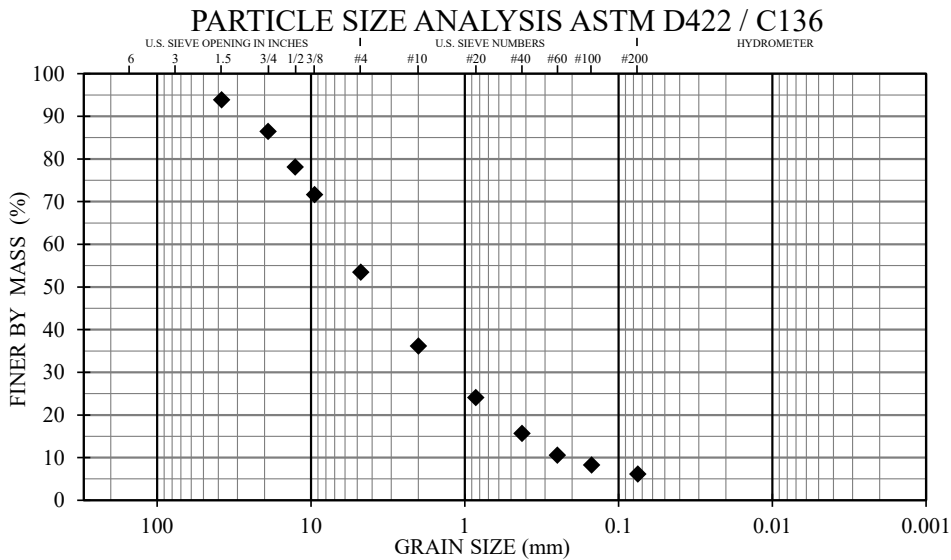
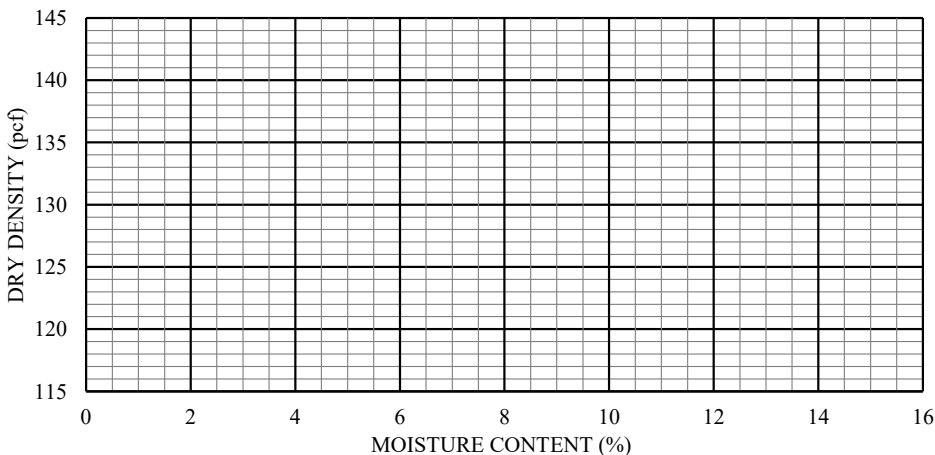
PROJECT CLIENT:	SCF
PROJECT NAME:	Takotna Clinic
PROJECT NO.:	5731-20
SAMPLE LOC.:	TP3
NUMBER/ DEPTH:	S1 / 0 - 1'
DESCRIPTION:	Well-graded sand w/ silt and gravel
DATE RECEIVED:	7/2/2020
TESTED BY:	
REVIEWED BY:	Erik Anderson

% GRAVEL	46.5	USCS	SW-SM
% SAND	47.4	USACOE FC	N/A
% SILT/CLAY	6.1	% PASS. 0.02 mm	N/A
% MOIST. CONTENT	6.5	% PASS. 0.002 mm	N/A
UNIFORMITY COEFFICIENT ( $C_u$ )		28.7	
COEFFICIENT OF GRADATION ( $C_g$ )		1.4	
ASTM D1557 (uncorrected)		N/A	
ASTM D4718 (corrected)		N/A	
OPTIMUM MOIST. CONTENT. (corrected)		N/A

SIEVE SIZE (mm)	SIEVE SIZE (U.S.)	TOTAL % PASSING	SPECIFICATION (% PASSING)
152.40	6"		
76.20	3"		
38.10	1.5"	94	
19.00	3/4"	86	
12.70	1/2"	78	
9.50	3/8"	72	
4.75	#4	53	
2.00	#10	36	
0.85	#20	24	
0.43	#40	16	
0.25	#60	11	
0.15	#100	8	
0.075	#200	6.1

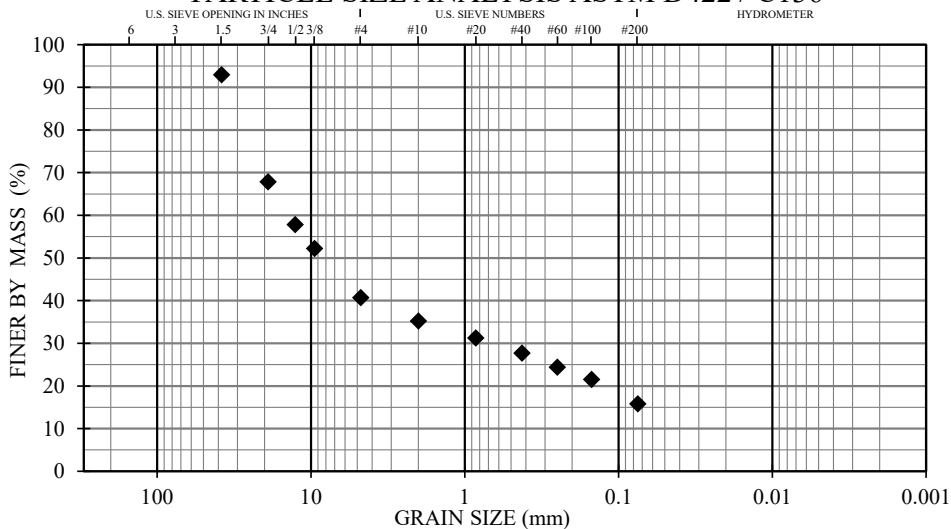
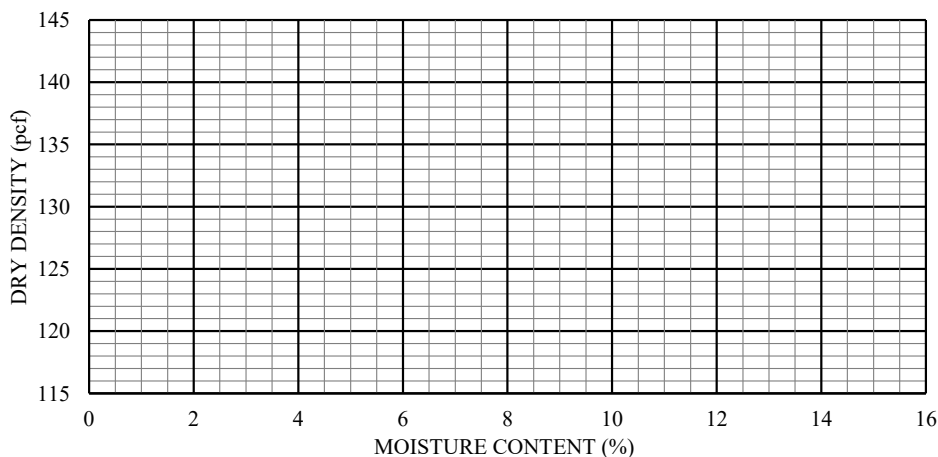
% GRAVEL	59.3	USCS	GM
% SAND	24.9	USACOE FC	N/A
% SILT/CLAY	15.8	% PASS. 0.02 mm	N/A
% MOIST. CONTENT	3.9	% PASS. 0.002 mm	N/A
UNIFORMITY COEFFICIENT ( $C_u$ )		UNKNOWN	
COEFFICIENT OF GRADATION ( $C_g$ )		UNKNOWN	
ASTM D1557 (uncorrected)		N/A	
ASTM D4718 (corrected)		N/A	
OPTIMUM MOIST. CONTENT. (corrected)		N/A
