# AK Native Primary Care Center Bldgs. I, II, III Roof IR Report

Thermographic Imaging of the ANPCC Roof for  
Moisture Detection & Heat Loss.

Project: SCF ANPCC, Anchorage ALASKA

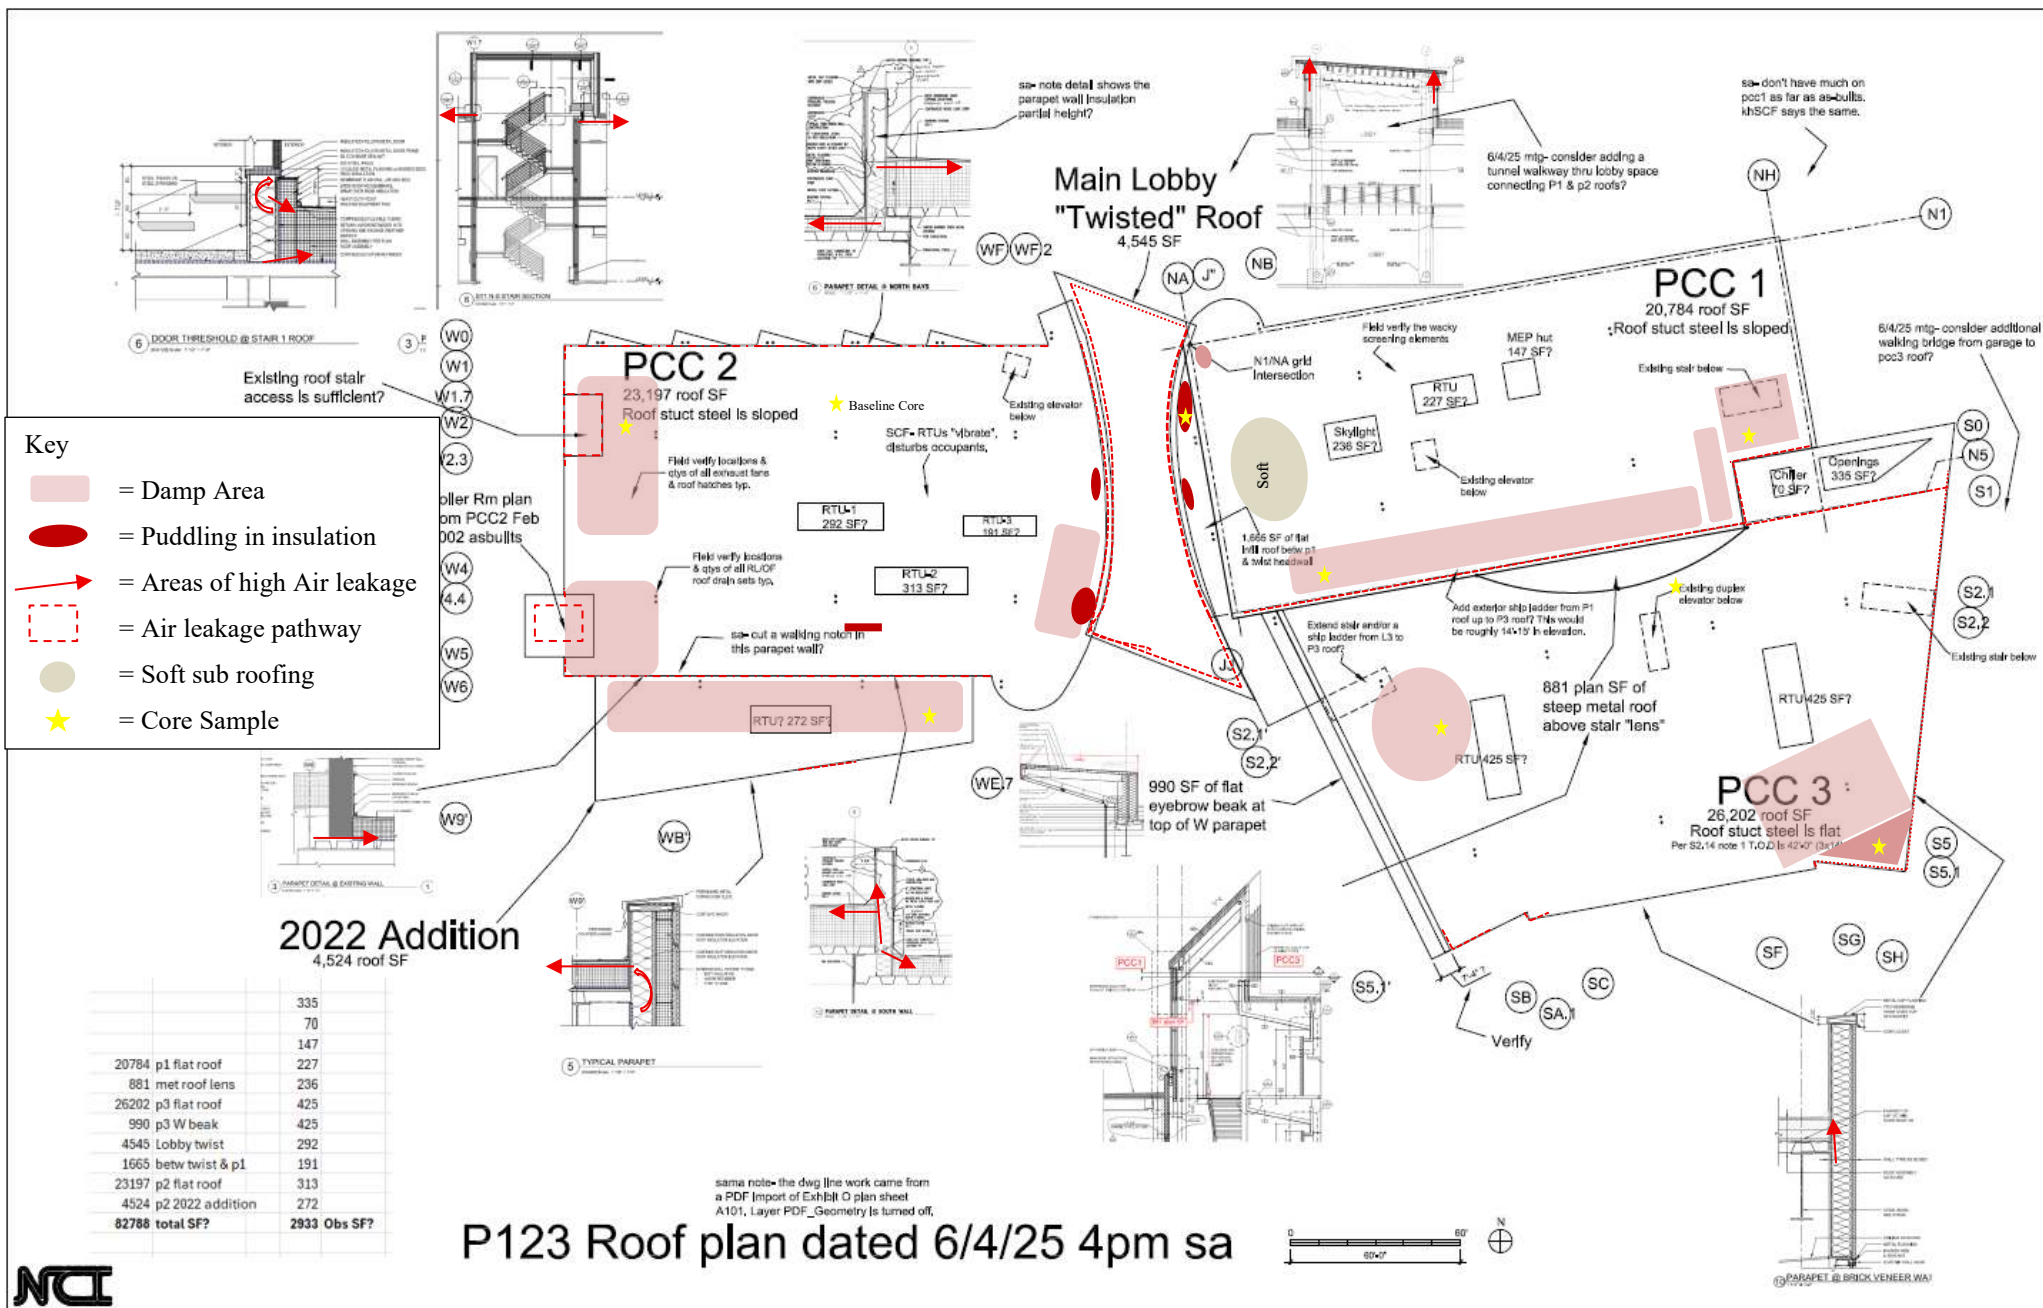
PCC 2 above, and PCC 1 & 3 below, have very similar signatures and reflect their age and level of degradation over time caused by excessive air leakage and building pressurization. White squares and circles reflect areas of moisture loading. Black arrows are call outs related to moisture signatures, puddles or air leakage pathways in the IR pictures.
