AK Native Primary Care Center Bldgs I,II, III  
Roof IR Report 6-18-2025 & 6-20-2025  
Thermographic Imaging of the ANPCC Roof for Moisture  
Detection & Heat Loss.

## PCC #3 Roof

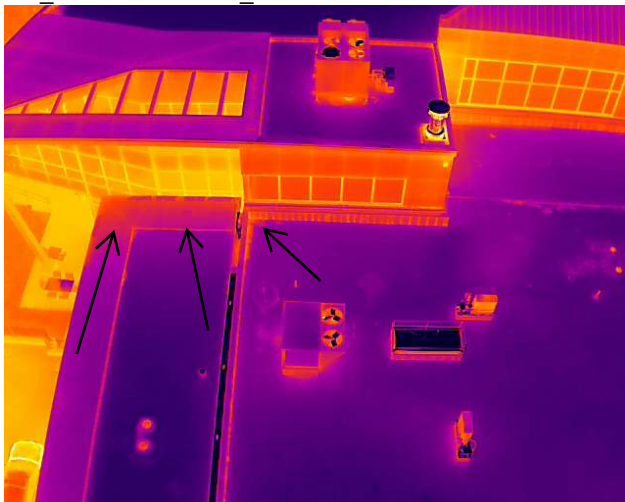
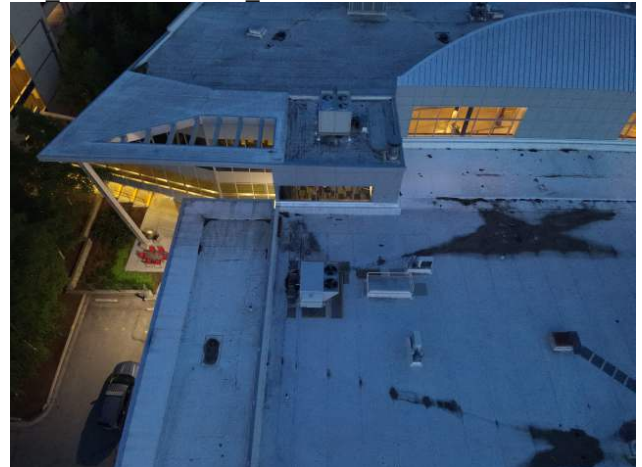
DJI\_20250619005757\_01... 6/19/2025 12:57:57 AM

**Comment:** The walls sections at column S0 and N5 between PCC 1 and PCC 3 have significant air leakage at the roof to wall joint that over time has driven vapor into the roofing and degraded the dens deck and caused the PVC roof delaminate from the substrate. The impact of relying on the roofing membrane as the primary air barrier is the shortened life and eventual failure of the roofing system due to the moisture loading of the roof in a cold climate over time.

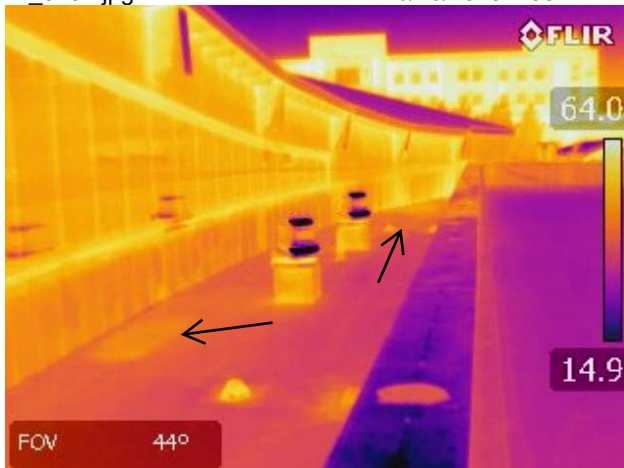
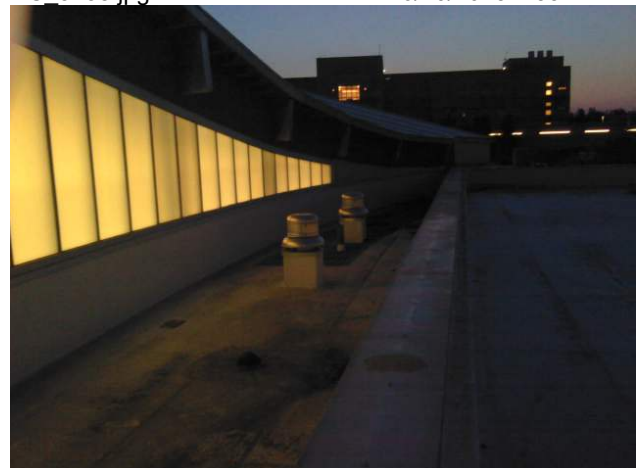
IR\_3257.jpg 6/20/2025 1:55:22 AM

Comment: The pool areas located between PCC1 and the Main Lobby has puddling in the insulation at the north side and center. The roof to wall joints and wall section below the clerestory windows has increased air leakage.

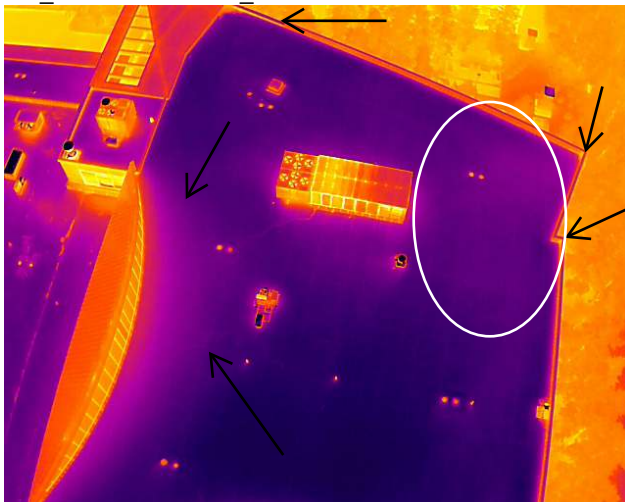
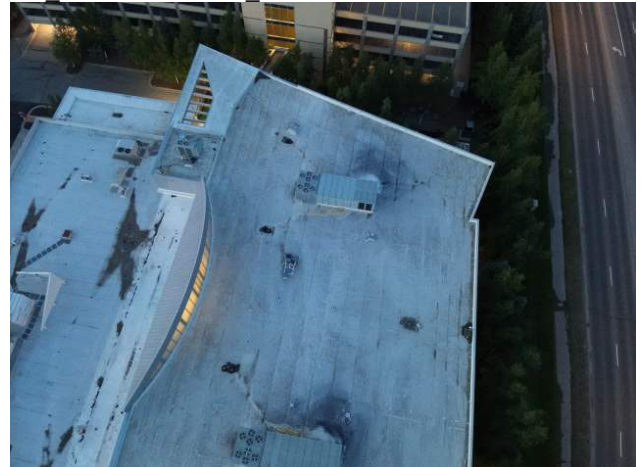
DJI\_20250619004146\_00... 6/19/2025 12:41:45 AM

Comment: PCC 3 Roof shows heavy moisture loading at Grid line SH & S5.1 due to air leakage at both corners. The curved signature in front of the curtain wall along Column S1 has an anomalous signature with the center of the signature east of the curtain wall. The moisture loading at the curtain wall does match other moisture logged roofing layers and appears to be similar damp conditions caused by air leakage associated with the roof to wall joint.

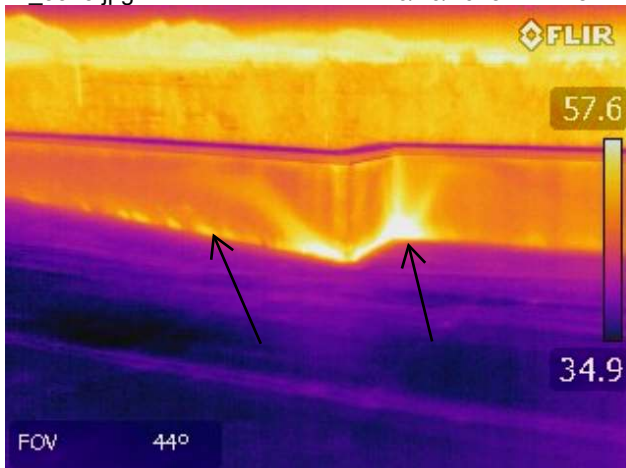
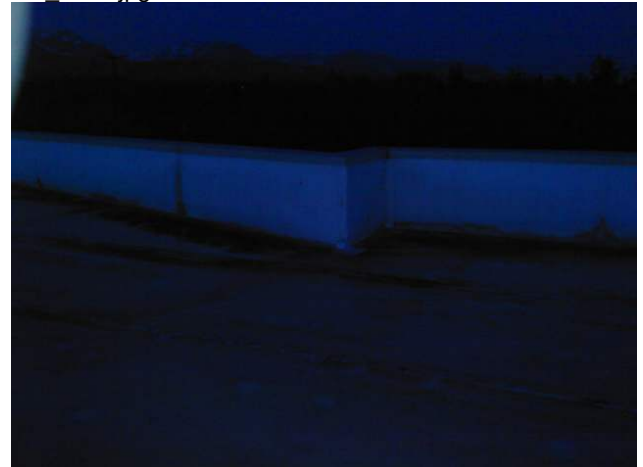
IR\_3325.jpg 6/20/2025 2:12:28 AM

Comment: The PCC 3 West side of the roof has a damp signature wrapping around the west HVAC RTU. Below the parapet walls of PCC3 had significant air leakage signatures at building corners. Where significant air leakage signatures were found the PVC roofing and parapet walls could typically be observed ballooning.
