AK Native Primary Care Center Bldgs I,II, III  
Roof IR Report 6-18-2025 & 6-20-2025  
Thermographic Imaging of the ANPCC Roof for Moisture  
Detection & Heat Loss.

**PCC 2 Southwest Building Corner at Mechanical Penthouse**

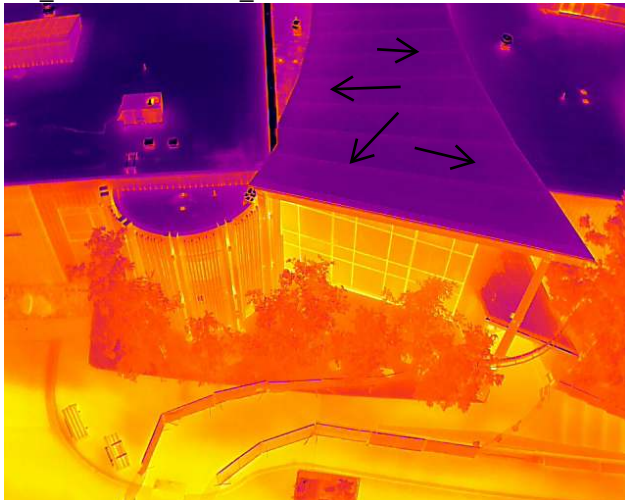
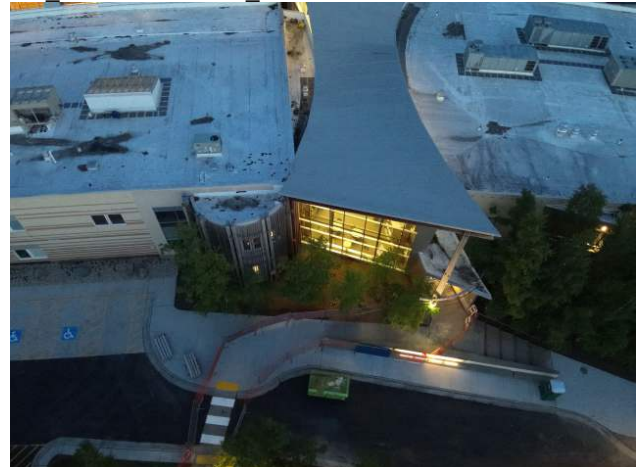
Comment: The twisted roof at the main lobby by has a largely uniform signature. A faint change in color happens at the perimeter of the roof line. See images below for potential cause of the change in signature.

Comment: The roof to wall joint and beam penetrations around the entire perimeter of the main lobby has air leakage signatures under normal building pressures.
