# SOUTHCENTRAL FOUNDATION

## Anchorage Native Primary Care Center Facility Conditions Assessment

ROOFS AND MECHANICAL EQUIPMENT

August 28, 2025

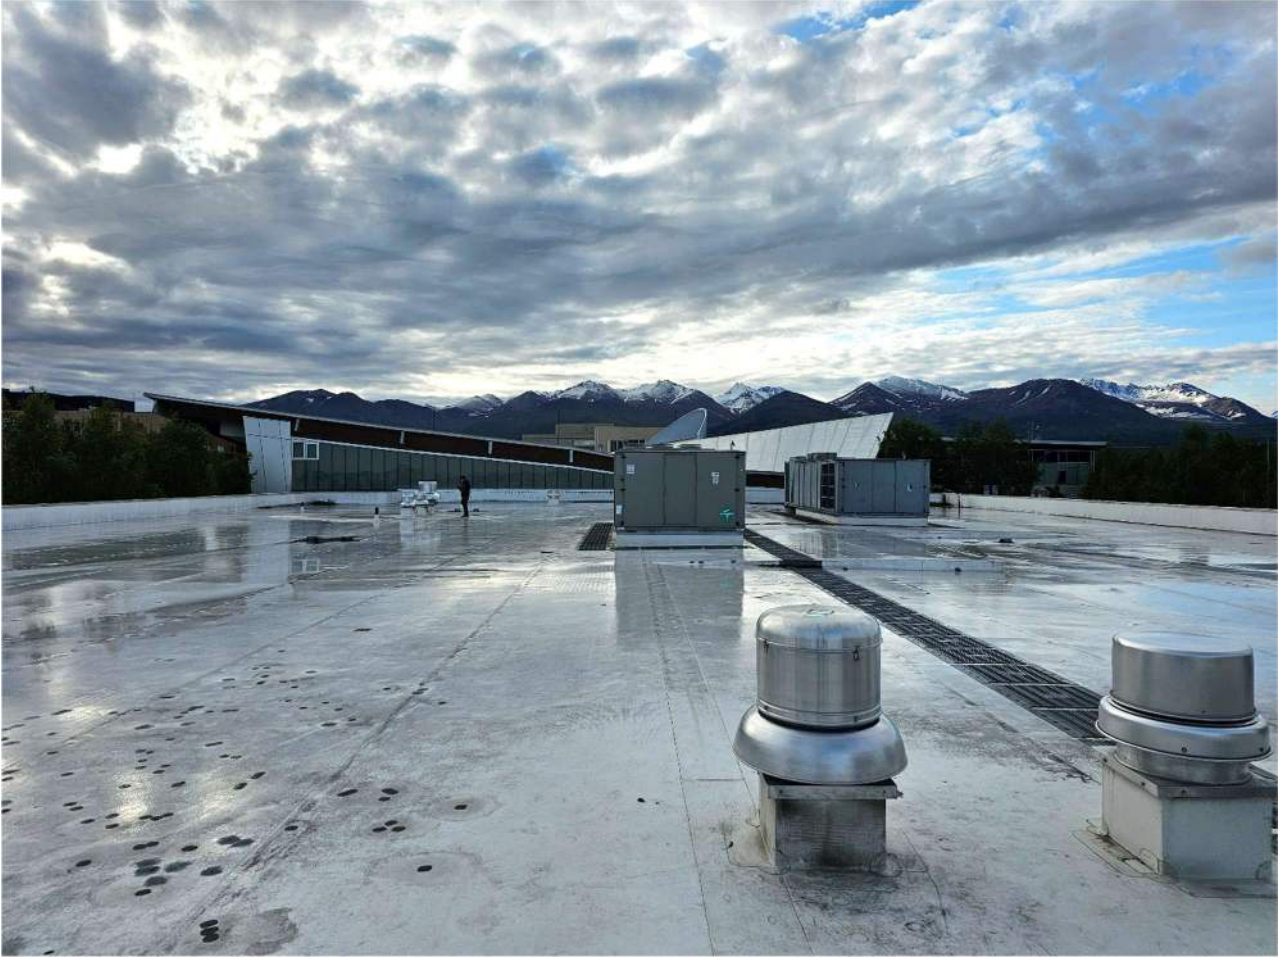
*PCC 2 Roof – facing east*

- Roof membrane shows a history of patches and repairs and is approaching the end of its useful life. Thermal imaging study indicates damp insulation and puddling moisture trapped within the roof assembly at several locations near the east side of the roof, adjacent to the Atrium.

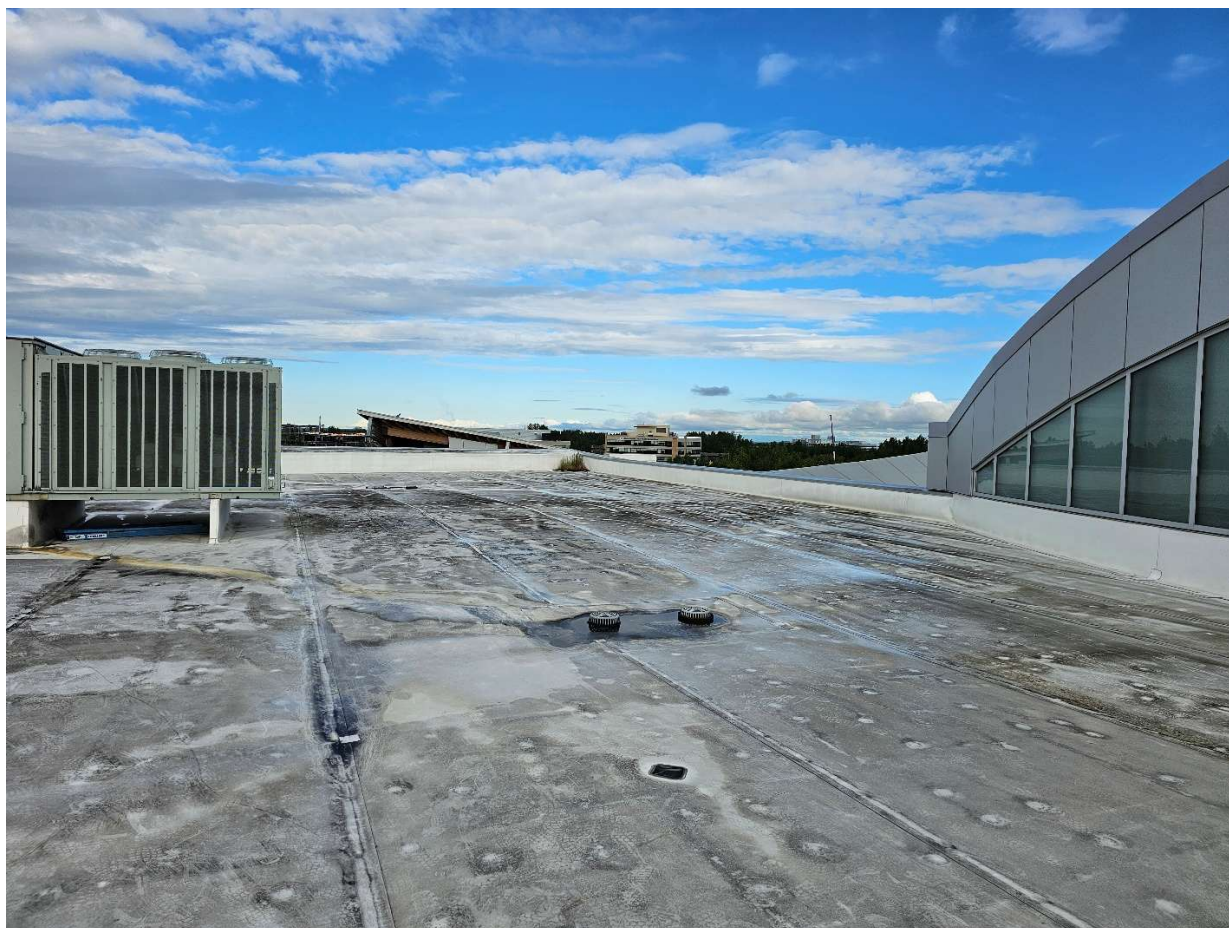
*PCC 3 Roof – facing west*

ballooning when building was positively pressurized, indicating leaks in the vapor barrier and other components of the roof assembly.

- There is no permanently attached fall protection system on the roof. Additionally, the daylight openings adjacent to the chiller unit at the northeast corner are not marked or protected in any way and pose a significant safety hazard to anyone accessing the roof.

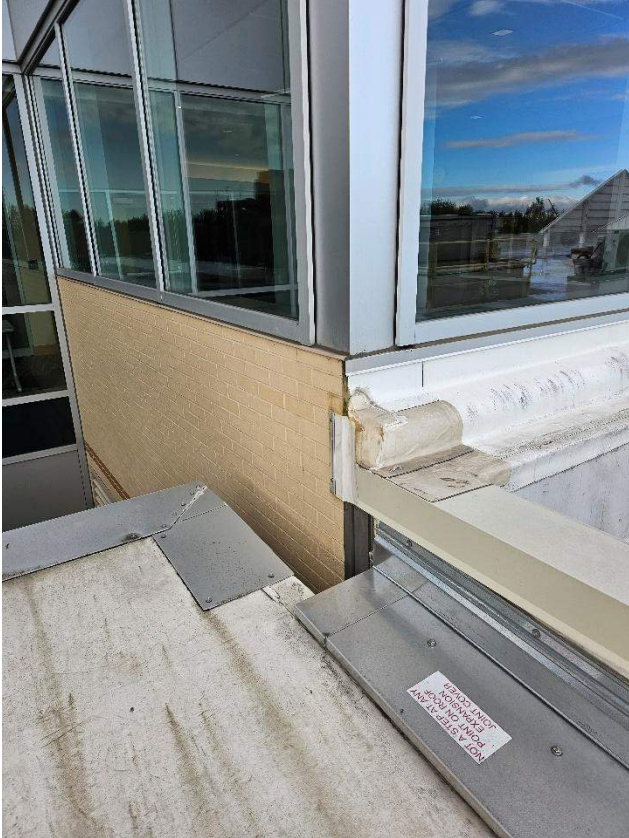
*PCC 1 Roof – seismic joint at east addition*

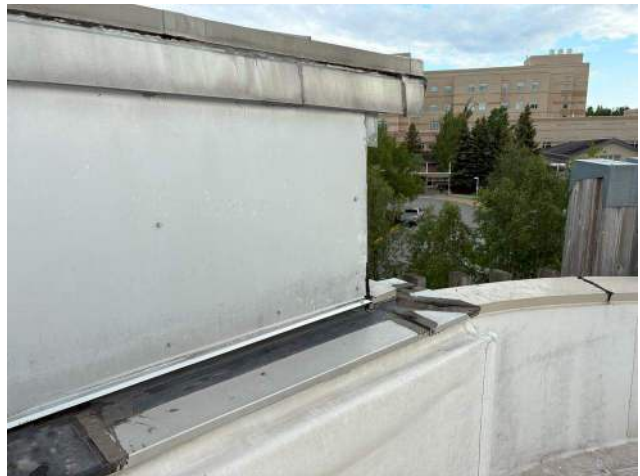
*PCC 1 Roof – seismic joint at Atrium*

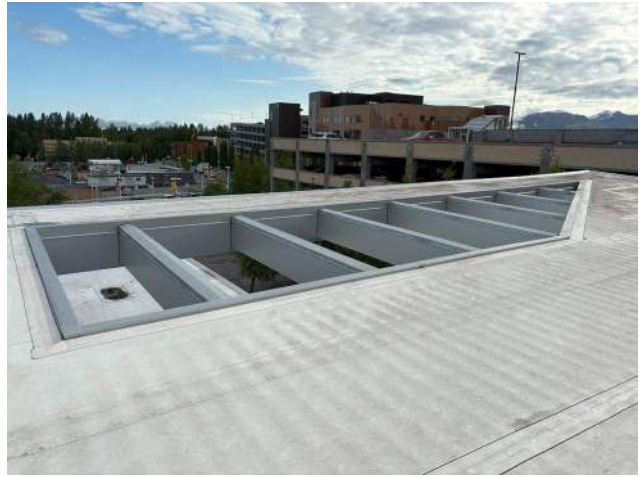
*PCC 3 Roof – openings at northeast corner*

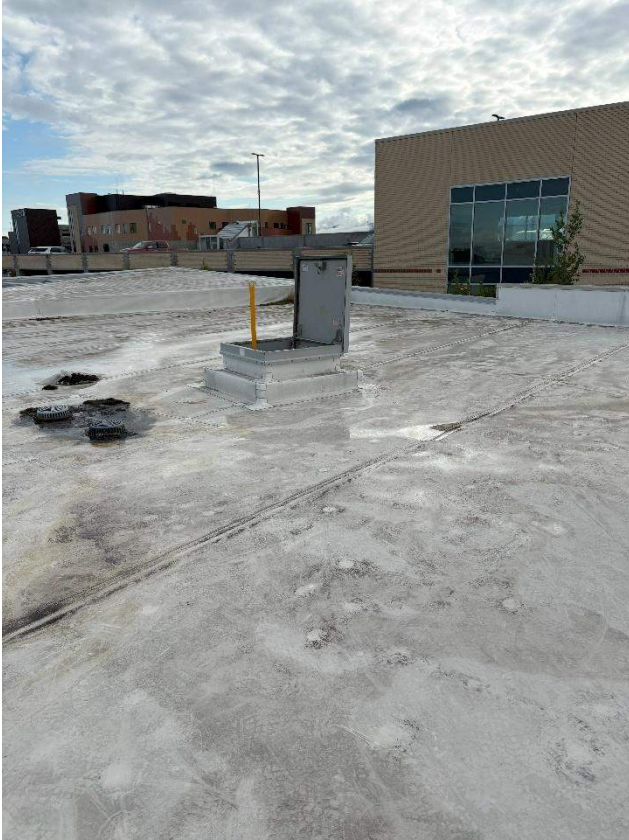
Access to the main PCC 3 roof occurs via a fixed vertical ladder and small access hatch inside Stair 2. This is the only means of maintenance access to the rooftop equipment on PCC 3. The hatch has a telescoping extendable safety post, but no perimeter guardrail.

*PCC 3 Roof – access hatch*

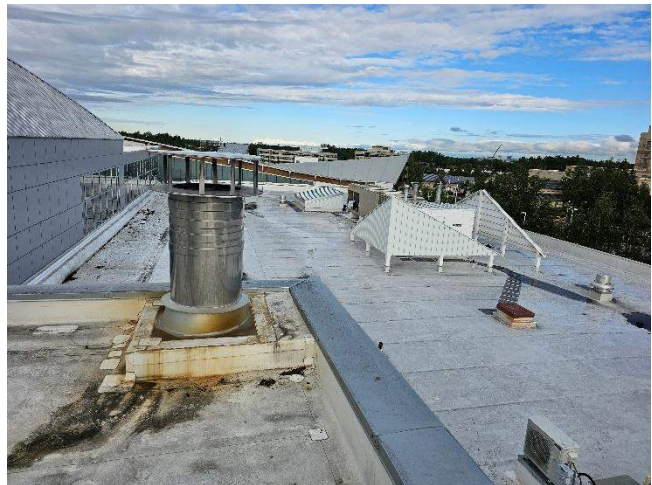
*PCC 3 Roof – northeast subsection, exhaust stack*

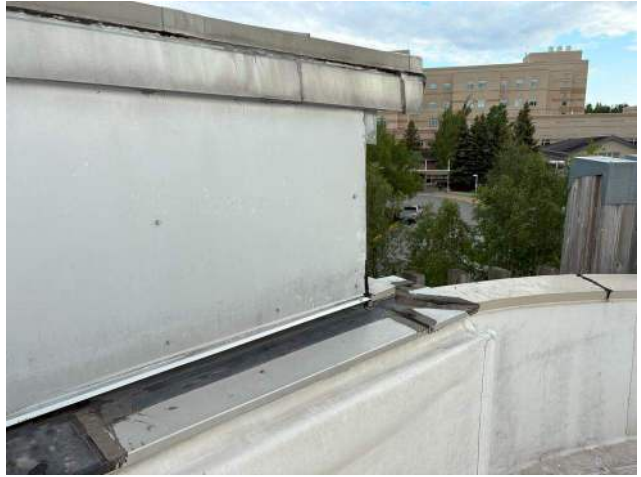
*Atrium – northeast corner edge condition*

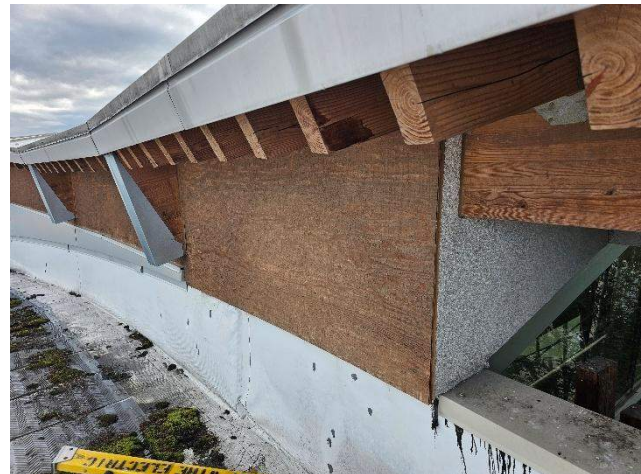
*Atrium – southwest corner eave condition*

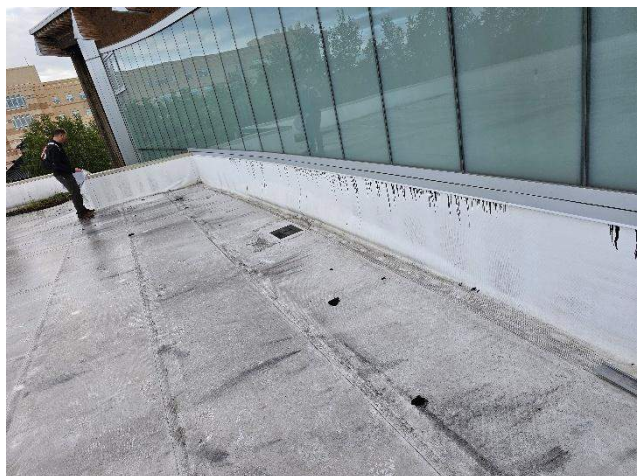
*Atrium – PCC 2 sidewall condition*

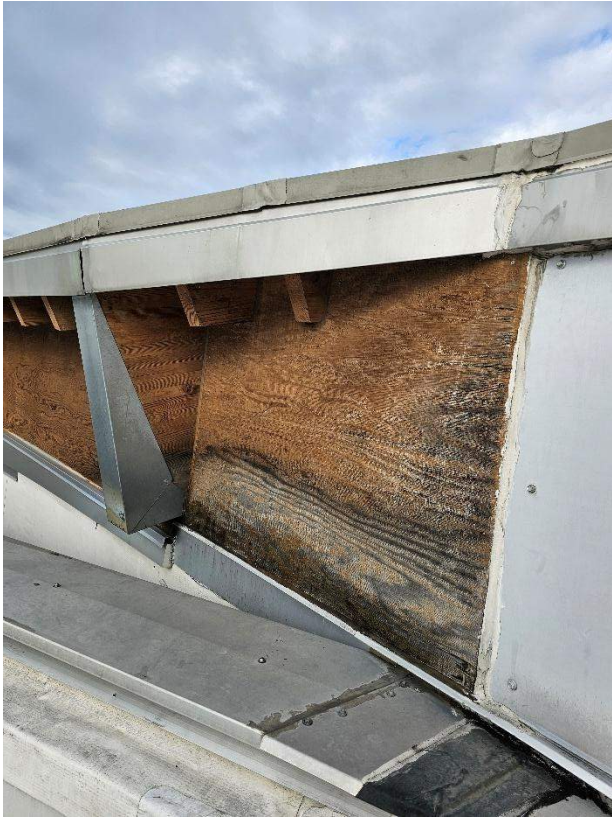
*Atrium – northeast corner at PCC1 seismic joint*

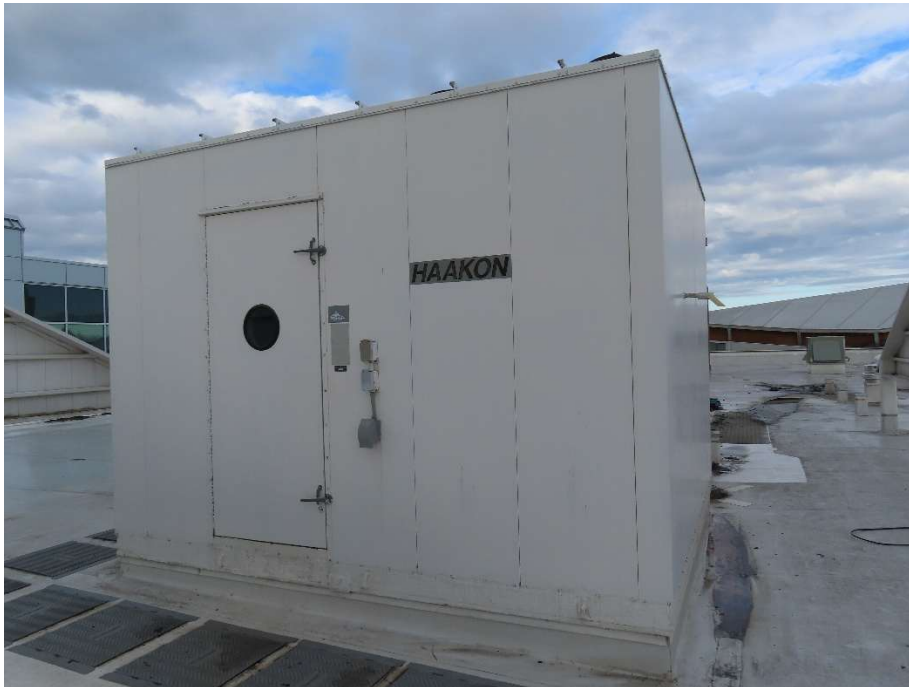
PCC1 penthouse “boiler in a box”

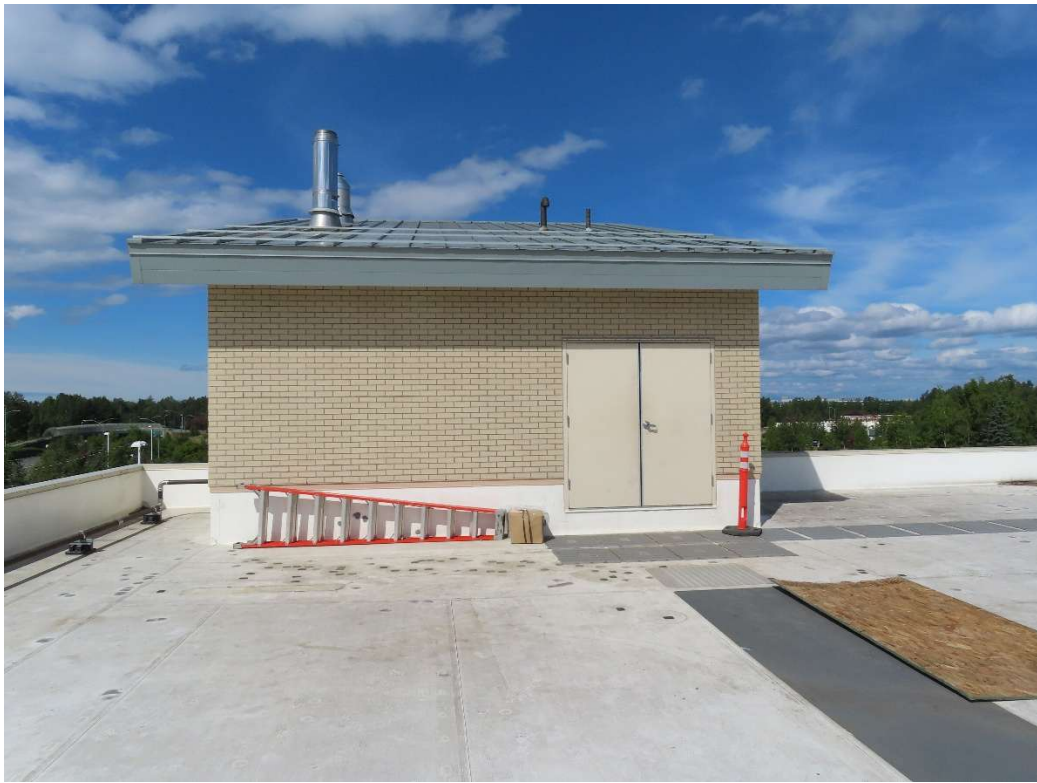
PCC2 boiler mechanical room exterior

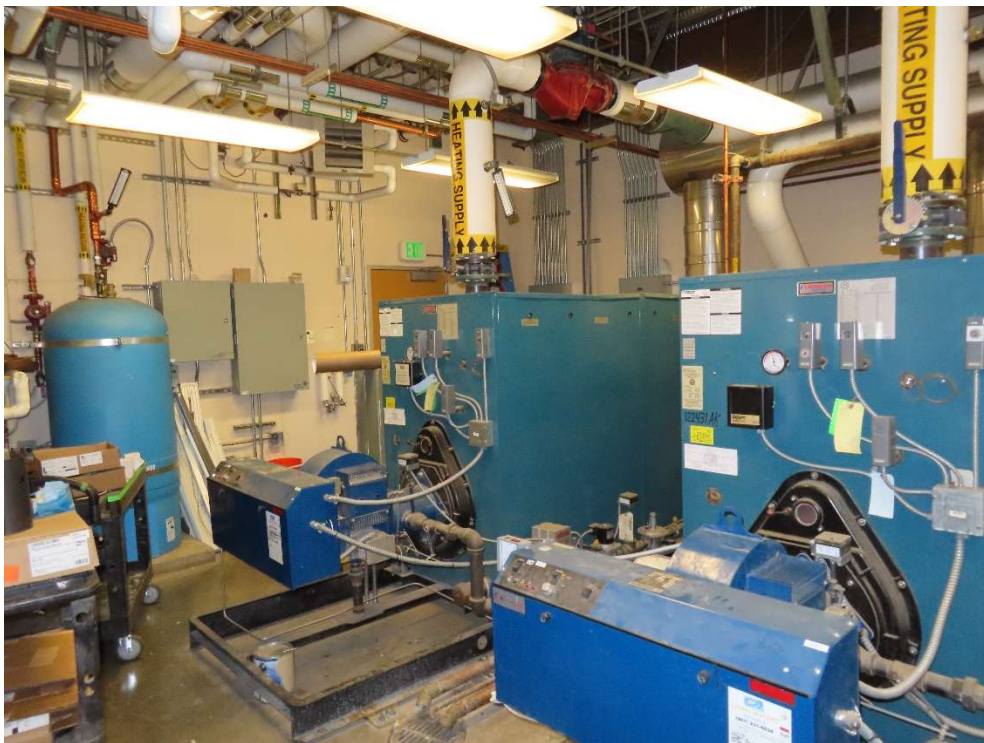
PCC3 boiler mechanical room, hot water generator shown at left, boiler re-circulation pumps above both boilers

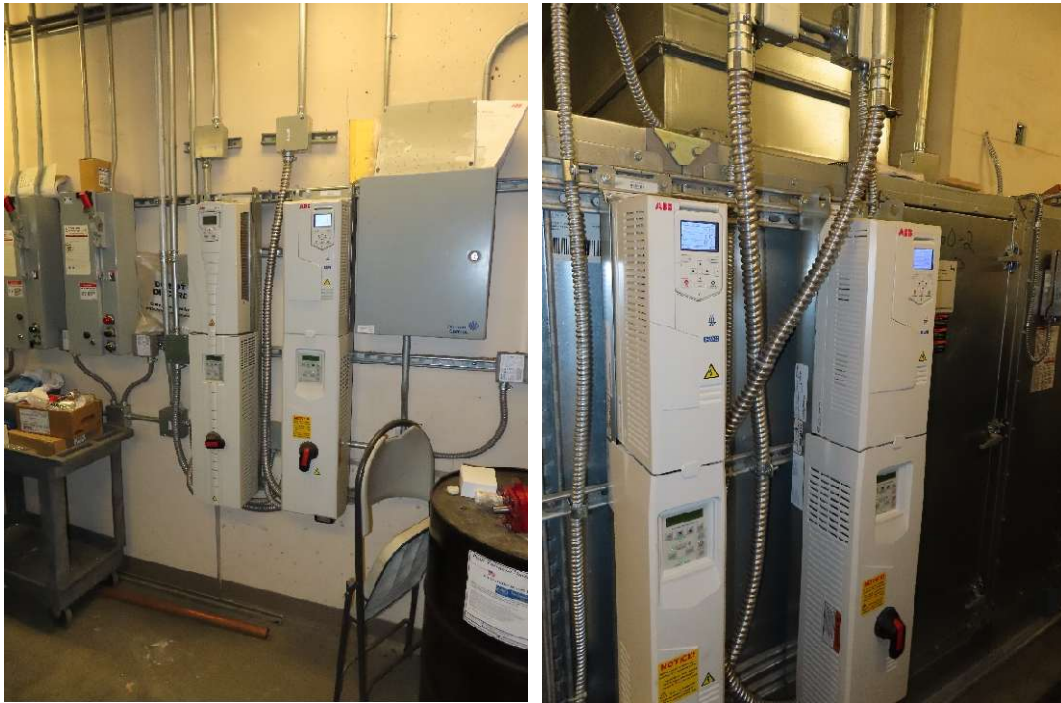
PCC3 heating circulation pump VFDs (photo at left) and AHU-3 fan motor VFDs in 2<sup>nd</sup> floor fan room (photo at right)

- CP-6 in PCC3 was running at 100% speed continually, with its VFD in bypass mode; this should be changed to auto mode to allow the VFD to adjust the pump speed

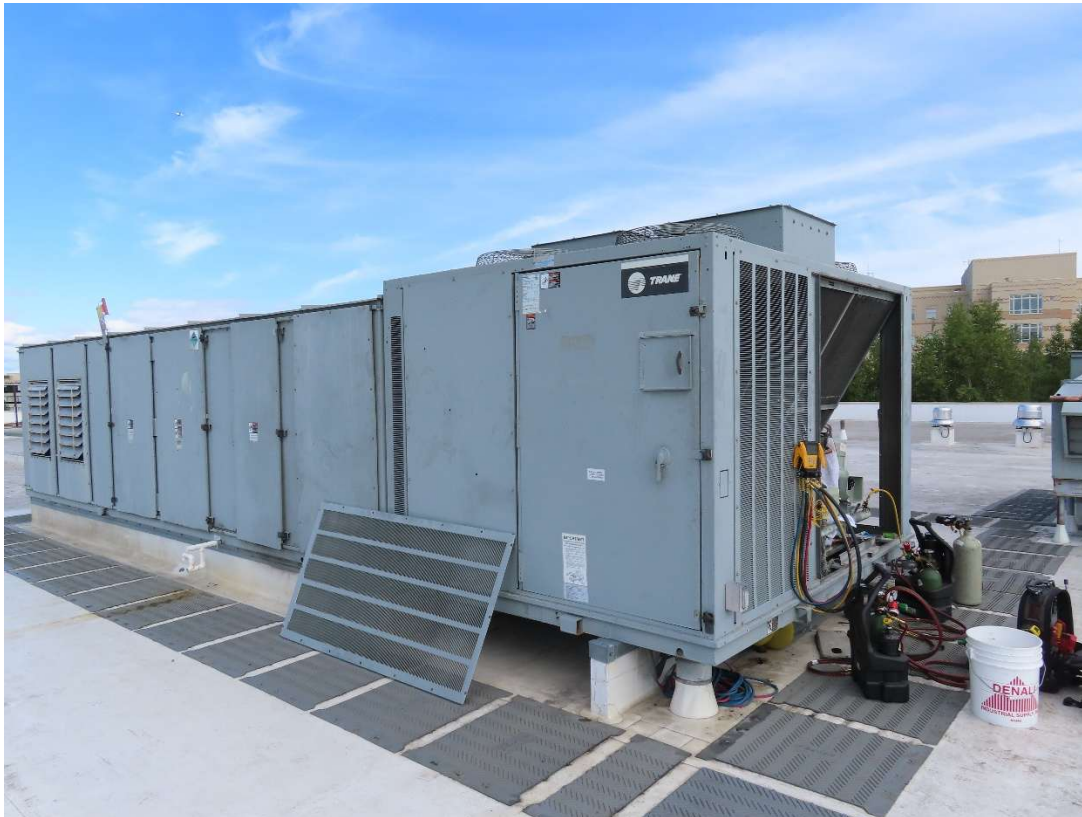
PCC2 rooftop unit RTU-B (aka RTU-2)
