RE: Addendum No. 1
VNPCC Parking Lot Improvements
RFP # SCF22-1079

Parcel #2 SW1/4 Sec.10, T17N, R1W, SM, Alaska

SOILS REPORT

KND ENGINEERING, Inc.**SOILS REPORT
PARCEL #2
WASILLA, ALASKA****1.0 PURPOSE AND SCOPE**

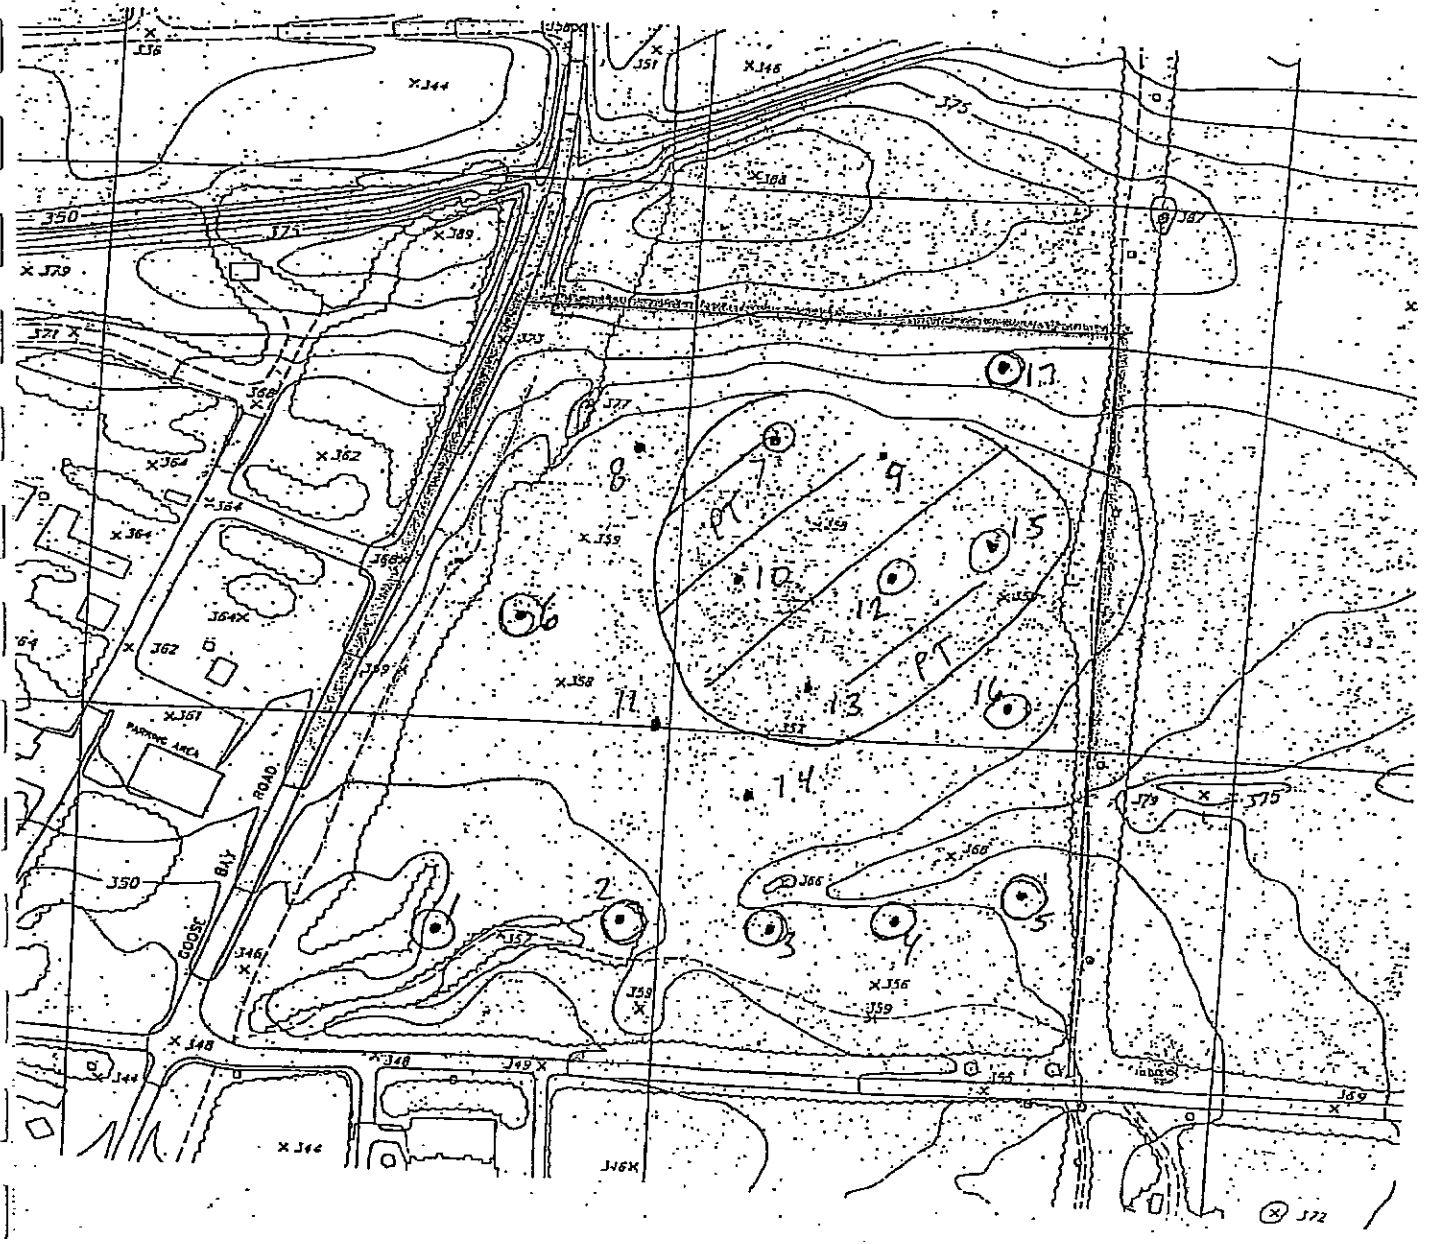
HIGHLIGHTED AREA - ESTIMATED PEAT EXTENT

TESTHOLE MONITORING TUBES ARE CIRCLED

17 testholes were excavated on August 28, 2003 to define subsurface conditions. The approximate locations of the test holes are shown in Figure 1.

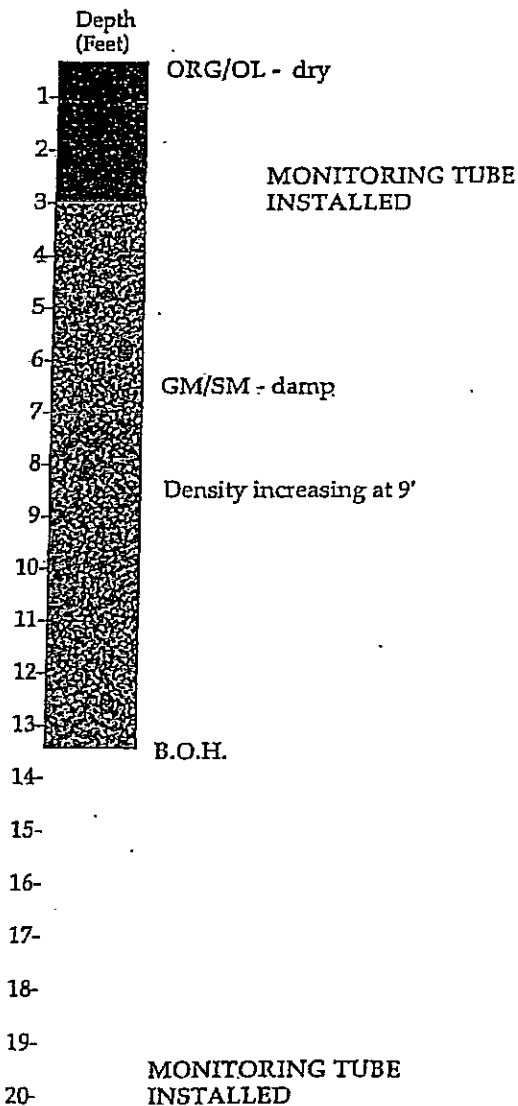
Project: Parcel #2 SW1/4 Sec.10, T17N, R1W, SM, Alaska TEST HOLE # 03-1

Was Ground water encountered?	NO	What depth?	NA
Depth to water after monitoring?	6.5'	Date?	9/6/03

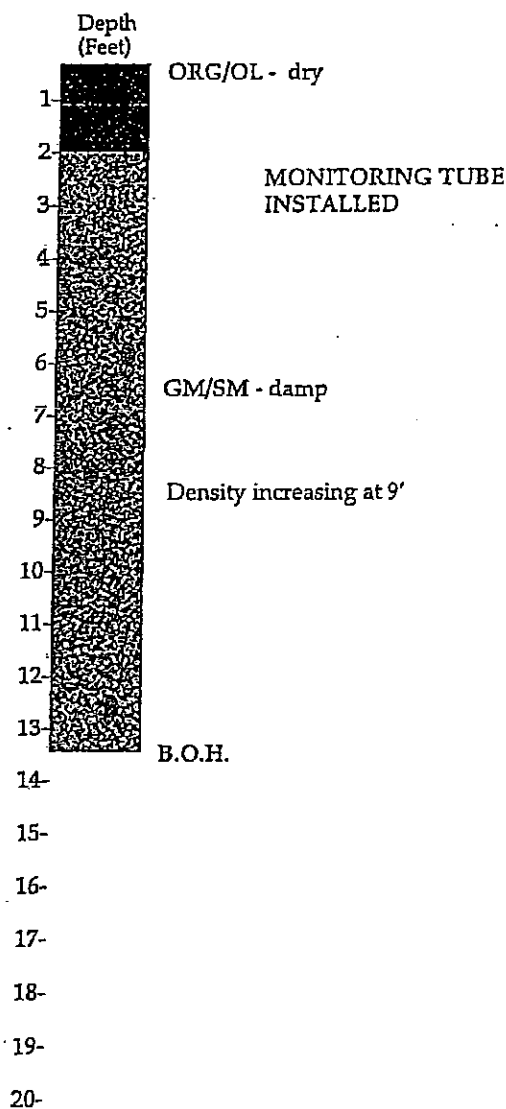
Project: Parcel #2 SW1/4 Sec.10, T17N, R1W, SM, Alaska TEST HOLE # 03-2

Was Ground water encountered?	NO	What depth?	NA
Depth to water after monitoring?	6'	Date?	9/6/03

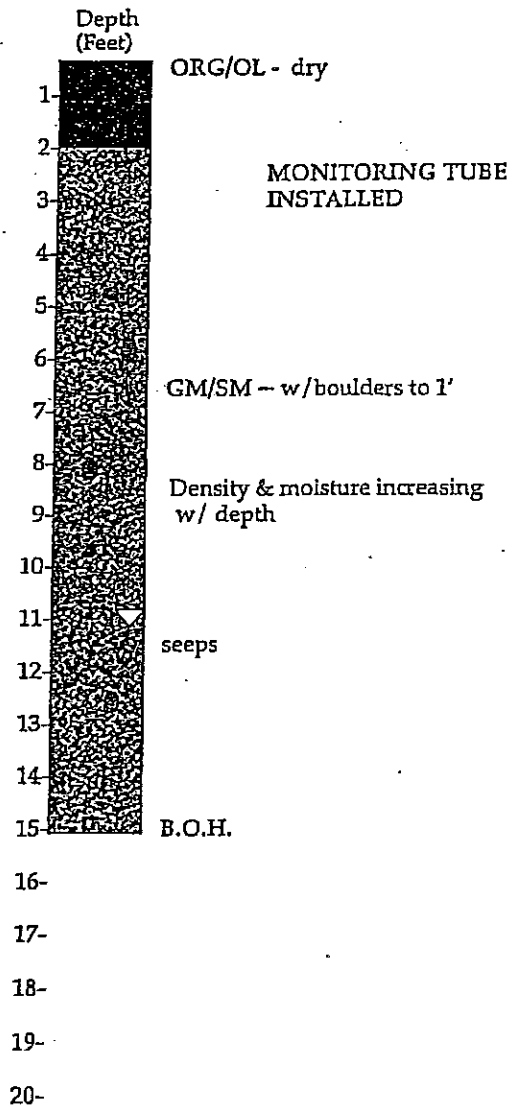
Project: Parcel #2 SW1/4 Sec.10, T17N, R1W, SM, Alaska TEST HOLE # 03-3

Was Ground water encountered?	YES	What depth?	11'
Depth to water after monitoring?	6.5'	Date?	9/6/03

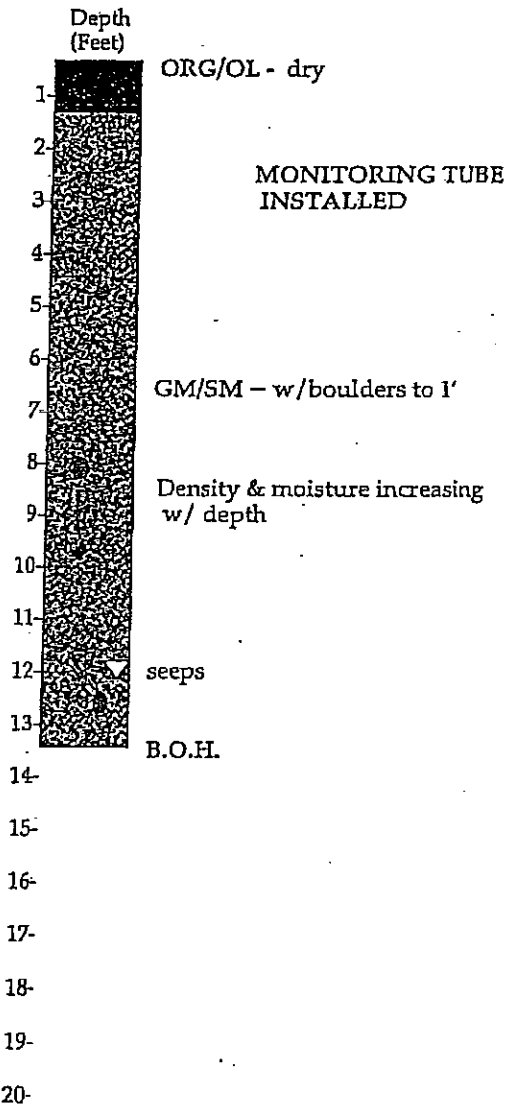
Project: Parcel #2 SW1/4 Sec.10, T17N, R1W, SM, Alaska TEST HOLE # 03-4

Was Ground water encountered? YES	What depth? 12'
Depth to water after monitoring? 8'	Date? 9/6/03

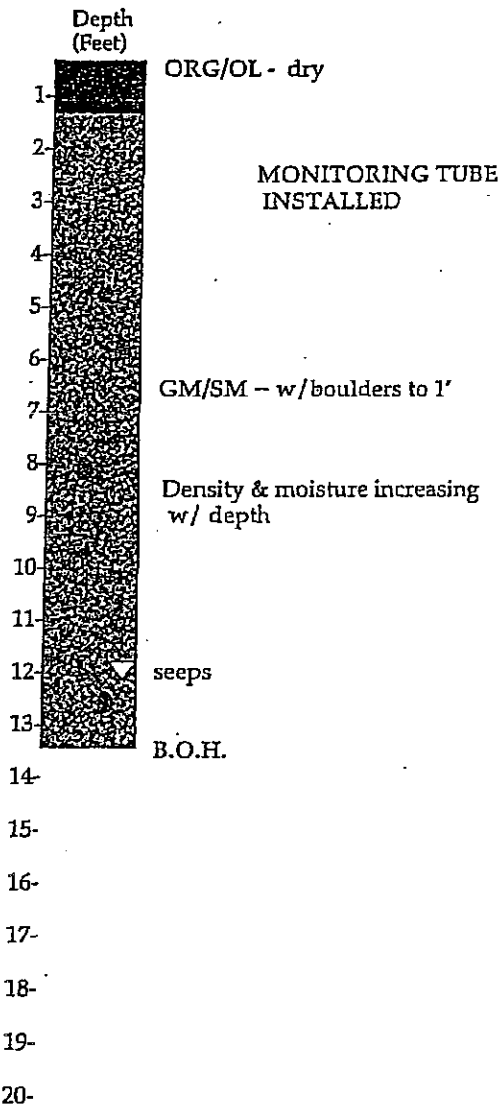
Project: Parcel #2 SW1/4 Sec.10, T17N, R1W, SM, Alaska TEST HOLE # 03-5

Was Ground water encountered?	YES	What depth?	12'
Depth to water after monitoring?	8'	Date?	9/6/03

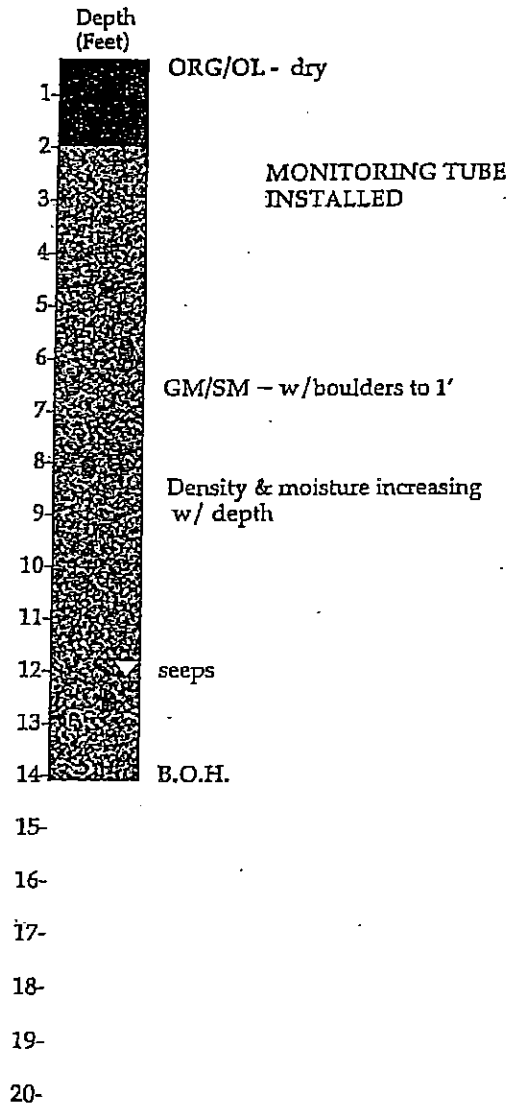
Project: Parcel #2 SW1/4 Sec.10, T17N, R1W, SM, Alaska TEST HOLE # 03-6

Was Ground water encountered? YES	What depth? 12'
Depth to water after monitoring? 9'	Date? 9/6/03

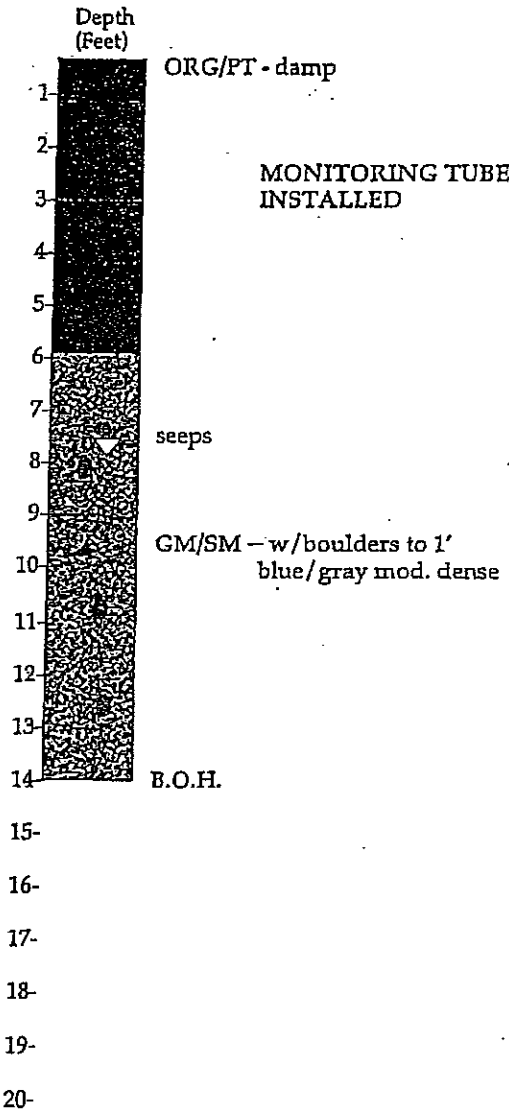
Project: Parcel #2 SW1/4 Sec.10, T17N, R1W, SM, Alaska TEST HOLE # 03-7

Was Ground water encountered?	YES	What depth?	8'
Depth to water after monitoring?	6.5'	Date?	9/6/03

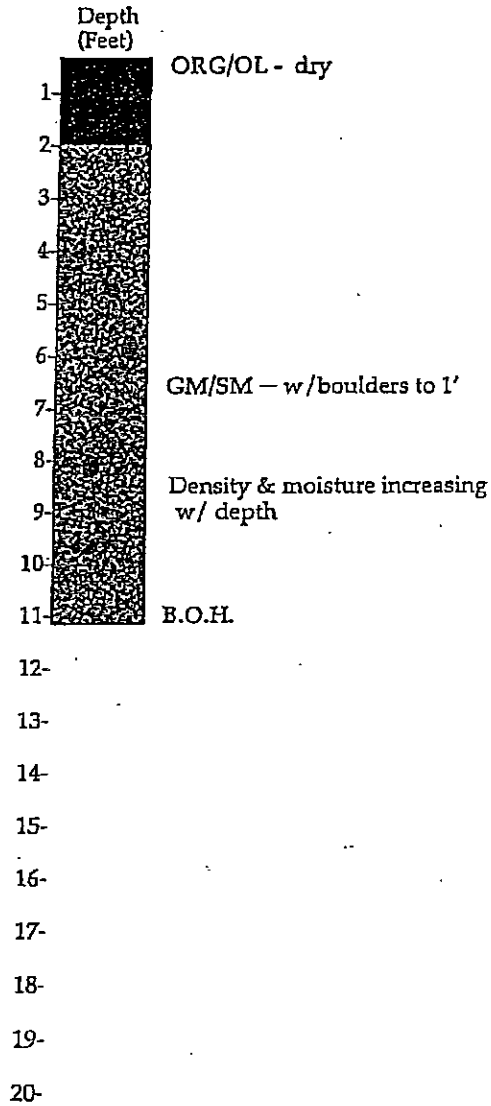
Project: Parcel #2 SW1/4 Sec.10, T17N, R1W, SM, Alaska TEST HOLE # 03-8

Was Ground water encountered?	NO	What depth?	NA
Depth to water after monitoring?	NA	Date?	NA

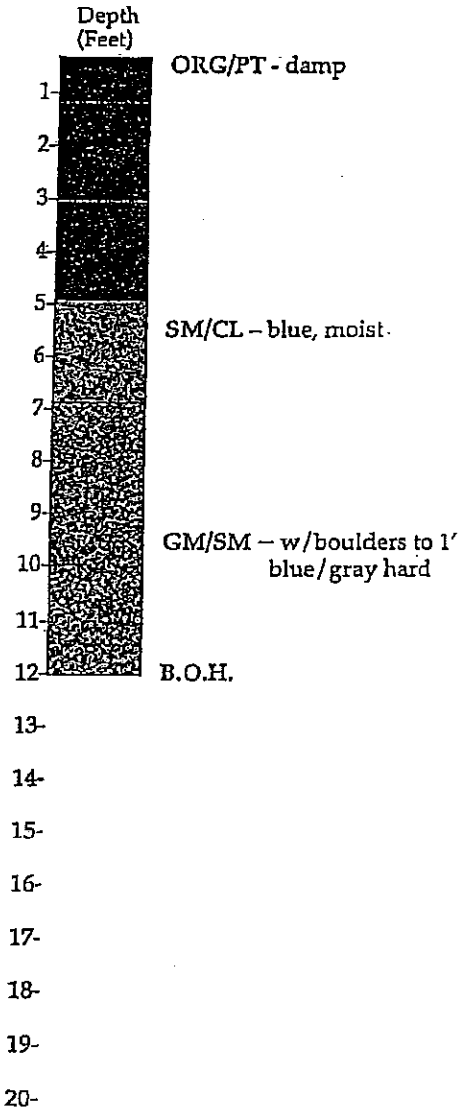
Project: Parcel #2 SW1/4 Sec.10, T17N, R1W, SM, Alaska TEST HOLE # 03-9

Was Ground water encountered?	NO	What depth?	NA
Depth to water after monitoring?	NA	Date?	NA

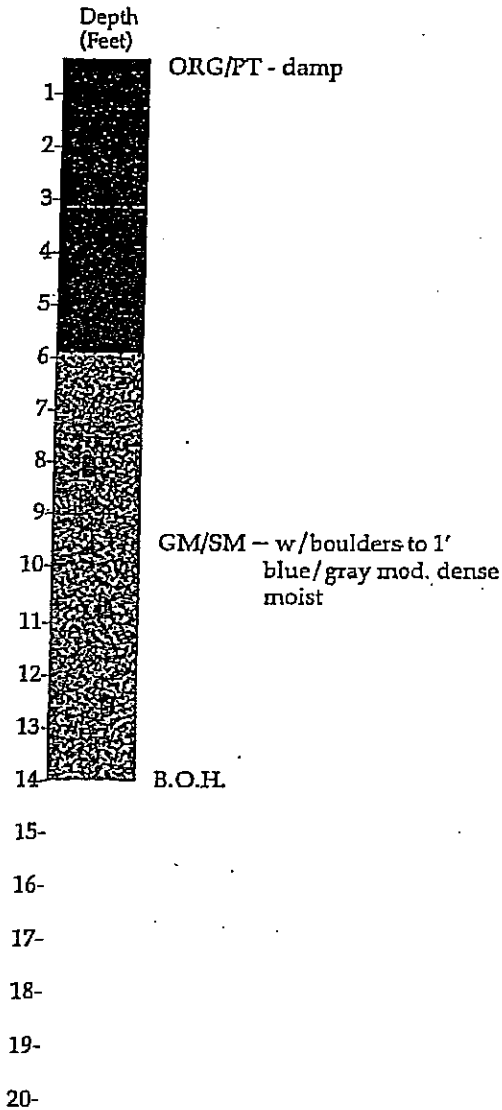
Project: Parcel #2 SW1/4 Sec.10, T17N, R1W, SM, Alaska TEST HOLE # 03-10

Was Ground water encountered?	NO	What depth?	NA
Depth to water after monitoring?	NA	Date?	NA

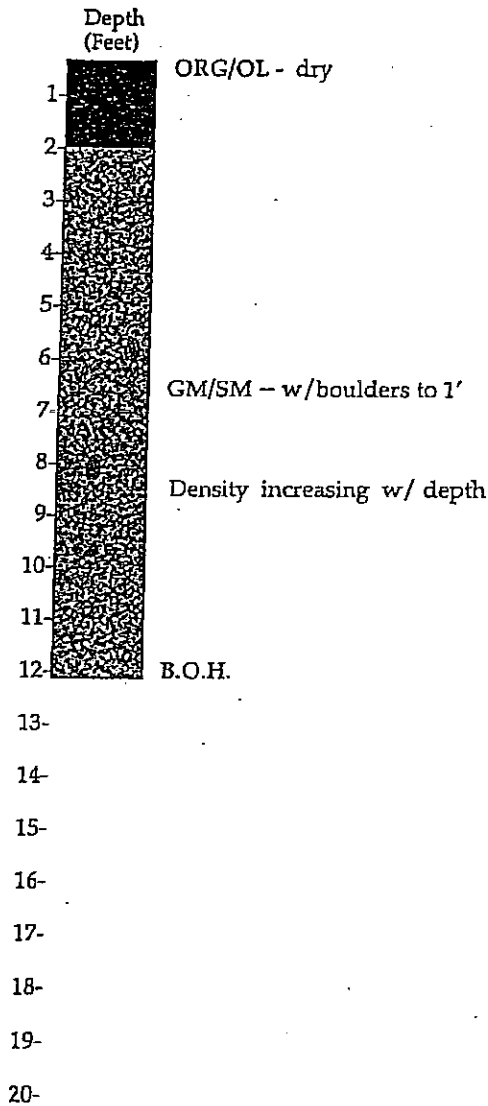
Project: Parcel #2 SW1/4 Sec.10, T17N, R1W, SM, Alaska TEST HOLE # 03-11

Was Ground water encountered?	NO	What depth?	NA
Depth to water after monitoring?	NA	Date?	NA

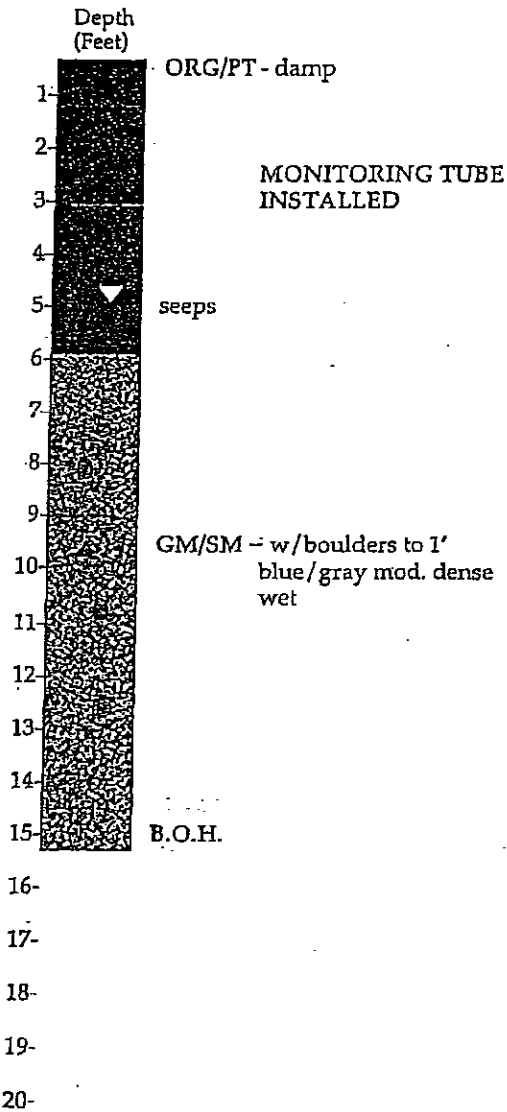
Project: Parcel #2 SW1/4 Sec.10, T17N, R1W, SM, Alaska TEST HOLE # 03-12

Was Ground water encountered? YES	What depth? 5'
Depth to water after monitoring? 3.5'	Date? 9/6/03

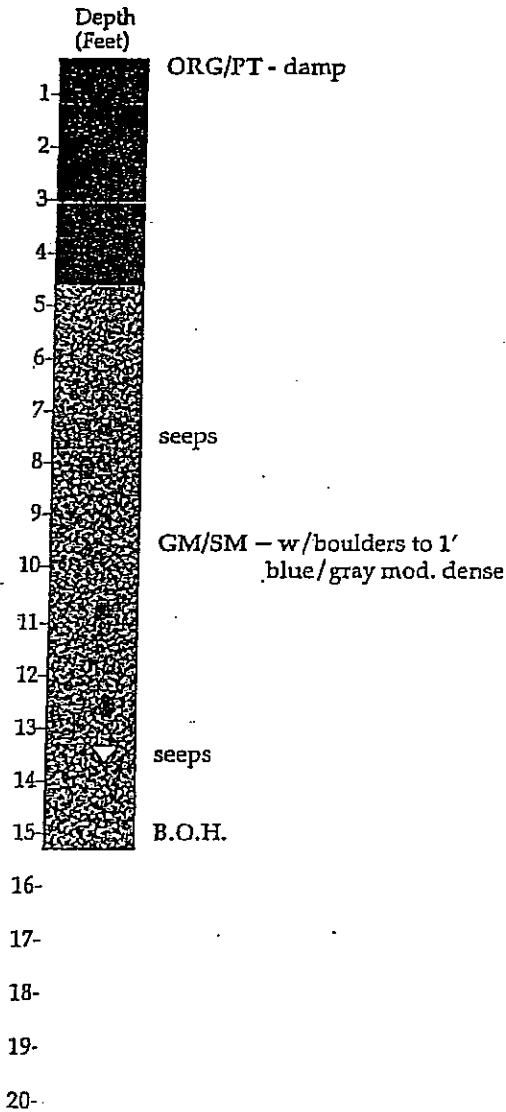
Project: Parcel #2 SW1/4 Sec.10, T17N, R1W, SM, Alaska TEST HOLE # 03-13

Was Ground water encountered?	YES	What depth?	14'
Depth to water after monitoring?	NA	Date?	NA

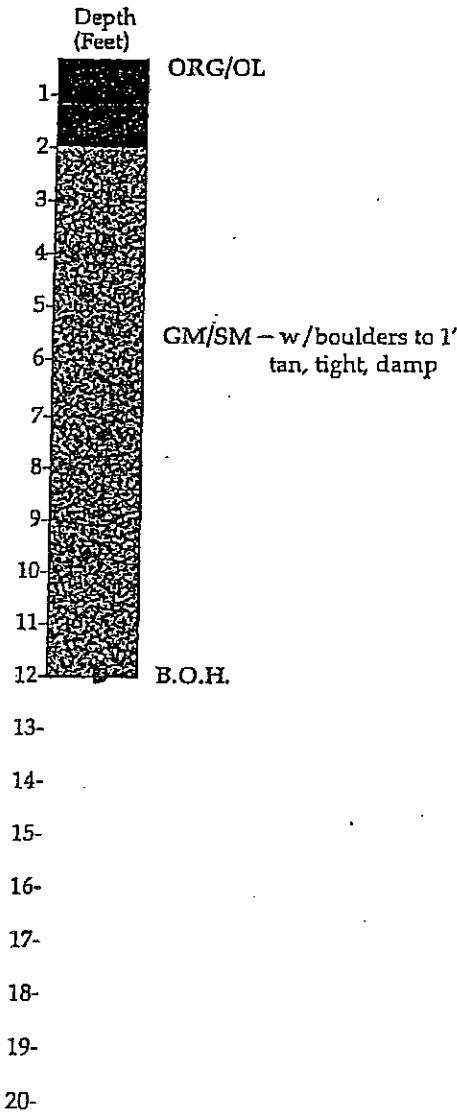
Project: Parcel #2 SW1/4 Sec.10, T17N, R1W, SM, Alaska TEST HOLE # 03-14

Was Ground water encountered?	NO	What depth?	NA
Depth to water after monitoring?	NA	Date?	NA

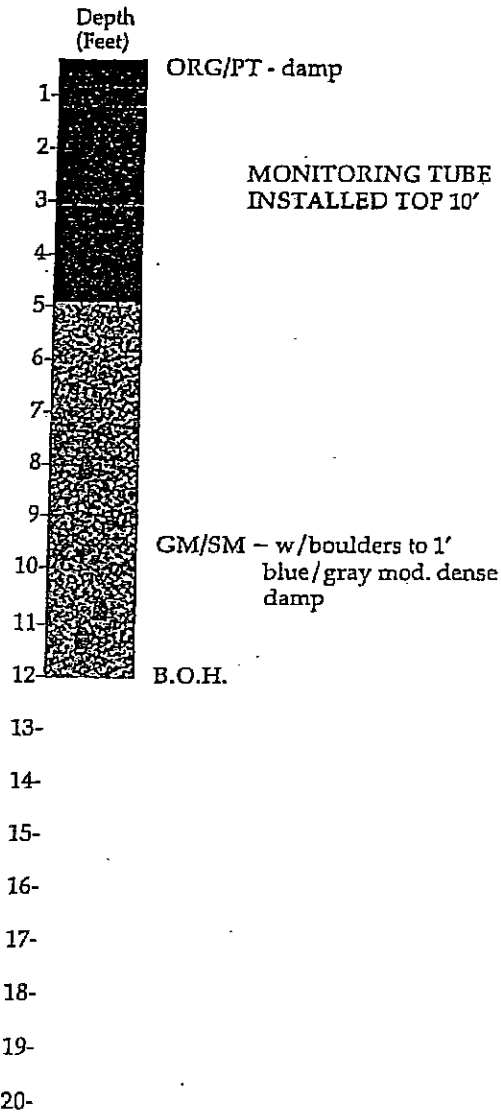
Project: Parcel #2 SW1/4 Sec.10, T17N, R1W, SM, Alaska TEST HOLE # 03-15

Was Ground water encountered?	NO	What depth?	NO
Depth to water after monitoring?	6'	Date?	9/6/03

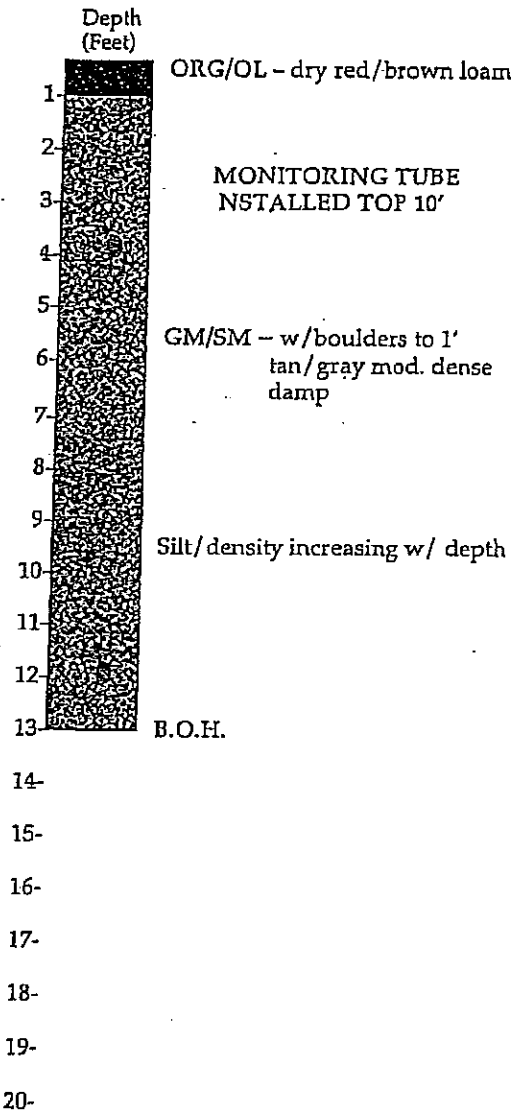
Project: Parcel #2 SW1/4 Sec.10, T17N, R1W, SM, Alaska TEST HOLE # 03-17

Was Ground water encountered?	NO	What depth?	NA
Depth to water after monitoring?	DRY	Date?	9/6/03

Groundwater: During excavation, ground water was encountered in 7 of the testholes. After monitoring, groundwater was present between 3.5' and 9' in all the testholes that were monitored, with the exception of TH03-17, which was dry.
