SOUTHCENTRAL FOUNDATION
NEW CLINIC FOR
DENTAL, OPTOMETRY and BEHAVIORAL HEALTH
TUDOR RD. and TUDOR CENTER DRIVE, ANCHORAGE, ALASKA

drawn	O, JS
checked	DB, JS
date	9-17-02
revisions	
1	6-3-02 E&F
2	7-8-02 C&S
3	8-15-02 GEN REVS
4	8-26-02 95%
5	9-17-02 100%
job no.	20152
dwg title	EXTERIOR ELEVATIONS WINDOW TYPES CURTAINWALL TYPES
sheet no.	A4.2

SOUTHCENTRAL FOUNDATION
 NEW CLINIC FOR
 DENTAL, OPTOMETRY and BEHAVIORAL HEALTH
 TUDOR RD. and TUDOR CENTER DRIVE ANCHORAGE ALASKA

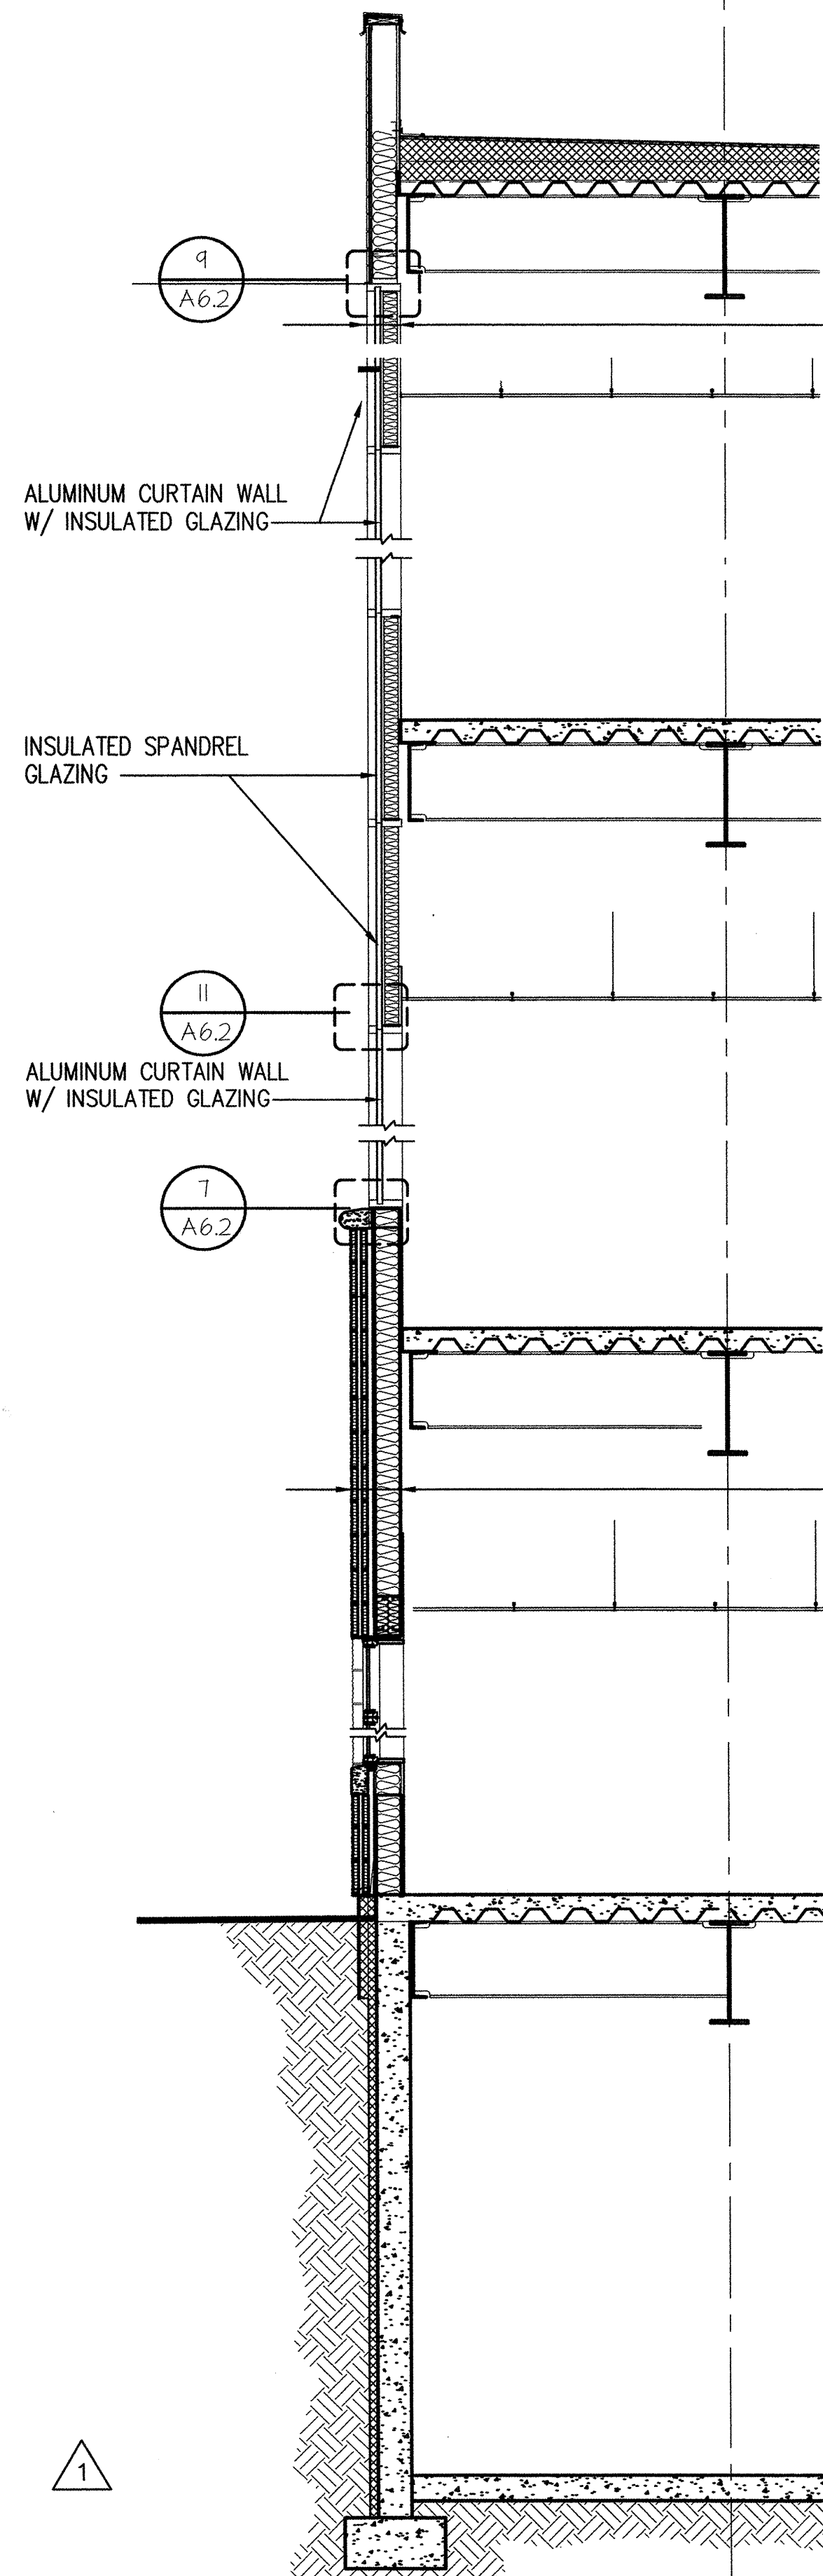
TYPICAL BRICK TILE WALL ASSEMBLY:
 1/2" BRICK TILE ON
 LATEX MORTAR SYSTEM ON
 CEMENT BACKER BOARD
 METAL STUDS @ 16" O.C.
 BATT INSULATION
 VAPOR RETARDER
 GWB

PRE-CAST CONCRETE SILL

TYP. CMU VENEER WALL:
 4" CMU VENEER W/ WALL TIES
 STEEL LEDGER ANGLES
 (SEE STRUCTURAL)
 AIR SPACE
 AIR INFILTRATION BARRIER
 EXTERIOR SHEATHING
 6" METAL STUDS
 BATT INSULATION
 VAPOR RETARDER
 GWB

BASE FLASHING

TYPICAL BASEMENT FOUNDATION WALL:
 RIGID FOUNDATION INSULATION OVER
 DAMPROOFING ON
 C.I.P. CONC. FOUNDATION WALL

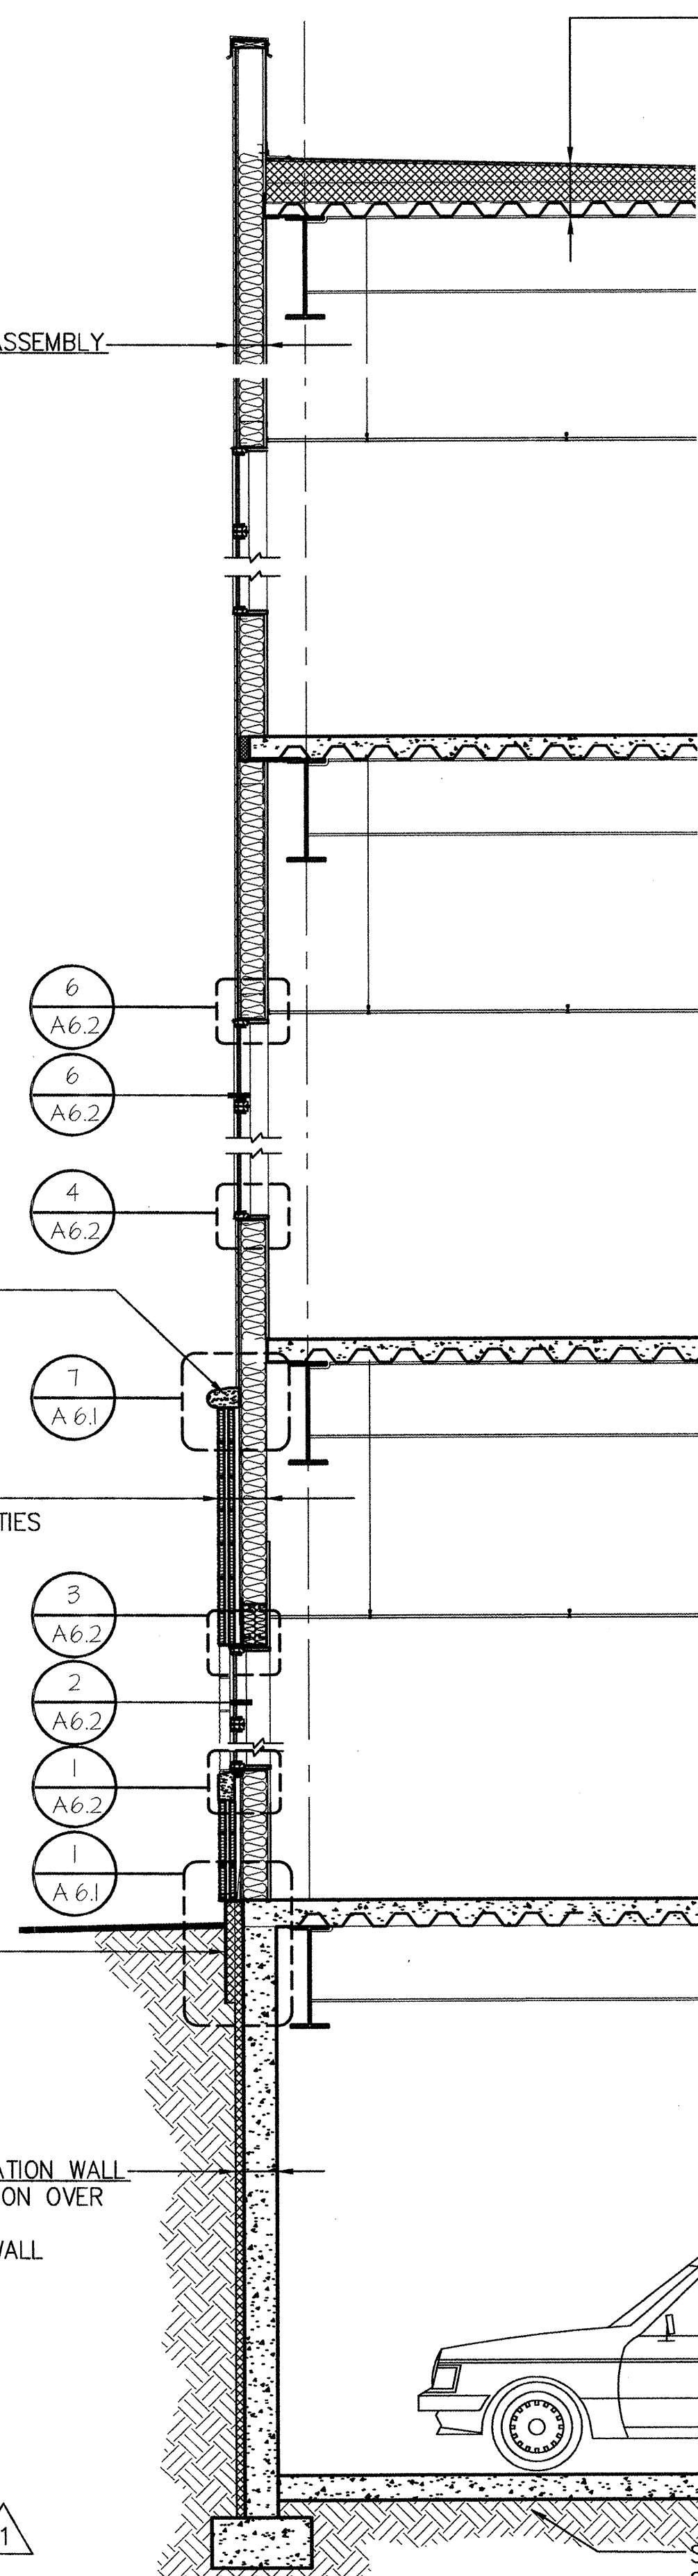
TYPICAL ROOF ASSEMBLY:
 MECH. FASTENED PVC MEMBRANE OVER
 RECOVERY BOARD OVER
 TAPERED RIGID INSULATION OVER
 VAPOR RETARDER OVER
 METAL DECK ON
 ROOF SHEATHING ON
 STEEL STRUCTURE

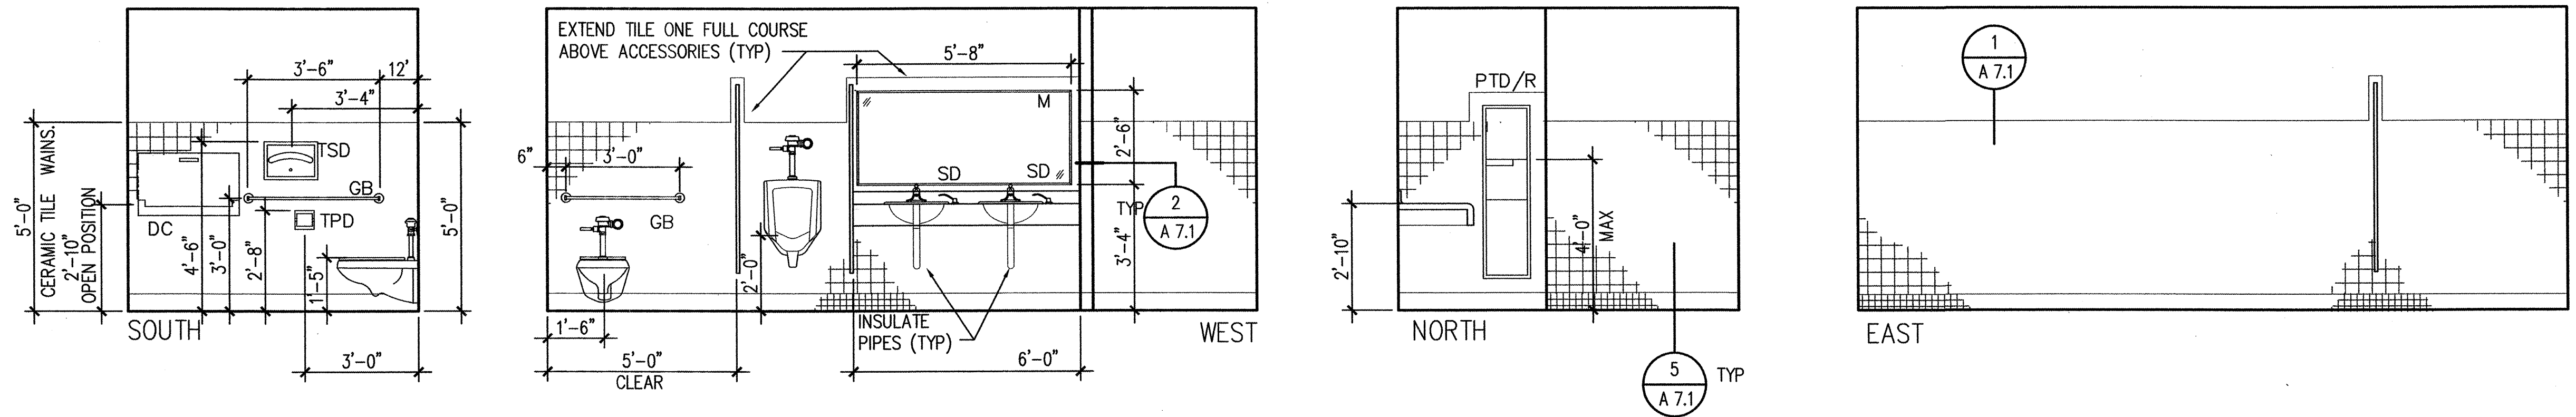
1 MEN'S TOILET, ROOM 360
 3/8" = 1'-0"

ROOMS 181 & 264 SIM.
 FOR WAINSCOT TILE PATTERN, SEE 3/A7.1.

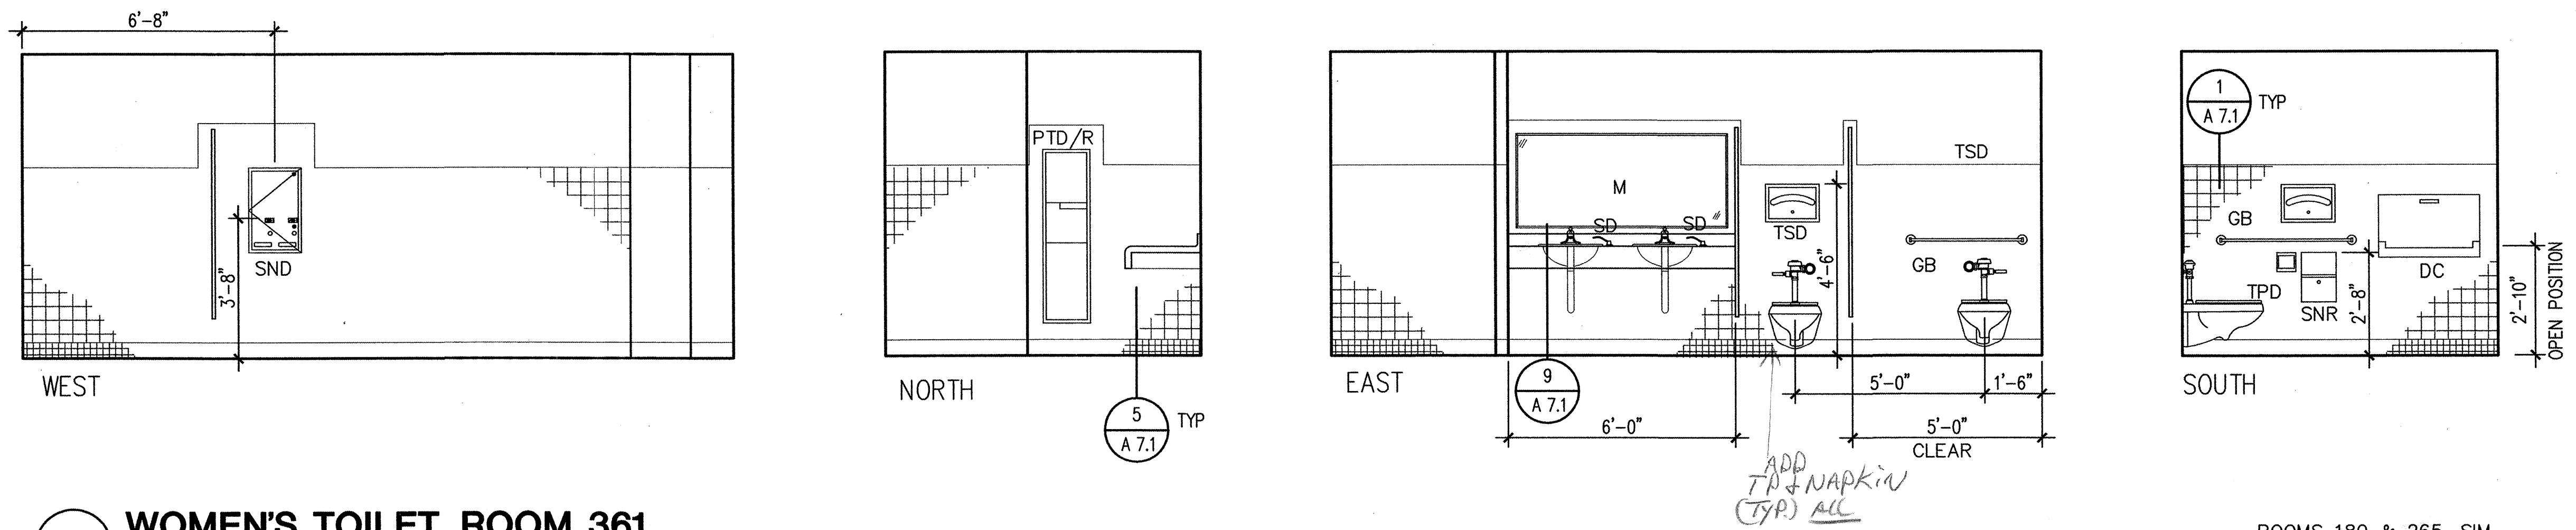
2 WOMEN'S TOILET, ROOM 361
 3/8" = 1'-0"

ROOMS 180 & 265, SIM.
 FOR WAINSCOT TILE PATTERN, SEE 3/A7.1.

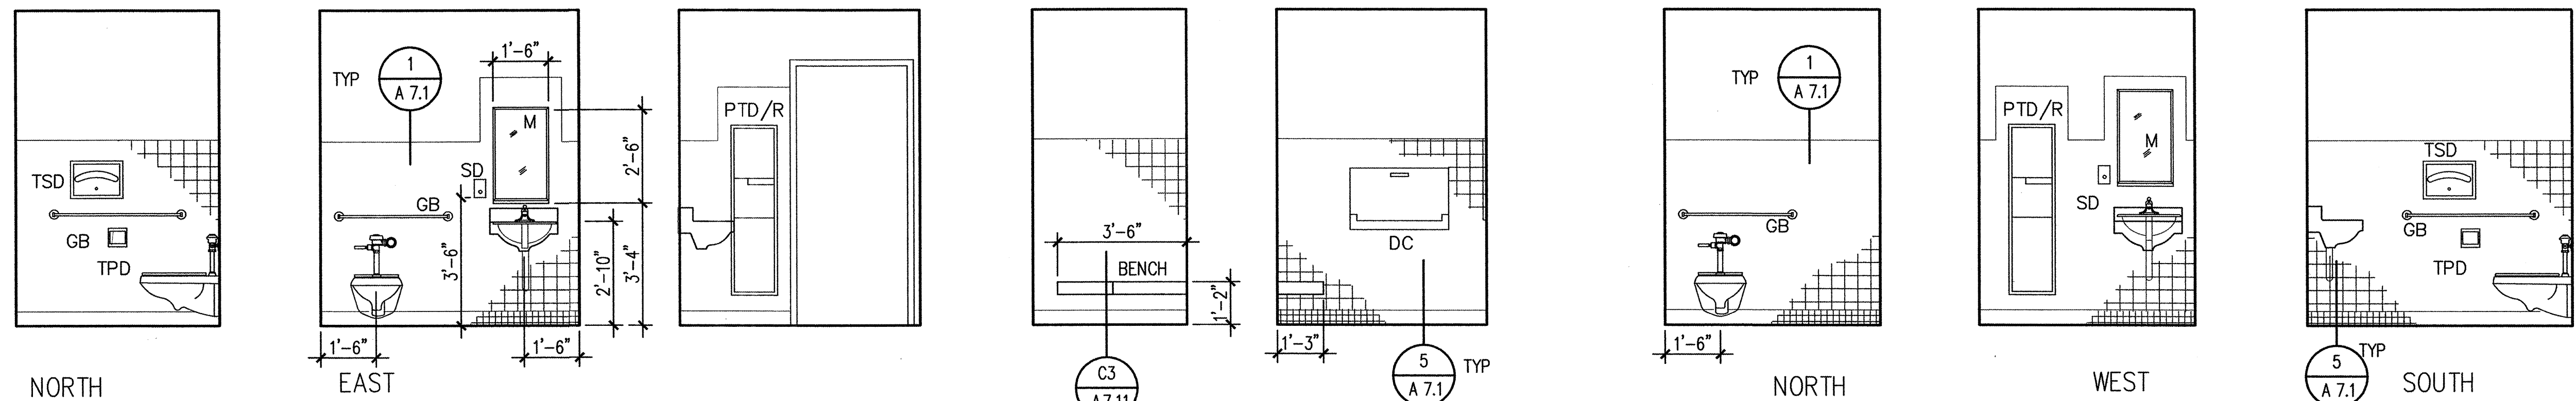
3 TOILET, ROOM 332
 3/8" = 1'-0"

SEE 1/A5.1 FOR TYPICAL MOUNTING HEIGHTS AND GRAB BAR PLACEMENT DIMENSIONS NOT SHOWN HERE.

FOR WAINSCOT TILE PATTERN, SEE 3/A7.1.

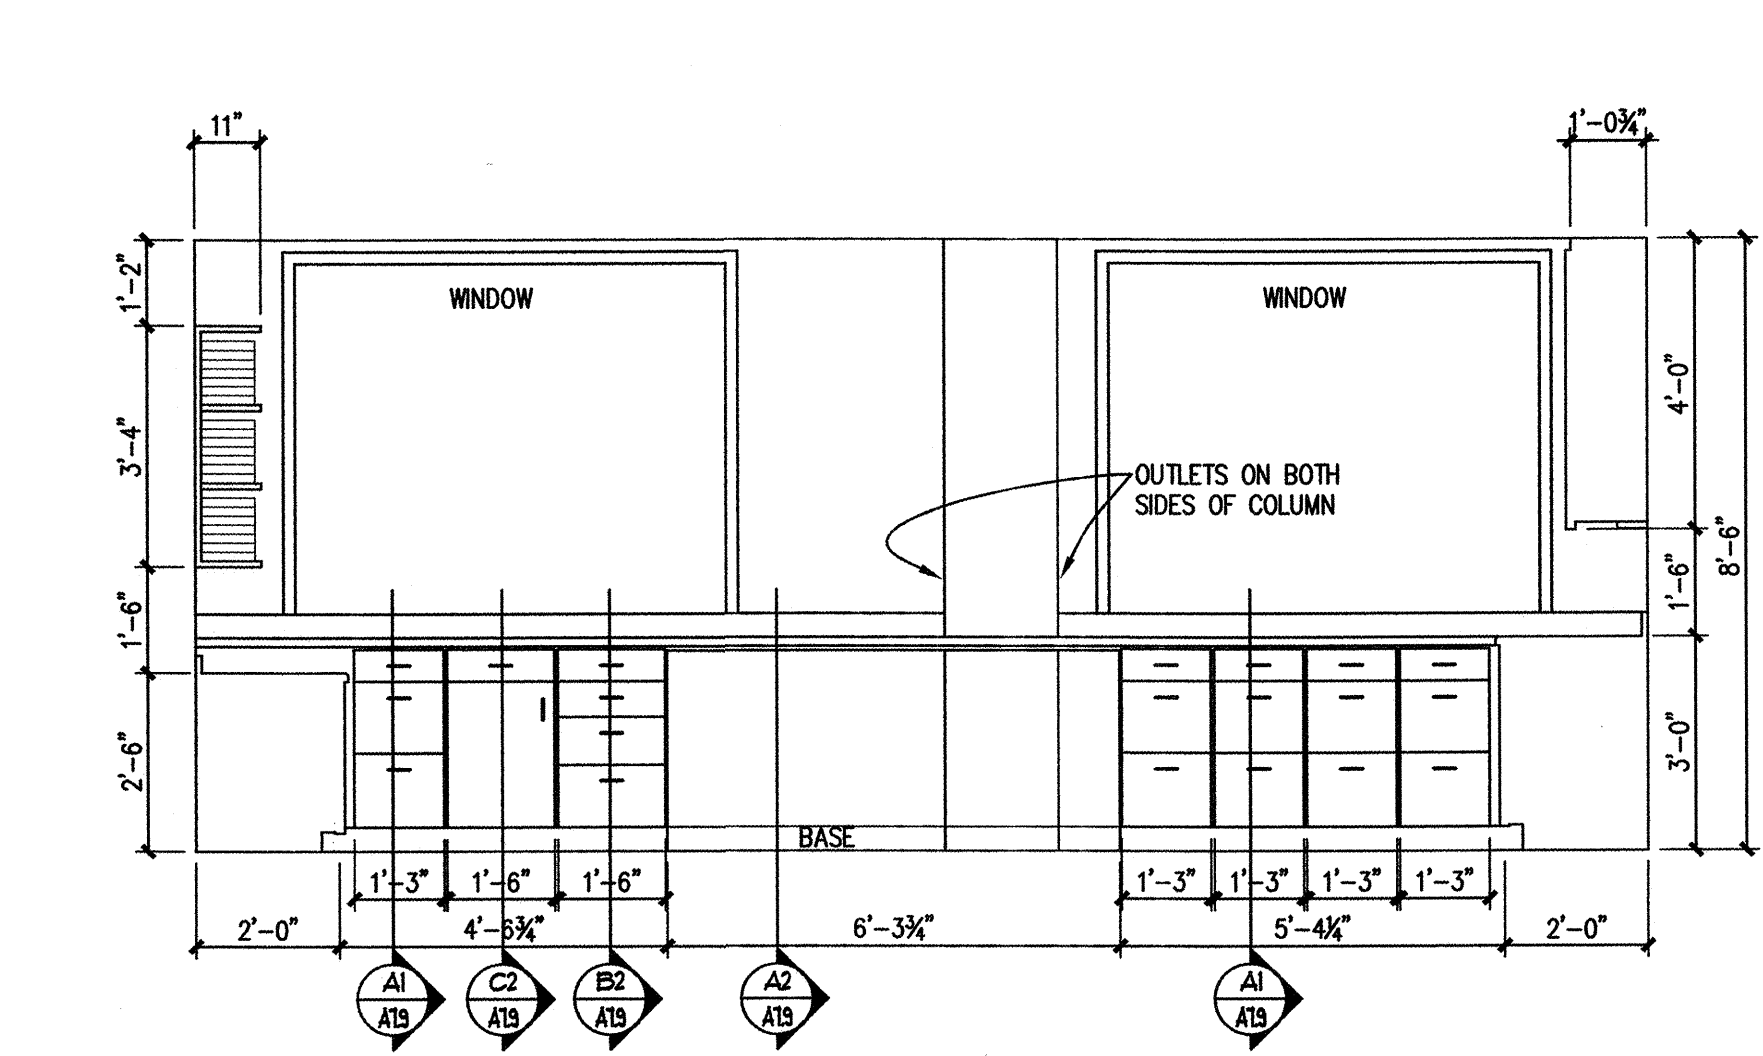
B3 LABORATORY - RM 221
 3/8" = 1'-0"

Pat, Mark has pointed us in the right direction on this one. The detail bugs at B3/A5.14 that read C1/A5.17 should both be edited to read C1/A7.8. The cubby/slots drawn on A5.14 are owner added at a later time.

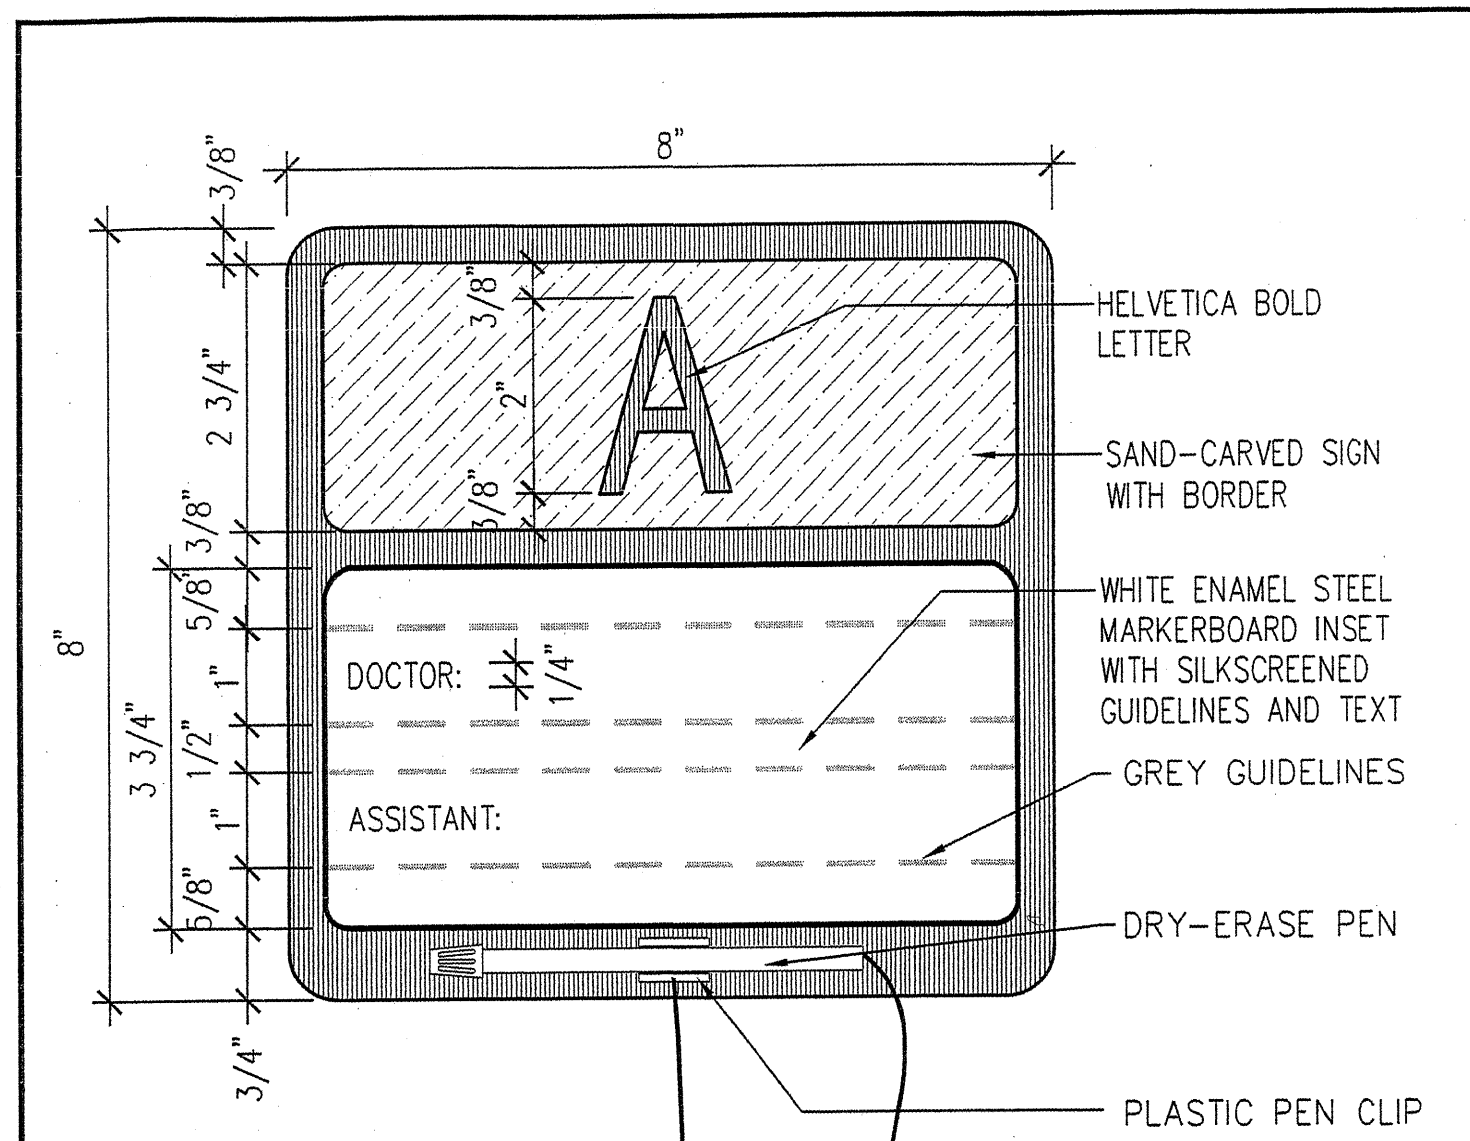
drawn JS title Panel Sign w/Markerboard
 checked JS
 date 3/5/03
 job no. 20152

NOTE: PROVIDE (21) SIGNS, LETTERED CONSECUTIVELY PER ATTACHED MEMO. ATTACH WITH DOUBLE-STICK TAPE TO DENTAL CABINETS.

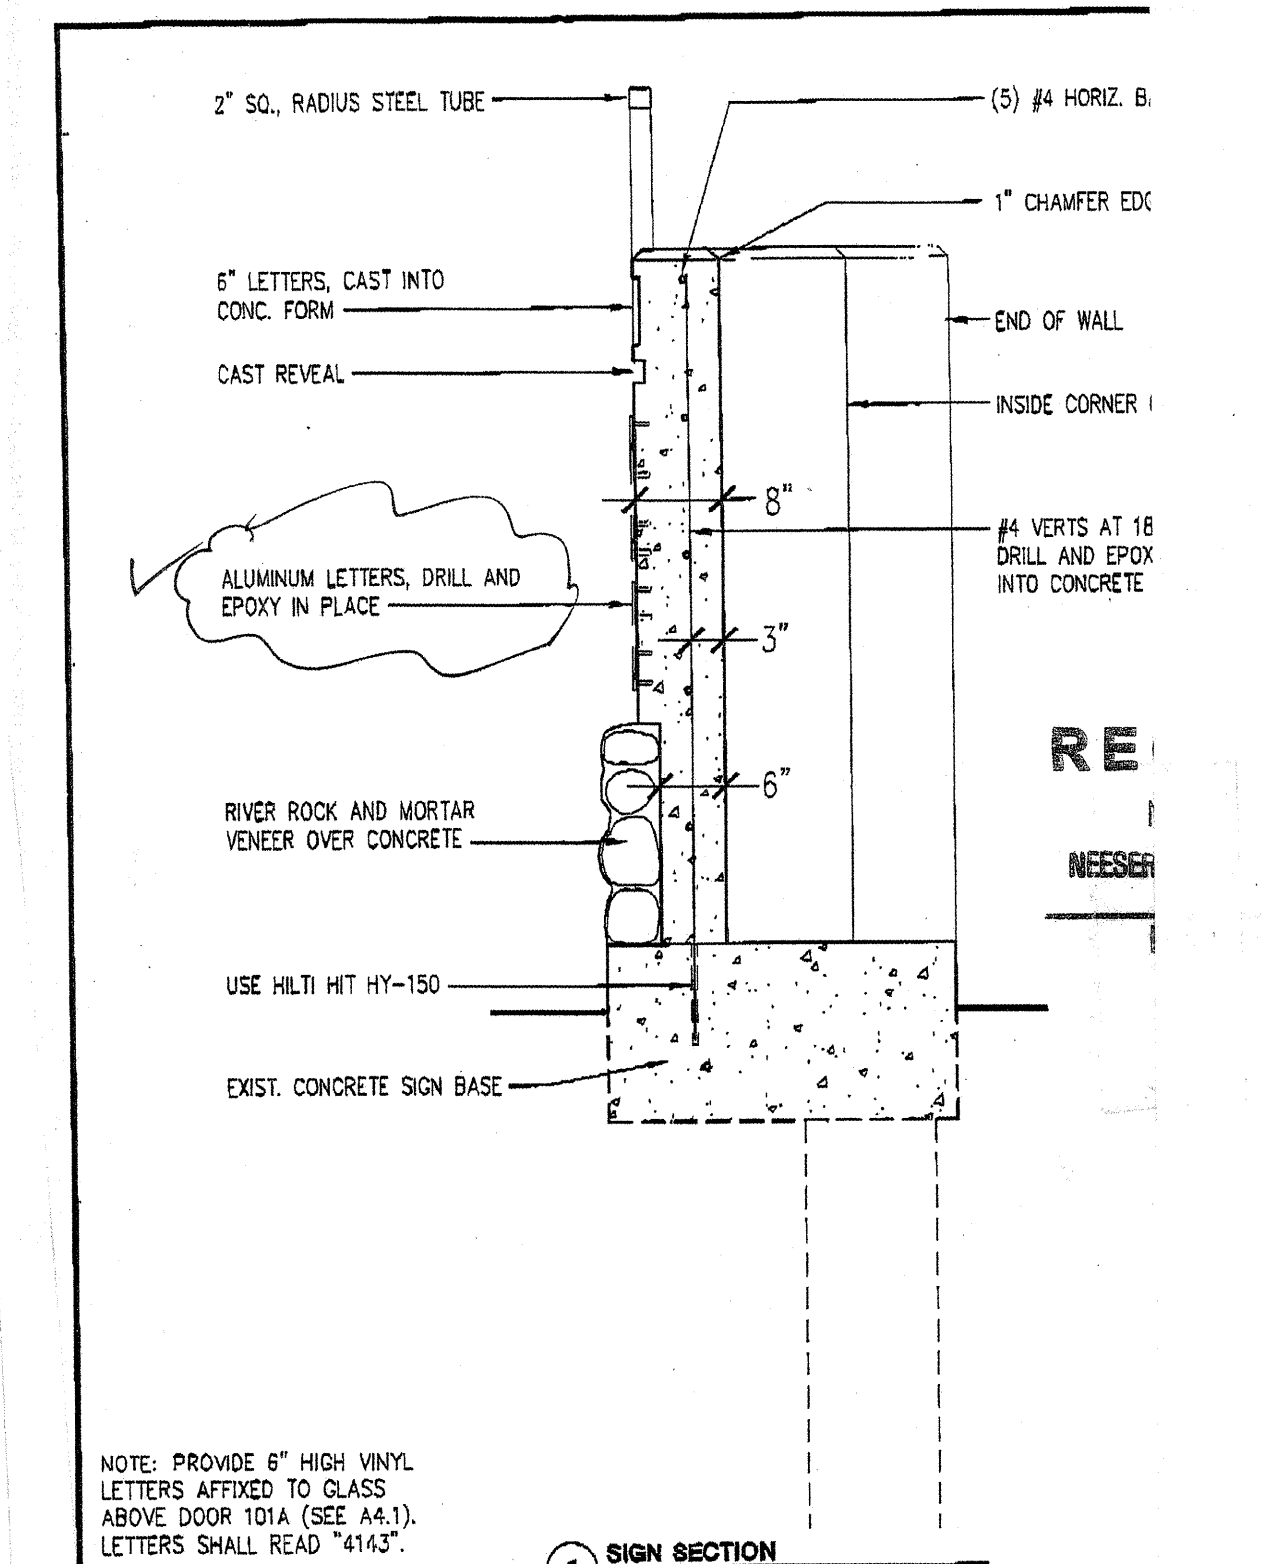
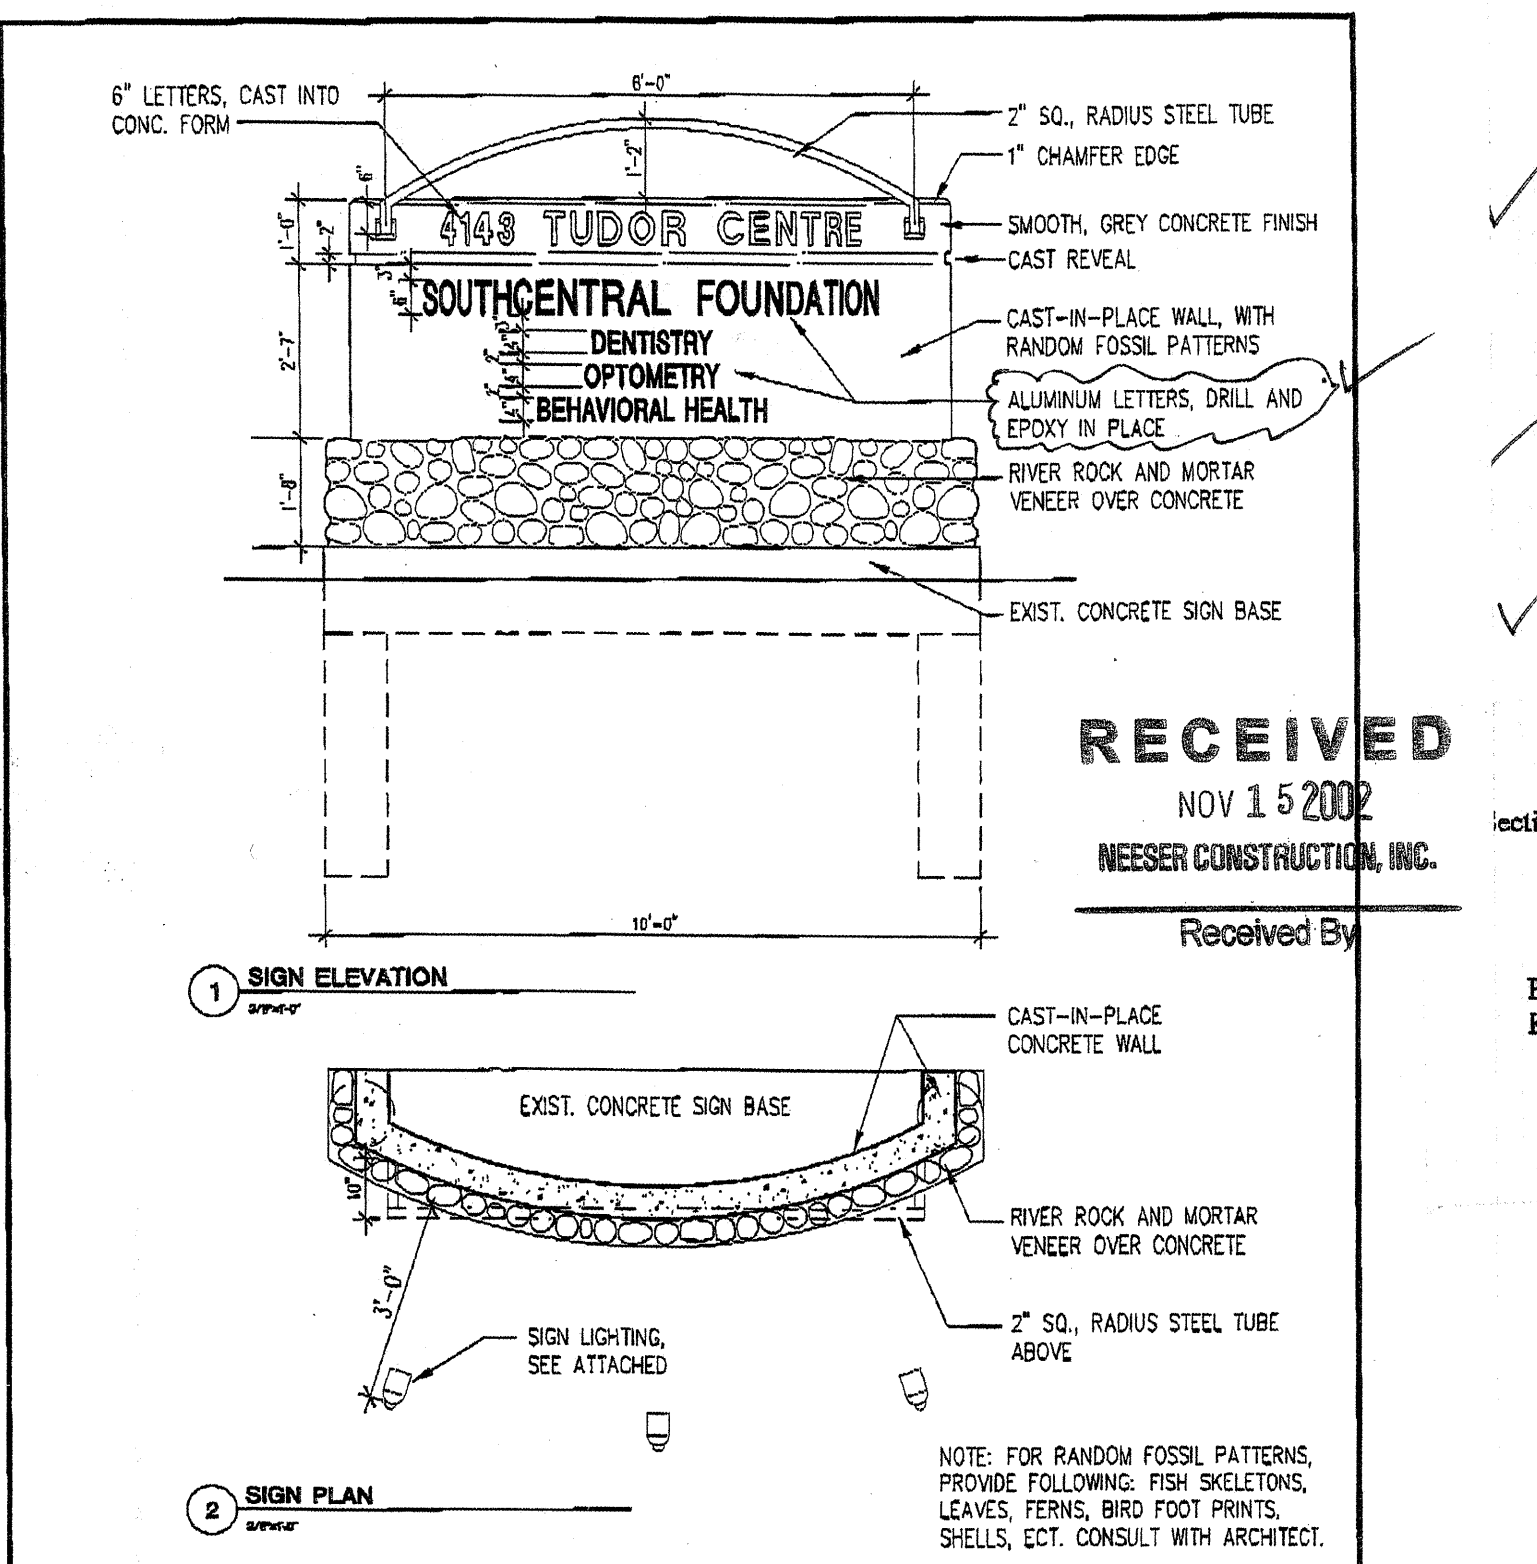
drawn JS title Monument Sign / Building Address
 checked JS
 date 11/6/02
 job no. 20152

- Exterior address/aluminum letters and numbers shall be fastened to the brick tile monument sign at the entry to the site and aluminum letters shall be fastened to the curved steel section above the front entry canopy. Kumin Associates will provide information on quantity of letters and verbiage, with input from Southcentral Foundation.
- Provide vinyl letters, 8" high on glass above main entry door to read "4143". Kumin Associates will confirm any additional vinyl lettering, (name, hours of operation, etc.) with Southcentral Foundation and revert.
- Kumin Associates will provide final details for facility monument sign by end of week (11-2-02).
