# SOUTHCENTRAL FOUNDATION

## Anchorage Native Primary Care Center Facility Conditions Assessment

ROOFS AND MECHANICAL EQUIPMENT

August 28, 2025

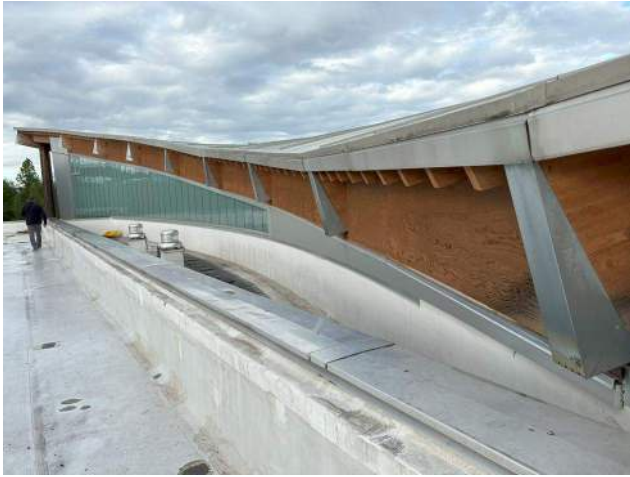
*Atrium – view from PCC1, looking southwest*

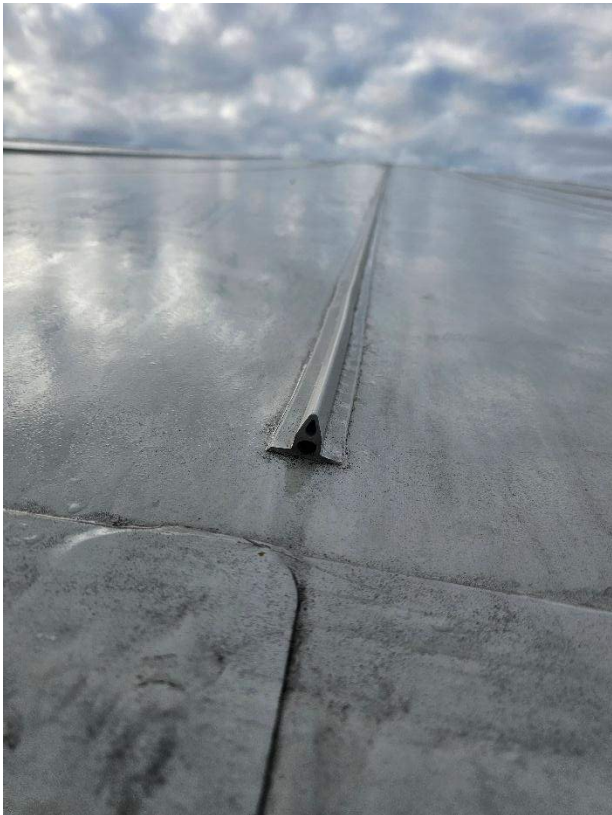
*Atrium – PVC rib*

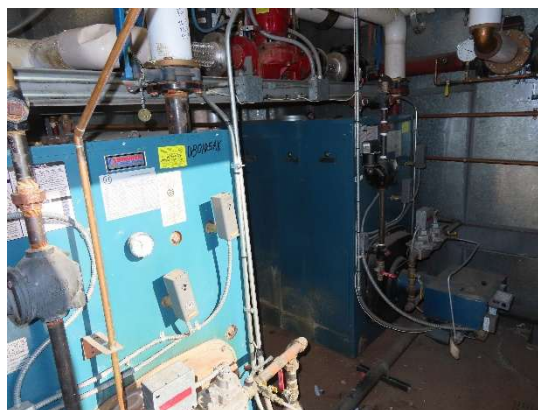
Heat is provided by two 959 MBH, natural gas fired, 3-pass, cast iron, hydronic boilers manufactured in 2002 and 2007, located in a rooftop penthouse. (photo at right)

| EEM No. | EEM Description | Estimated cost | Savings potential | Annual Cost savings | Simple payback (yrs) | Notes |
|---|---|---|---|---|---|---|
| 9 | Replace boilers as they reach their end of life (typically 25 years) with minimum 92% efficient condensing units | \$80,000 each, installed | 11% reduction in heating costs | \$17,129 | 18.7 | There are 4 standard efficiency boilers ranging in age from 2002 to 2008 |

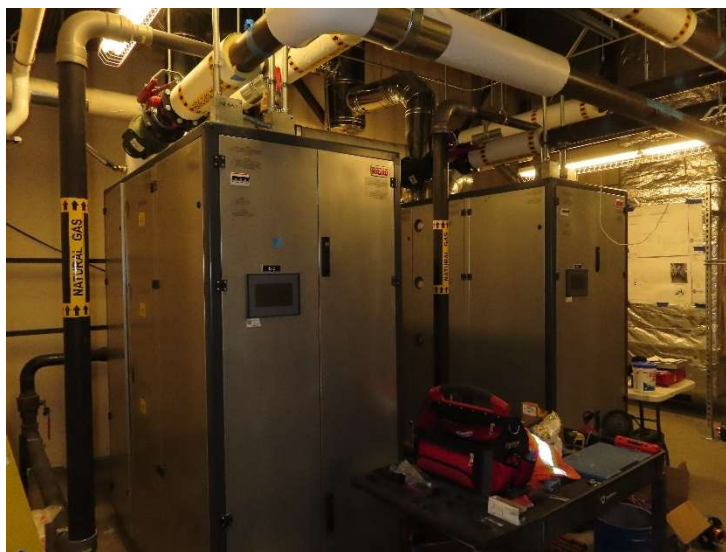
Heat is provided by two 3,000 MBH Riello condensing, hydronic boilers manufactured in 2023, located in a rooftop penthouse. (photo at right)

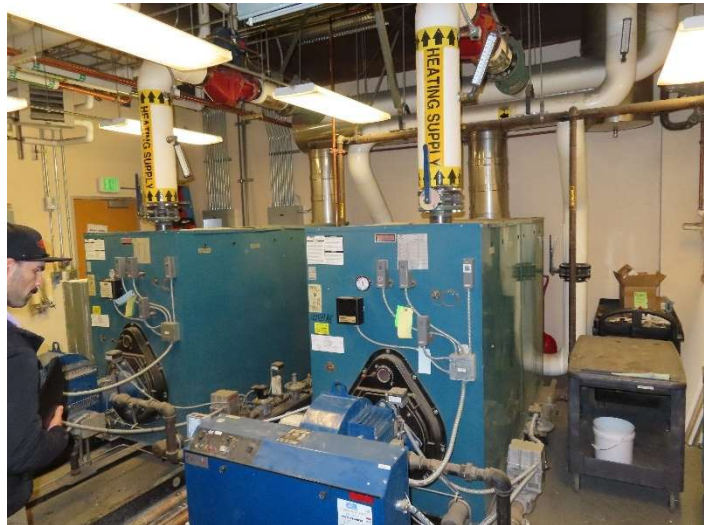
Heat is provided by two 2,957 MBH, natural gas fired, 3-pass, cast iron, hydronic boilers manufactured in 2008, located in the first floor PCC3 boiler room which is located in the PCC1 building. (photo at right)

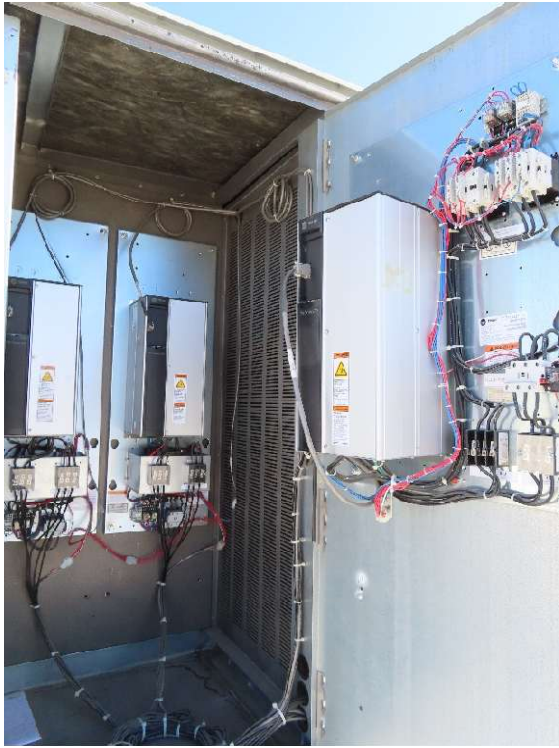
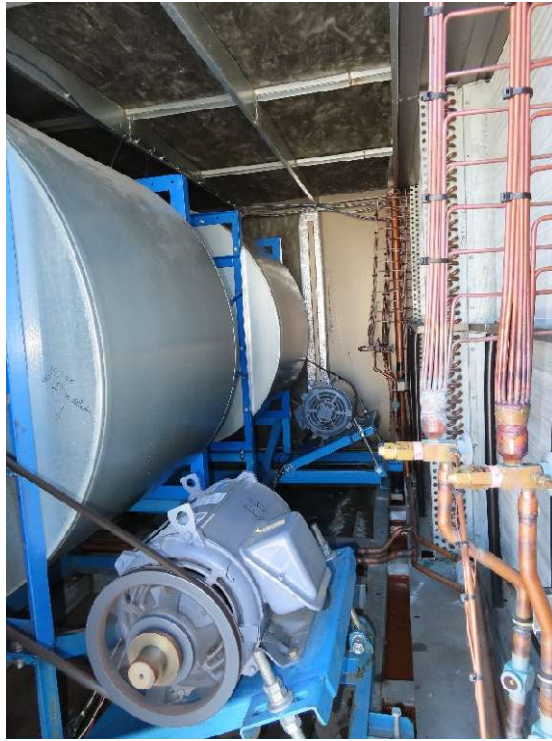
PCC3, RTU-2 VFD drives shown at left, 1 for each of 2 supply fan motors, shown at right and 1 for the return fan motor (not shown)
